Evaluation of Overhead Support Inspection Program

The Ohio Department of Transportation,
Office of Statewide Planning & Research

January 2015

Final Report

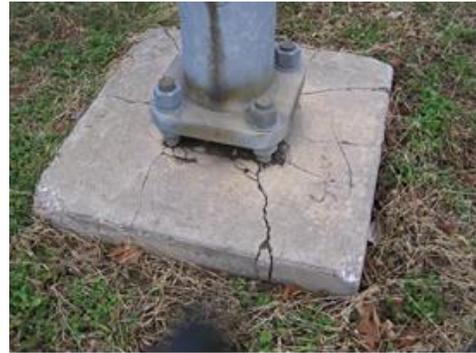
Figure 4.2 Cracked foundation

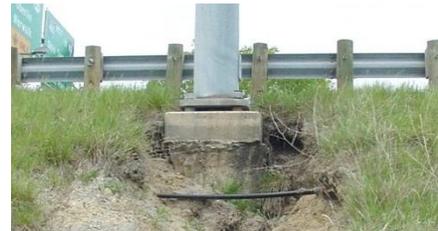
Figure 4.3 Soil erosion

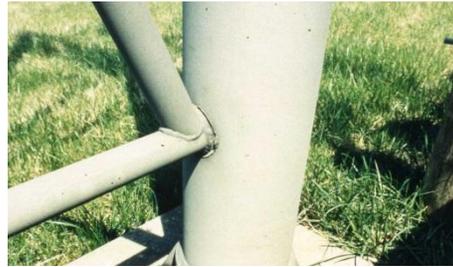
Figure 4.5 Cracked weld

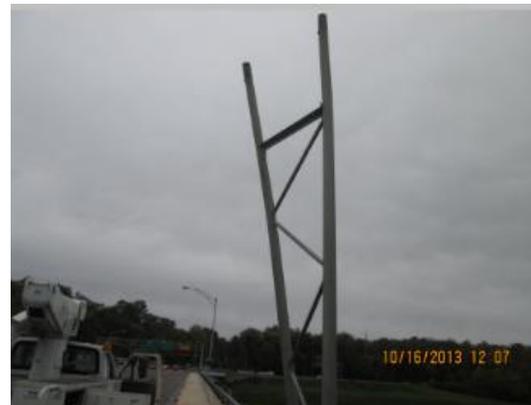
The one support rated as critical “1”, was a BMS box truss, in which the truss had been hit by a dump truck with its dump bed in the raised position. The truss was subsequently removed, but the end posts were still on the bridge at the time of inspection and the foundation components were inspected (Figure 5.29).

Figure 5.29 Damaged BMS

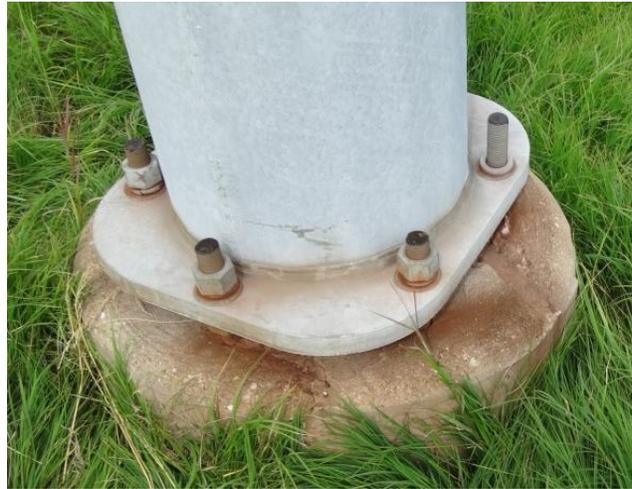
Figure 6.9 Missing anchor nut

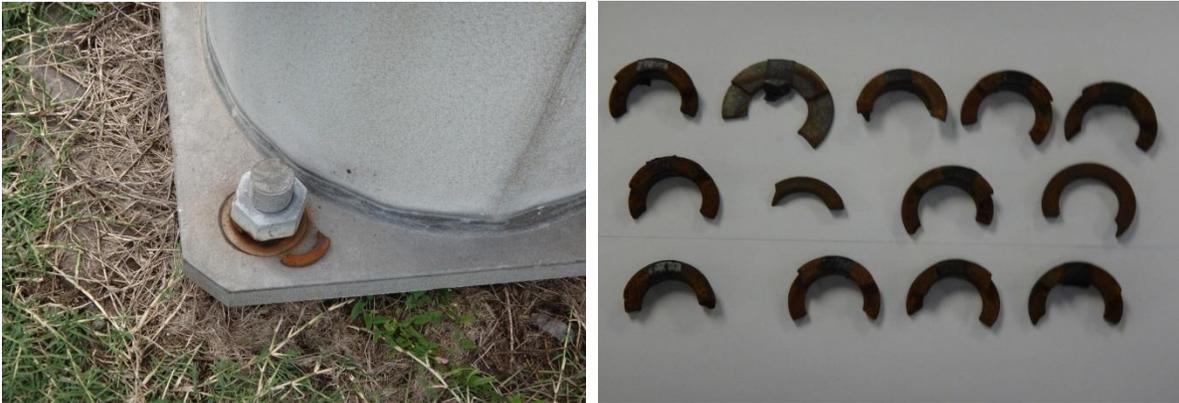
Figure 6.11 (Left) Cracked washers; (Right) Cracked washers collected by District 12
