MUS-93-12.84
Mine Grouting Project

A Straightforward Enigma

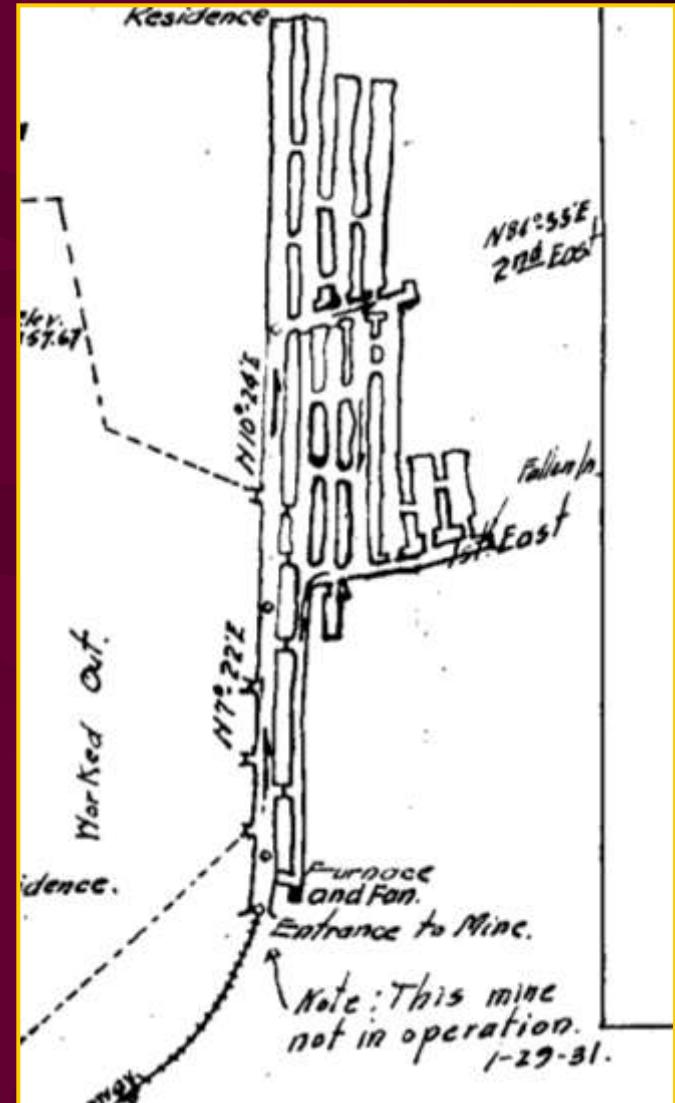
Ex. Mine Map (1.0 mi. east of MUS-93 project)

- Rooms driven on Face Cleat, N84°W.
- Long, Narrow Pillars.
- No Second (retreat) mining.
- Coal Elev. 858.0±; 30 ft. below MUS-93 site (El. 890.0).
- Drift entry from valley outcrop.

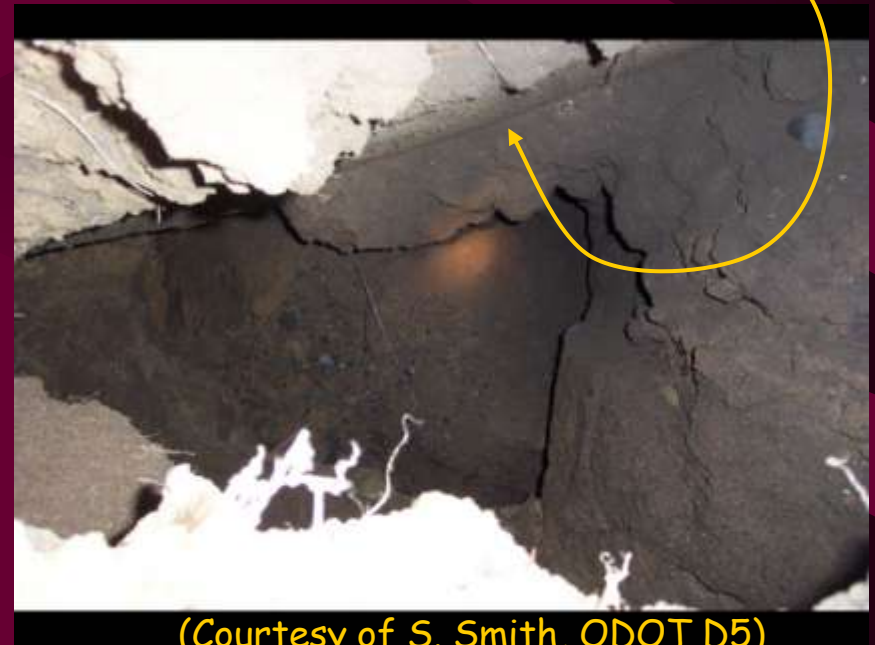
Photo taken inside sinkhole,
note abutment wall.

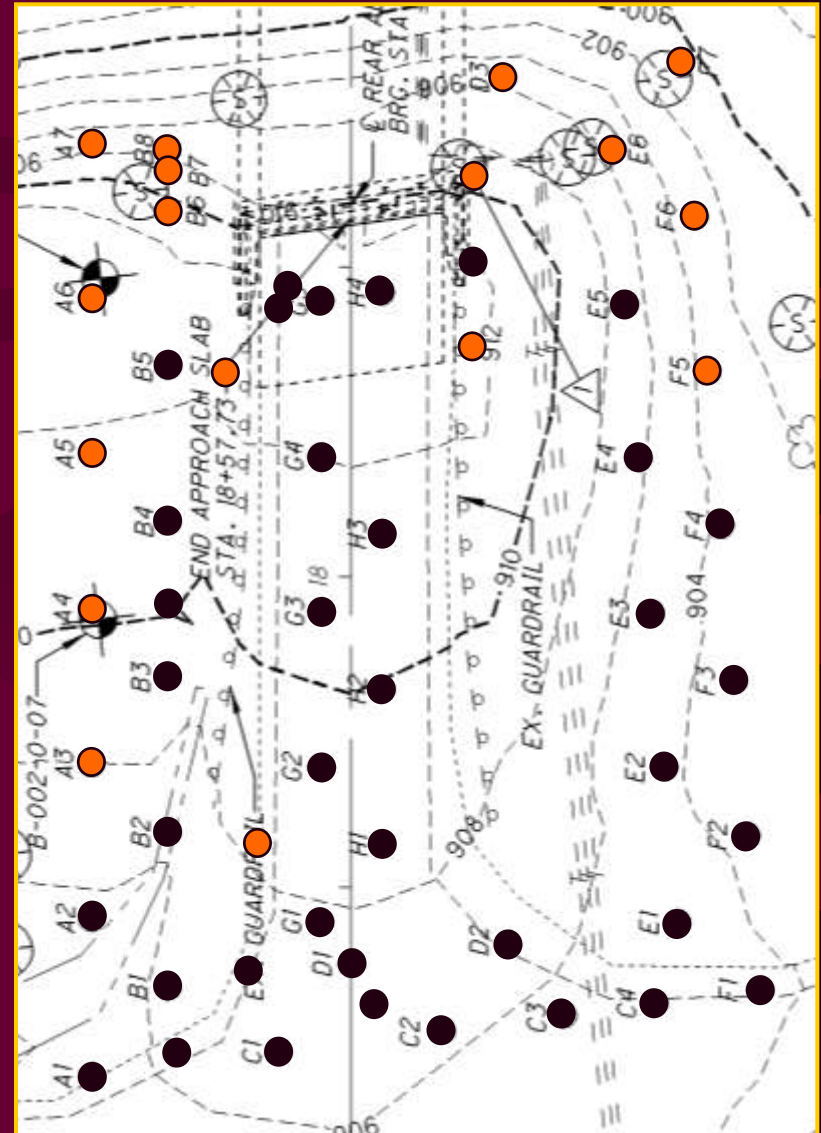
Enigmatic Anomaly #1

- North side I70 lots of open voids, South side mostly coal.
- Proximity to crop line and shallow cover contribute to poor roof stability.
- Proximity to probable entrance, more coal left insitu.

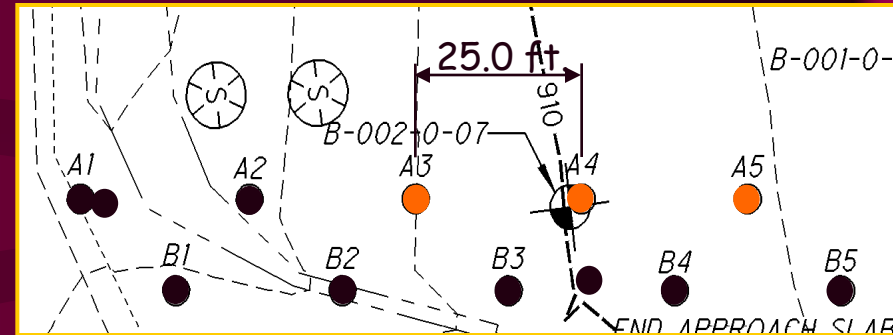
Enigmatic Anomaly #3

- A3 & A4 both encountered voids at 898.0 and 900.7, respectively. A3 was open 5 feet and full of water; A4 was open 5 feet and dry.
- Put light source in A3 could not see from A4.
- Borehole camera could see towards A3.
- A3 took 18 CY grout; A4 took 58 CY grout.
- Miners could have used soil to block rooms for ventilation control since this section of the mine was near the crop line.
- Possible collapse, but drilled like insitu material.

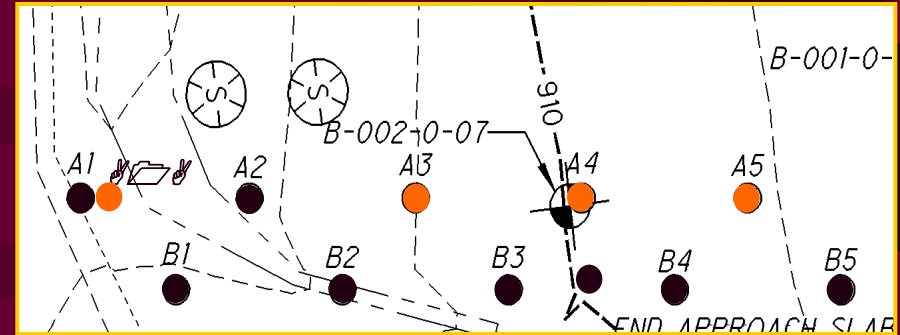
Enigmatic Anomaly #4

- A1 hit a coal pillar. A1A encountered a void. As soon as drill tools removed hole, hole would squeeze in with a highly plastic soil material. A1A was drilled out 3 times, same result.
- 9 feet of rock was drilled before encountering the void.
- Backfilled soil has become saturated enough to be at/near the liquid limit so as to act as a pseudo-liquid?
- Grout could not displace the "mud", virtually no take.

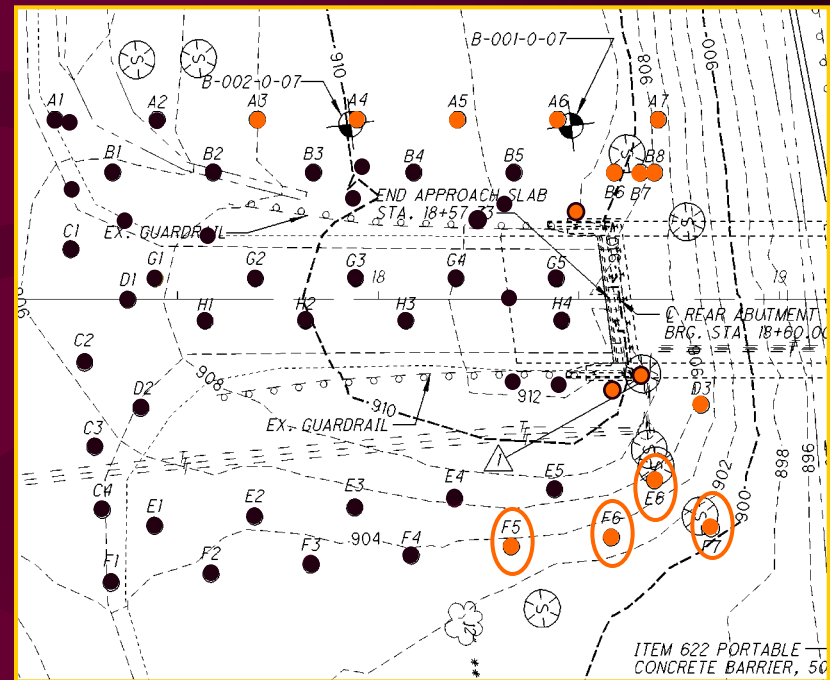
Enigmatic Anomaly #5

- E6, F5, F6, F7 encounter void 4 to 5 feet height but the camera inspection showed about 0.8 ft of open void and relatively horizontal soil backfill.
- This backfill was not as 'fluid' as that encountered in A1A.
- Whether the backfill was contemporaneous with the mining or part of the Interstate construction is unclear.

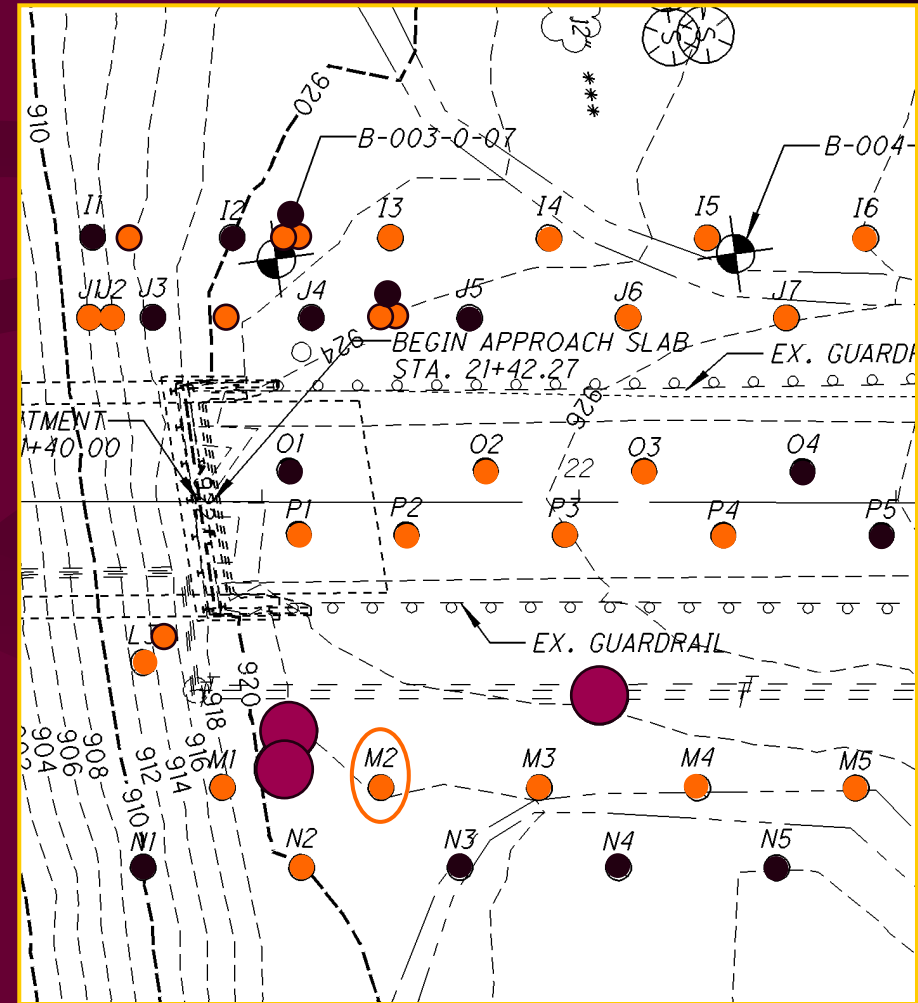
Enigmatic Anomaly #6

- M2 was drilled with 8-inch diameter air rig which never encountered rock. However, when grouted it took over 68 CY.
- Camera inspection suggested soil walls thru the bottom of mine elevation.
- Area likely a previous collapsed backfilled with soil or a backfilled air or water shaft.

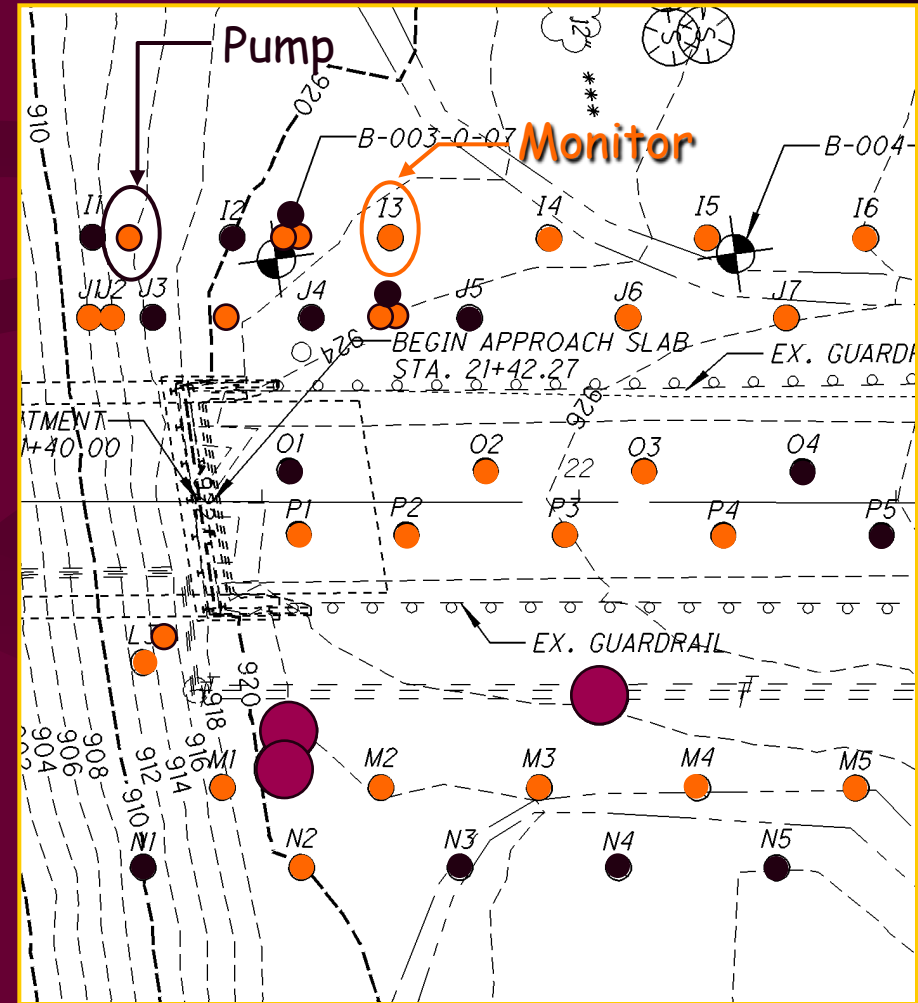
Enigmatic Anomaly #7

- Pump Test in I1A, monitored in I3. 4-inch Godwin, CD100M operating at 1900 rpm (710 gpm).
- Pumped for 88 minutes. Obtained a drawdown of 0.3 ft (30 min/0.1 ft).
- Wanted to drawdown pool ± 2 ft. (10 hrs.) so grout injection wouldn't overpressure the mine pool.
- 12 hours later the pump was sucking air.

- Hadn't Drilled entire North side to realize the local N-S dip.
- Mine floor at the pump was about 18' higher than surrounding mine.
- Proved that mine was above the regional GWT.

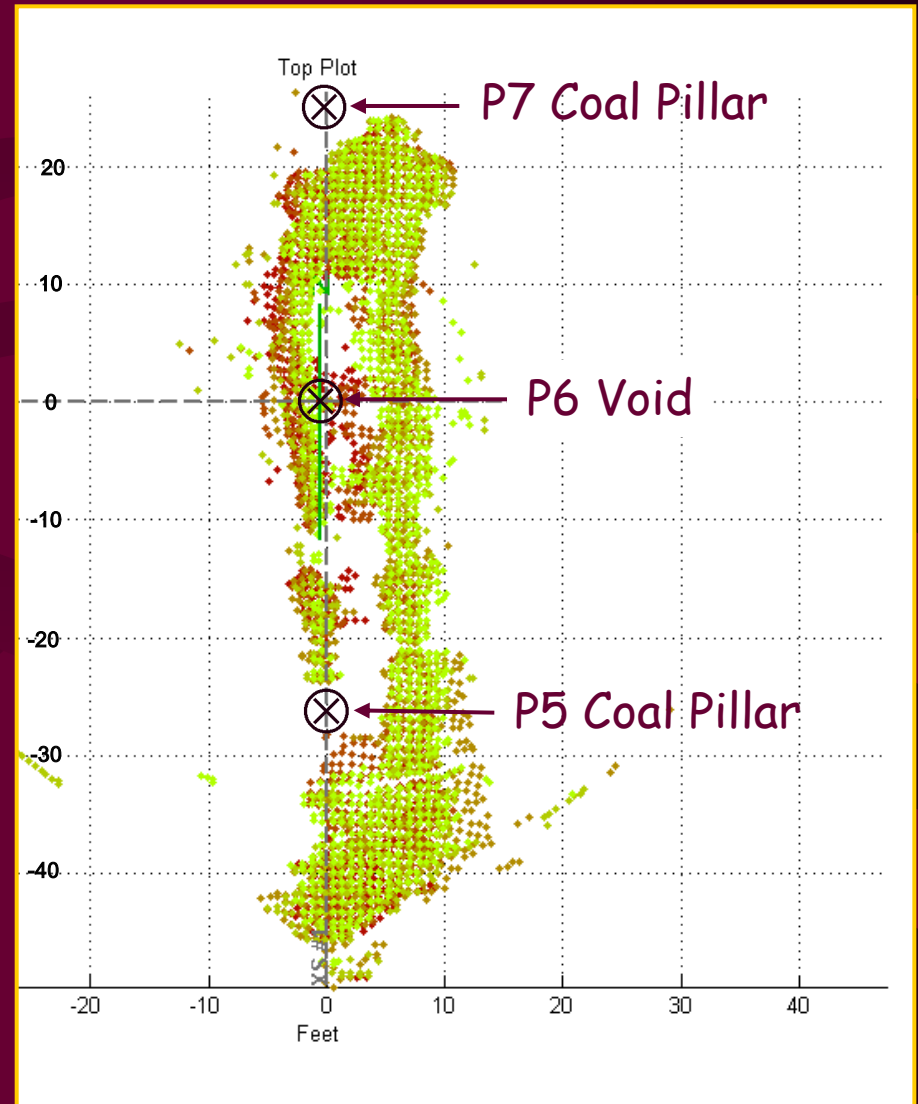
Sonar Mapping

- Scan in P6 revealed a void:
 - 2.5 ft. high.
 - 15 ft. wide.
 - 70 ft. long.
 - Est. volume 97 cy.
- Excellent correlation with borehole camera.
- P6 took 90 cy grout!
