DIRECTOR'S CLAIMS BOARD
ODOT Project 1060(09)
Claim 07-091060-02
Final Quantities – 304 Base and Asphalt Surface course
Decided: January 8, 2013

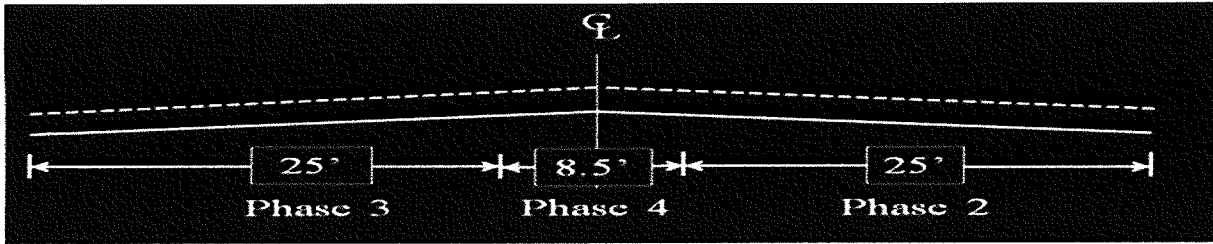
Figure A

constructed by working on 25' of the right lane, then 25' on the left lane, then the last 8.5' in the center (Figure A).

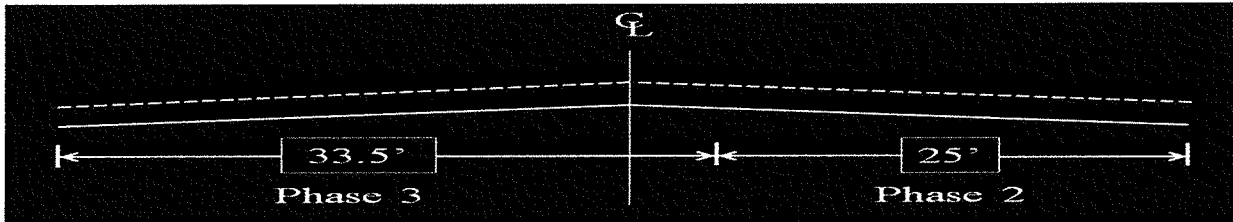
Figure B

Jergens modified this MOT plan to work on the first 25' of the right lane and then combined the center portion with the left lane and worked on the left 33.5' as one phase (Figure B). This was done without discussing the phasing change with ODOT.

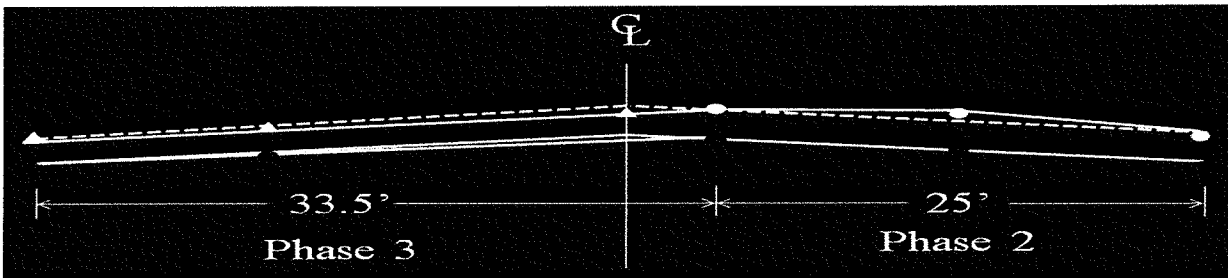
Figure C

During placement of the right lane (phase 2 below – yellow dotted) the Contractor laid additional asphalt over portions of the phase that created high spots that required grinding to correct (Figure C).

During placement of the left and center phase (phase 3 above – yellow triangle line) the Contractor did not account for the phase line movement and subsequently did not place the crown in the pavement. The correction was to mill off asphalt that was placed too high in phase 2 and place a variable depth scratch course (dashed line) of asphalt to create a constant cross slope, which in turn would allow for a uniform 1.5" surface course placement. This variable depth scratch course should have been from 0" at edge of pavement to 1.5" at the center line. Project documentation indicates the Contractor was notified during placement that the scratch course was being applied too thick but the Contractor ignored this communication. Since the Contractor started the variable scratch course too thick and held a constant cross slope, the thickness at the crown was in excess of 2½" or more. Elevations taken throughout the project show variations from plan in excess of 2".
