# Summary of Findings Concerning Longitudinal Cracking on 16' Wide Ramps

Office of Pavement Engineering  
October 14, 2003

**Abstract:** This paper summarizes the current practice in ODOT regarding the construction of rigid pavement ramps and recent problems reported with cracking.

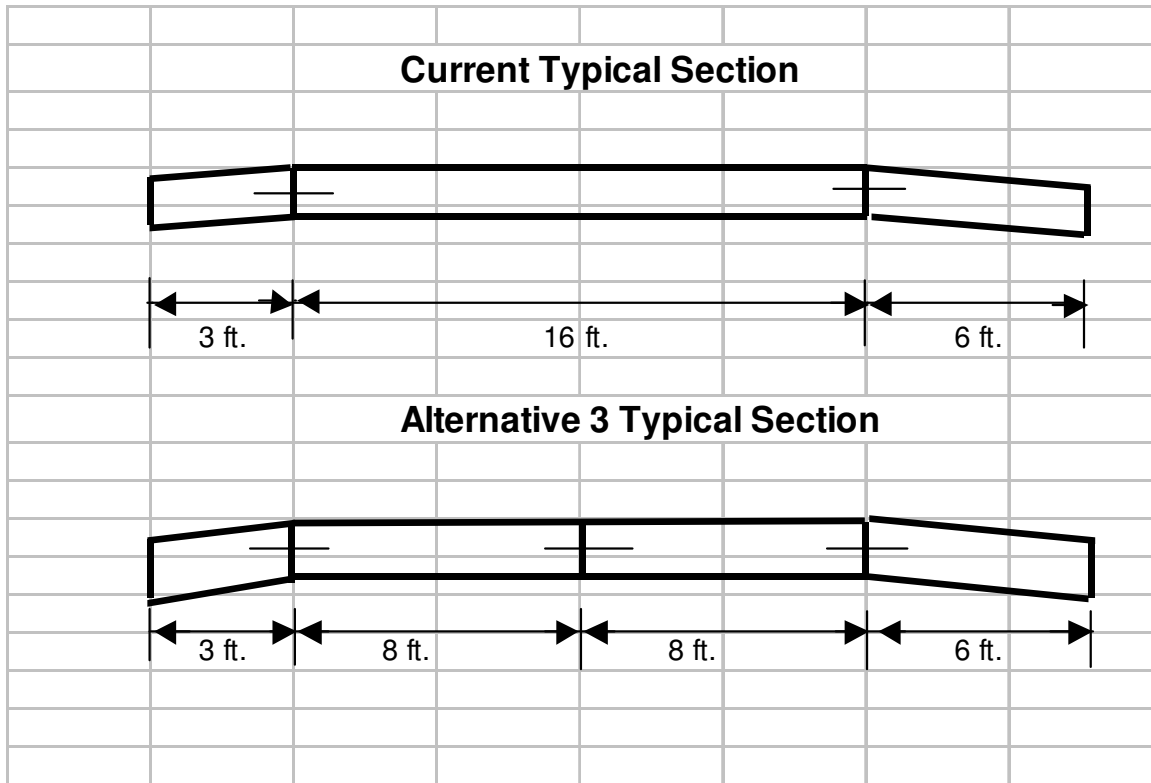
**Alternative 3:** Provide the same cross section as is currently specified, with an additional longitudinal joint in the center of the ramp. The ramp can be constructed with current methods. The ramp can be repaired in the future using part width construction while maintaining traffic.
