Road Safety Audit 2011

OTT – SR-53
0.00 to 5.37

ODOT District 2
Office of Planning & Programs
June 29, 2011

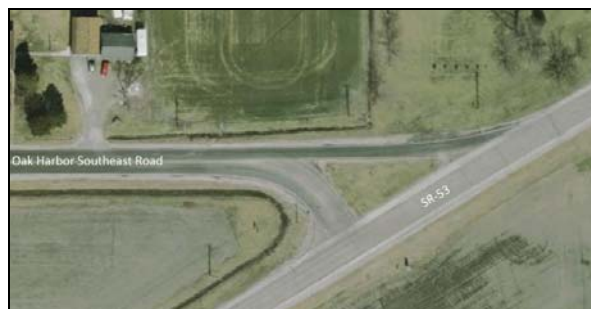
There are several intersections within the RSA section that have unique geometry. Little Portage East Road, Oak Harbor Southeast Road, and Darr-Hopfinger Road all have a slip lane for motorists traveling south on SR-53 to utilize when making a right-turn movement. See figure below.

The unique geometry at Little Portage East Road, Oak Harbor Southeast Road, and Darr-Hopfinger Road does not appear to be causing crash problems although these are intersections that should be monitored. A short term countermeasure of installing double yellow pavement markings north and south of the intersection has been identified due to the split movements of the vehicles entering and exiting these intersections. No crash pattern was identified at these intersections but the RSA team believes these markings will enhance the safety of the intersections.

- 3. Pavement Markings
 - i. Centerline
 - 1. Install Double Yellow on sweeping curve north of Paulsen Road
 - 2. Install Double Yellow at the three (3) intersections with unique geometry
 - a. Little Portage East Road (300' north and south of intersection)
 - b. Oak Harbor Southeast Road (300' north and south of intersection)
 - c. Darr-Hopfinger Road (300' north and south of intersection)

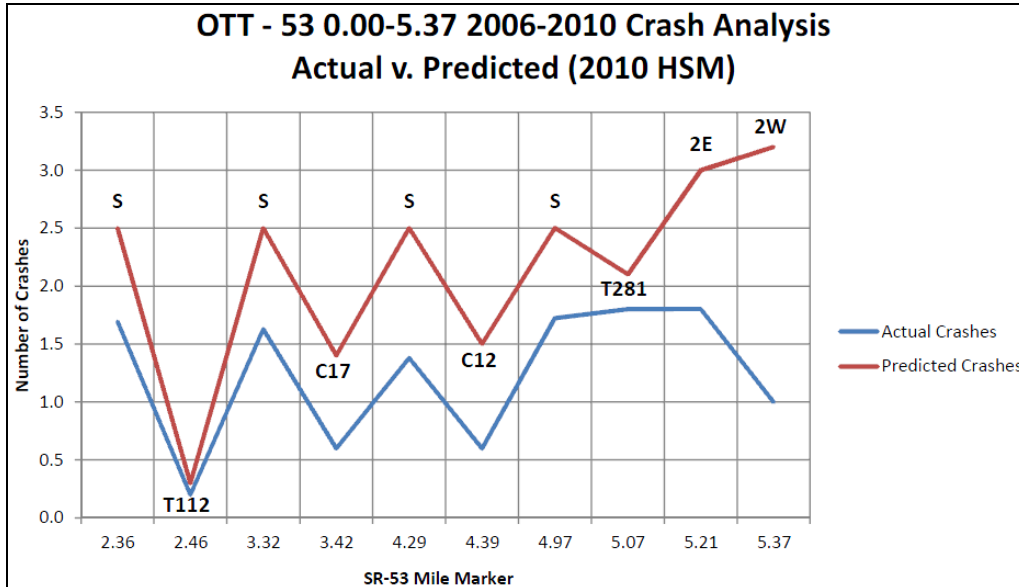
Crash rates for all the intersections within the RSA section were calculated and compared to the predicted rates per the *2010 Roadway Safety Manual*. For all intersections and roadway segments of the RSA the actual crash rate between 2006 and 2010 were lower than the predicted crash rate. See below for the graph and **Appendix H** for all the details.

Code	Location	Segment	Actual*	Actual Per year	Actual Per Location	Predicted	Reference	
S	Section	0	2.36	20	4	1.7	2.5	Figure 10-3
T112	Little Portage East	2.36	2.46	1	0.2	0.2	0.3	Figure 10-4
S	Section	2.46	3.32	7	1.4	1.6	2.5	Figure 10-3
C17	Oak Harbor SE	3.32	3.42	3	0.6	0.6	1.4	Figure 10-4
S	Section	3.42	4.29	6	1.2	1.4	2.5	Figure 10-3
C12	Darr-Hopfinger	4.29	4.39	3	0.6	0.6	1.5	Figure 10-4
S	Section	4.39	4.97	5	1	1.7	2.5	Figure 10-3
T281	Wilcox	4.97	5.07	9	1.8	1.8	2.1	Figure 10-4
2 E	SR-2 East	5.06	5.21	9	1.8	1.8	3	Figure 10-4
2 W	SR-2 West	5.21	5.37	5	1	1.0	3.2	Figure 10-4
*2006-2010 crashes			Total	68
