OTEC 2007 - Bridge Innovation

Performance of Distributed Anode System for Slab Bridge on I-75

ODOT - District 7, Planning

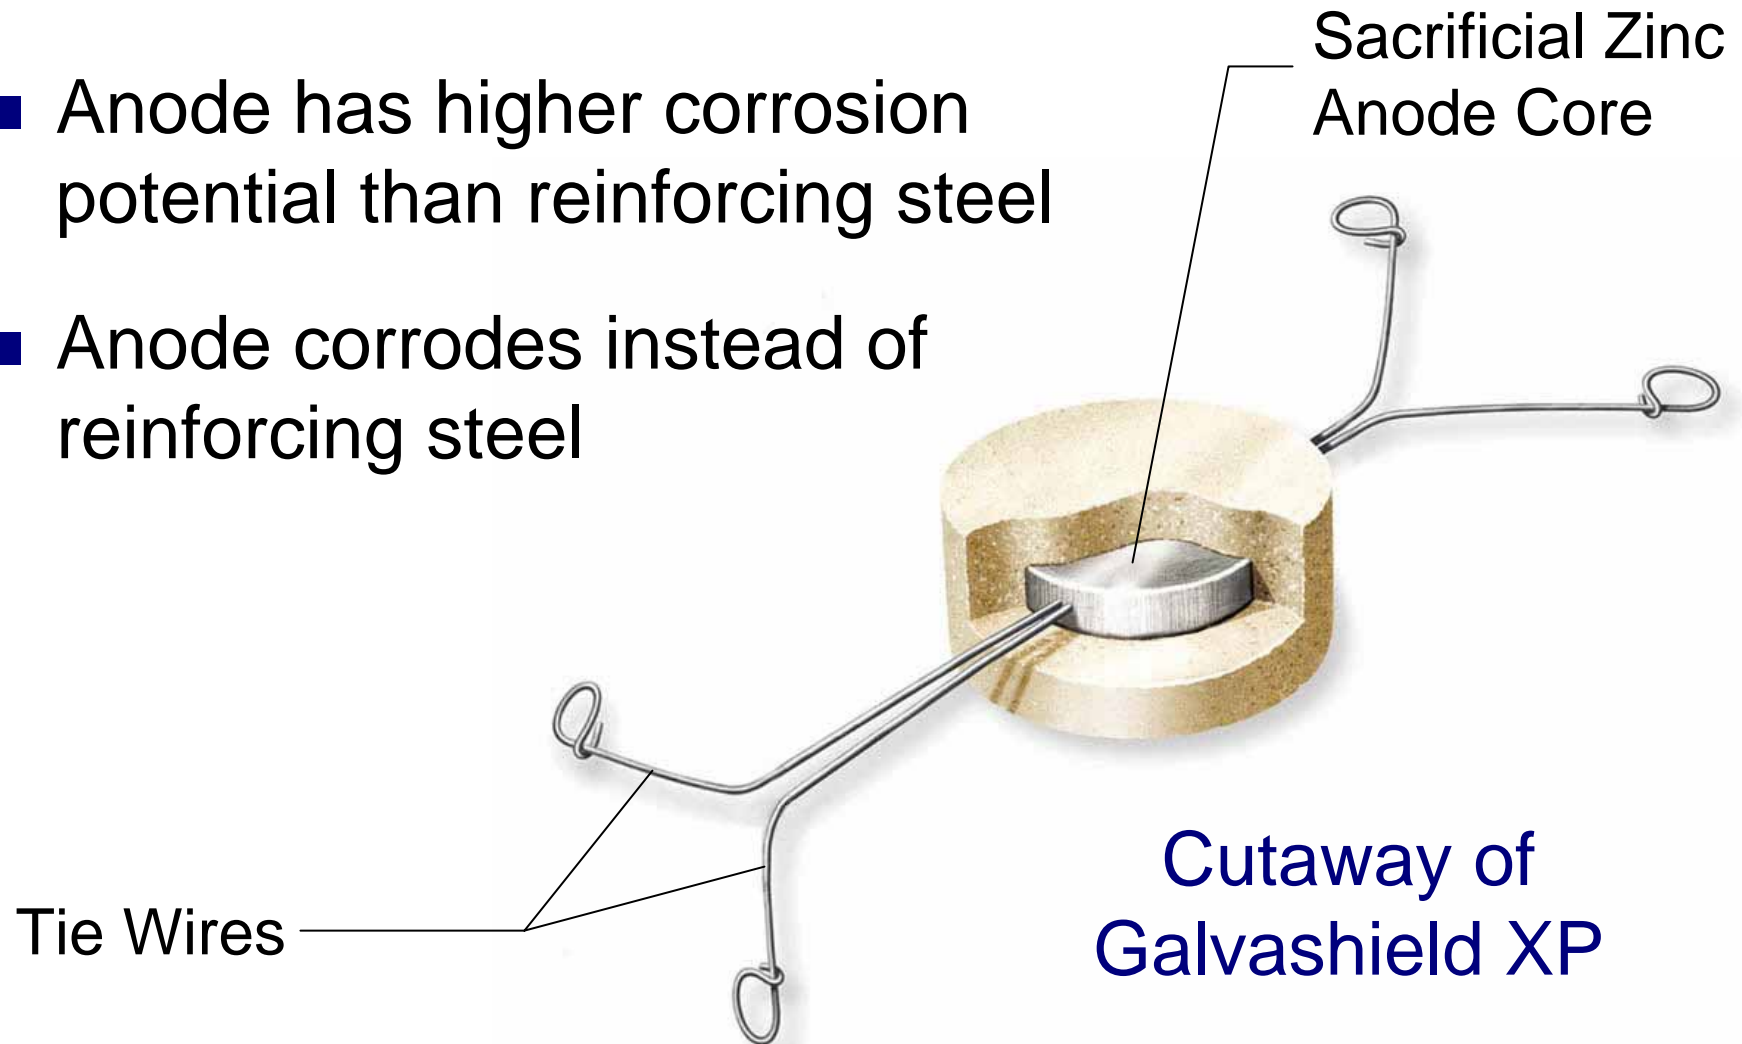
Galvashield XP “Pucks”

What Anode Is and How It Works

- Anode has higher corrosion potential than reinforcing steel
- Anode corrodes instead of reinforcing steel

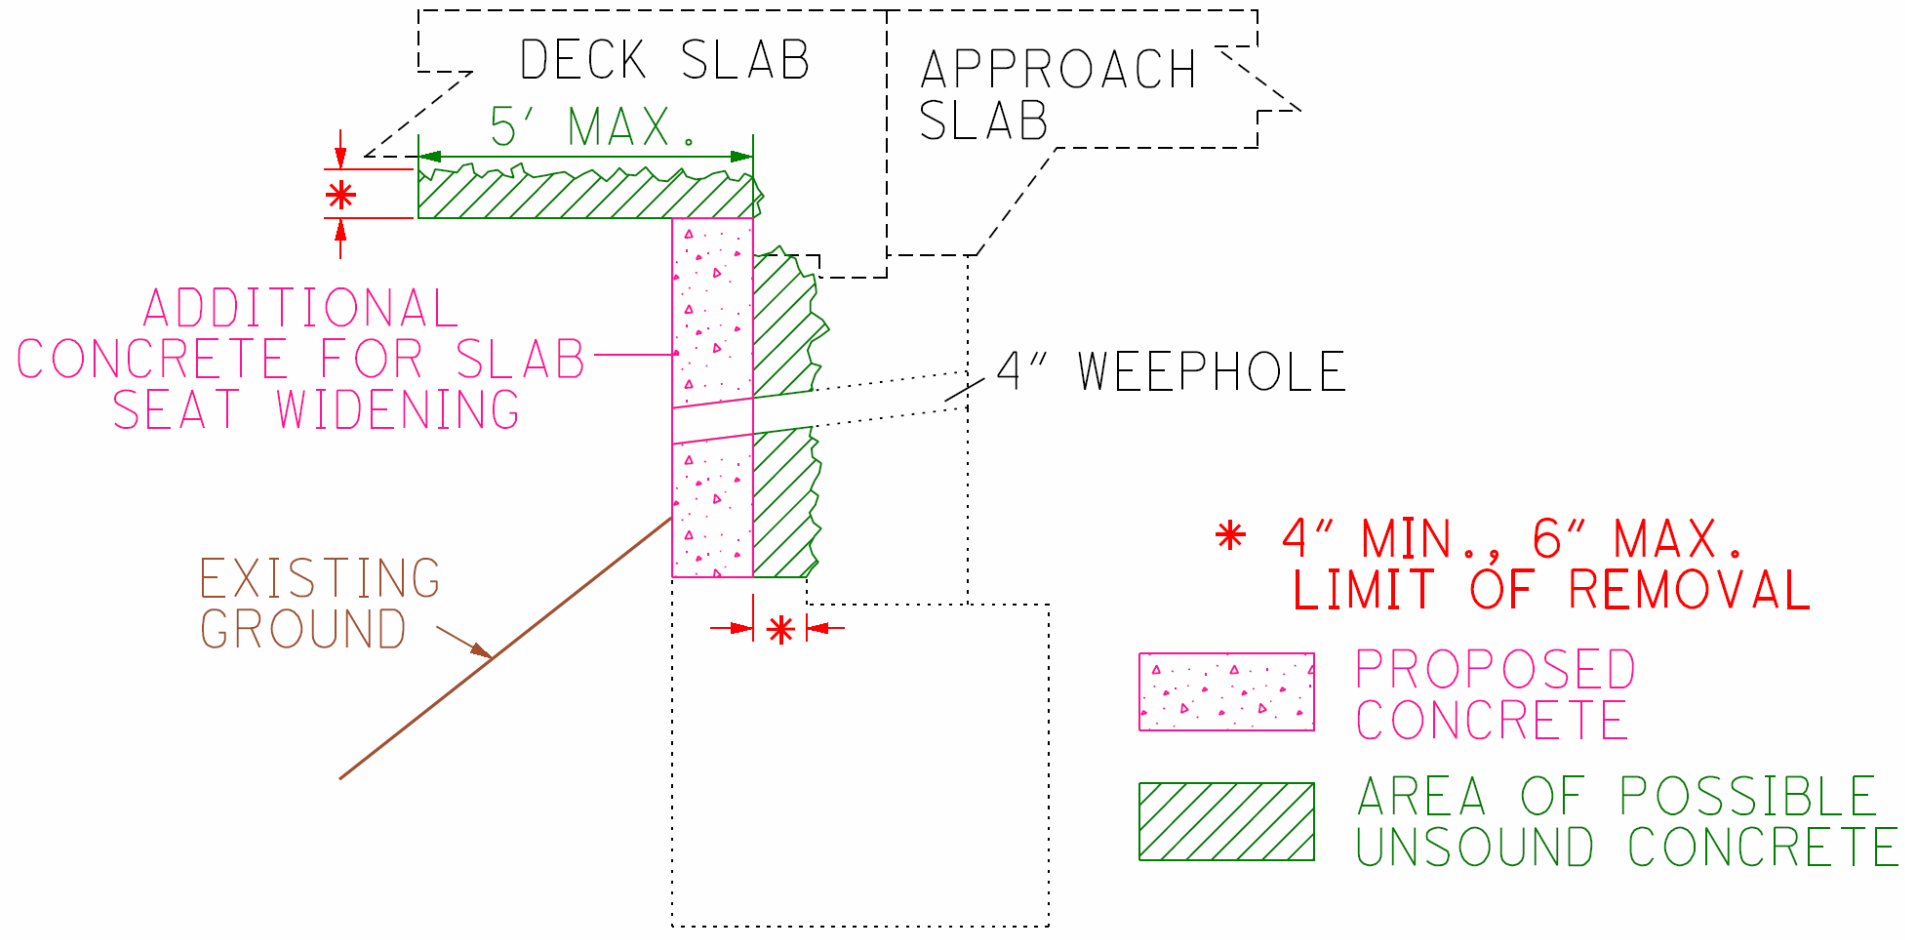
SECTION A-A

CONCRETE REMOVAL AND REPLACEMENT

Concrete Removal

- Remove less than 6"
- If more than 6", contractor to perform structural assessment
- Temporary shoring may be needed

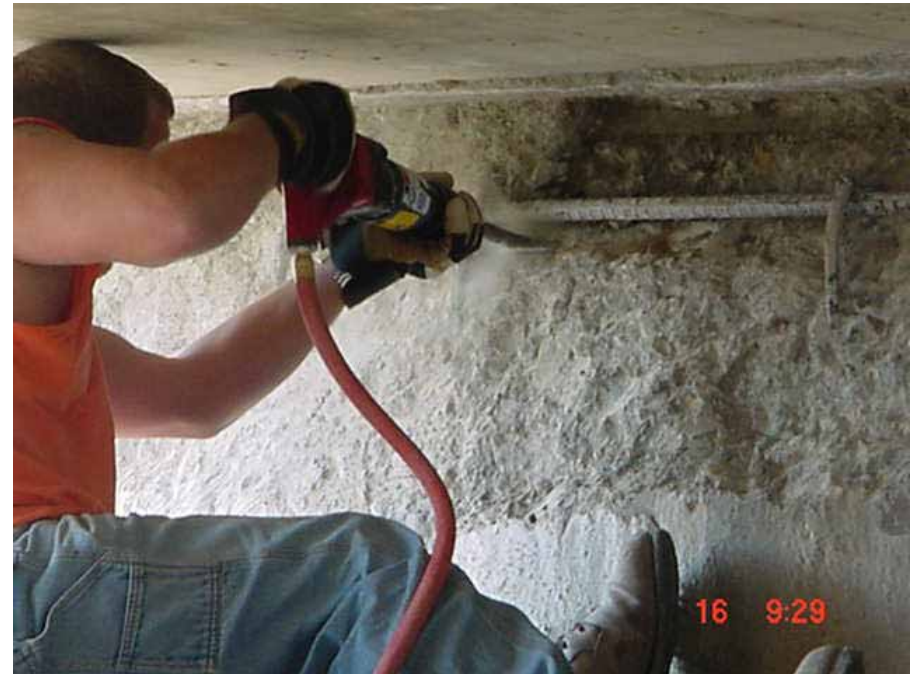
Temporary Shoring

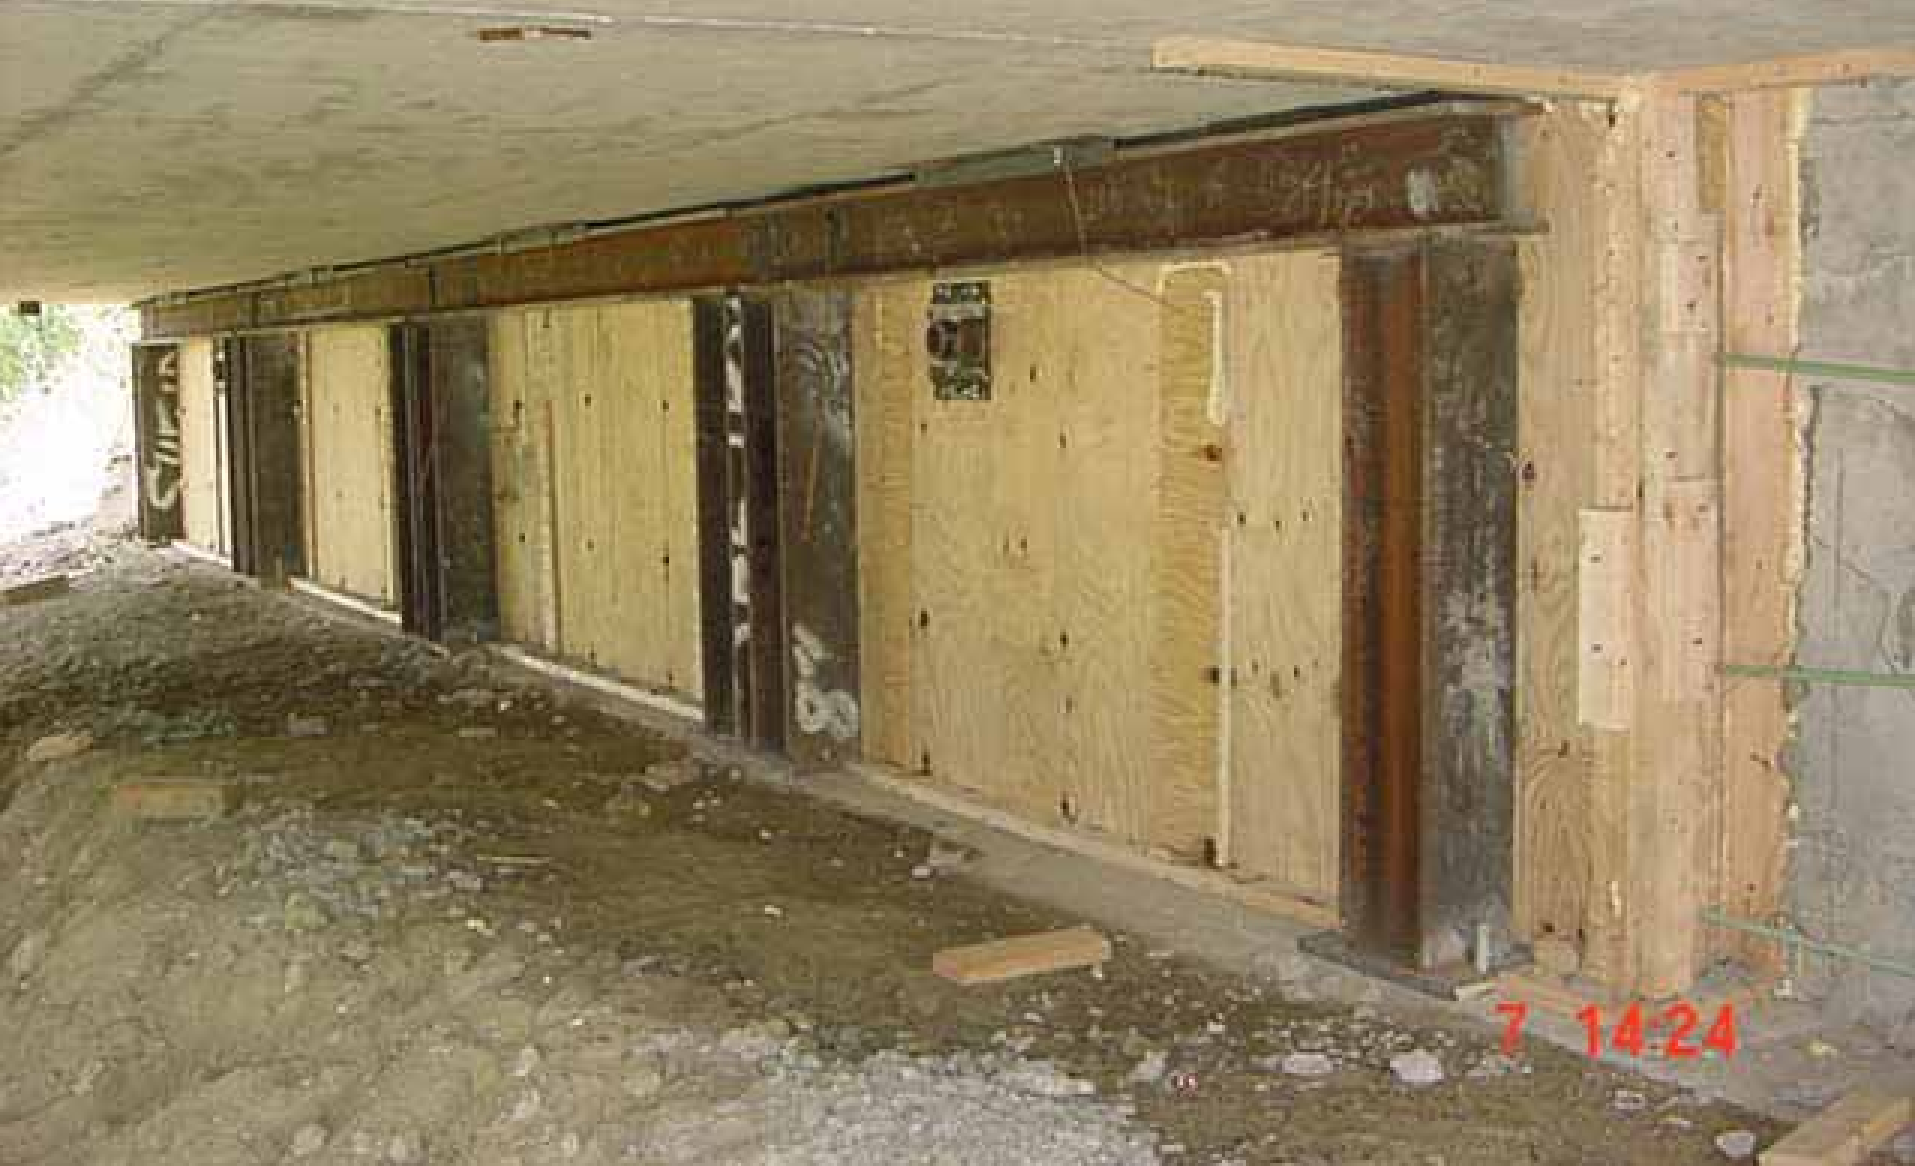
Part Width for Superloads

- Blanket permits issued up to 120,000 lbs.
- Loads must be accommodated throughout rehabilitation process

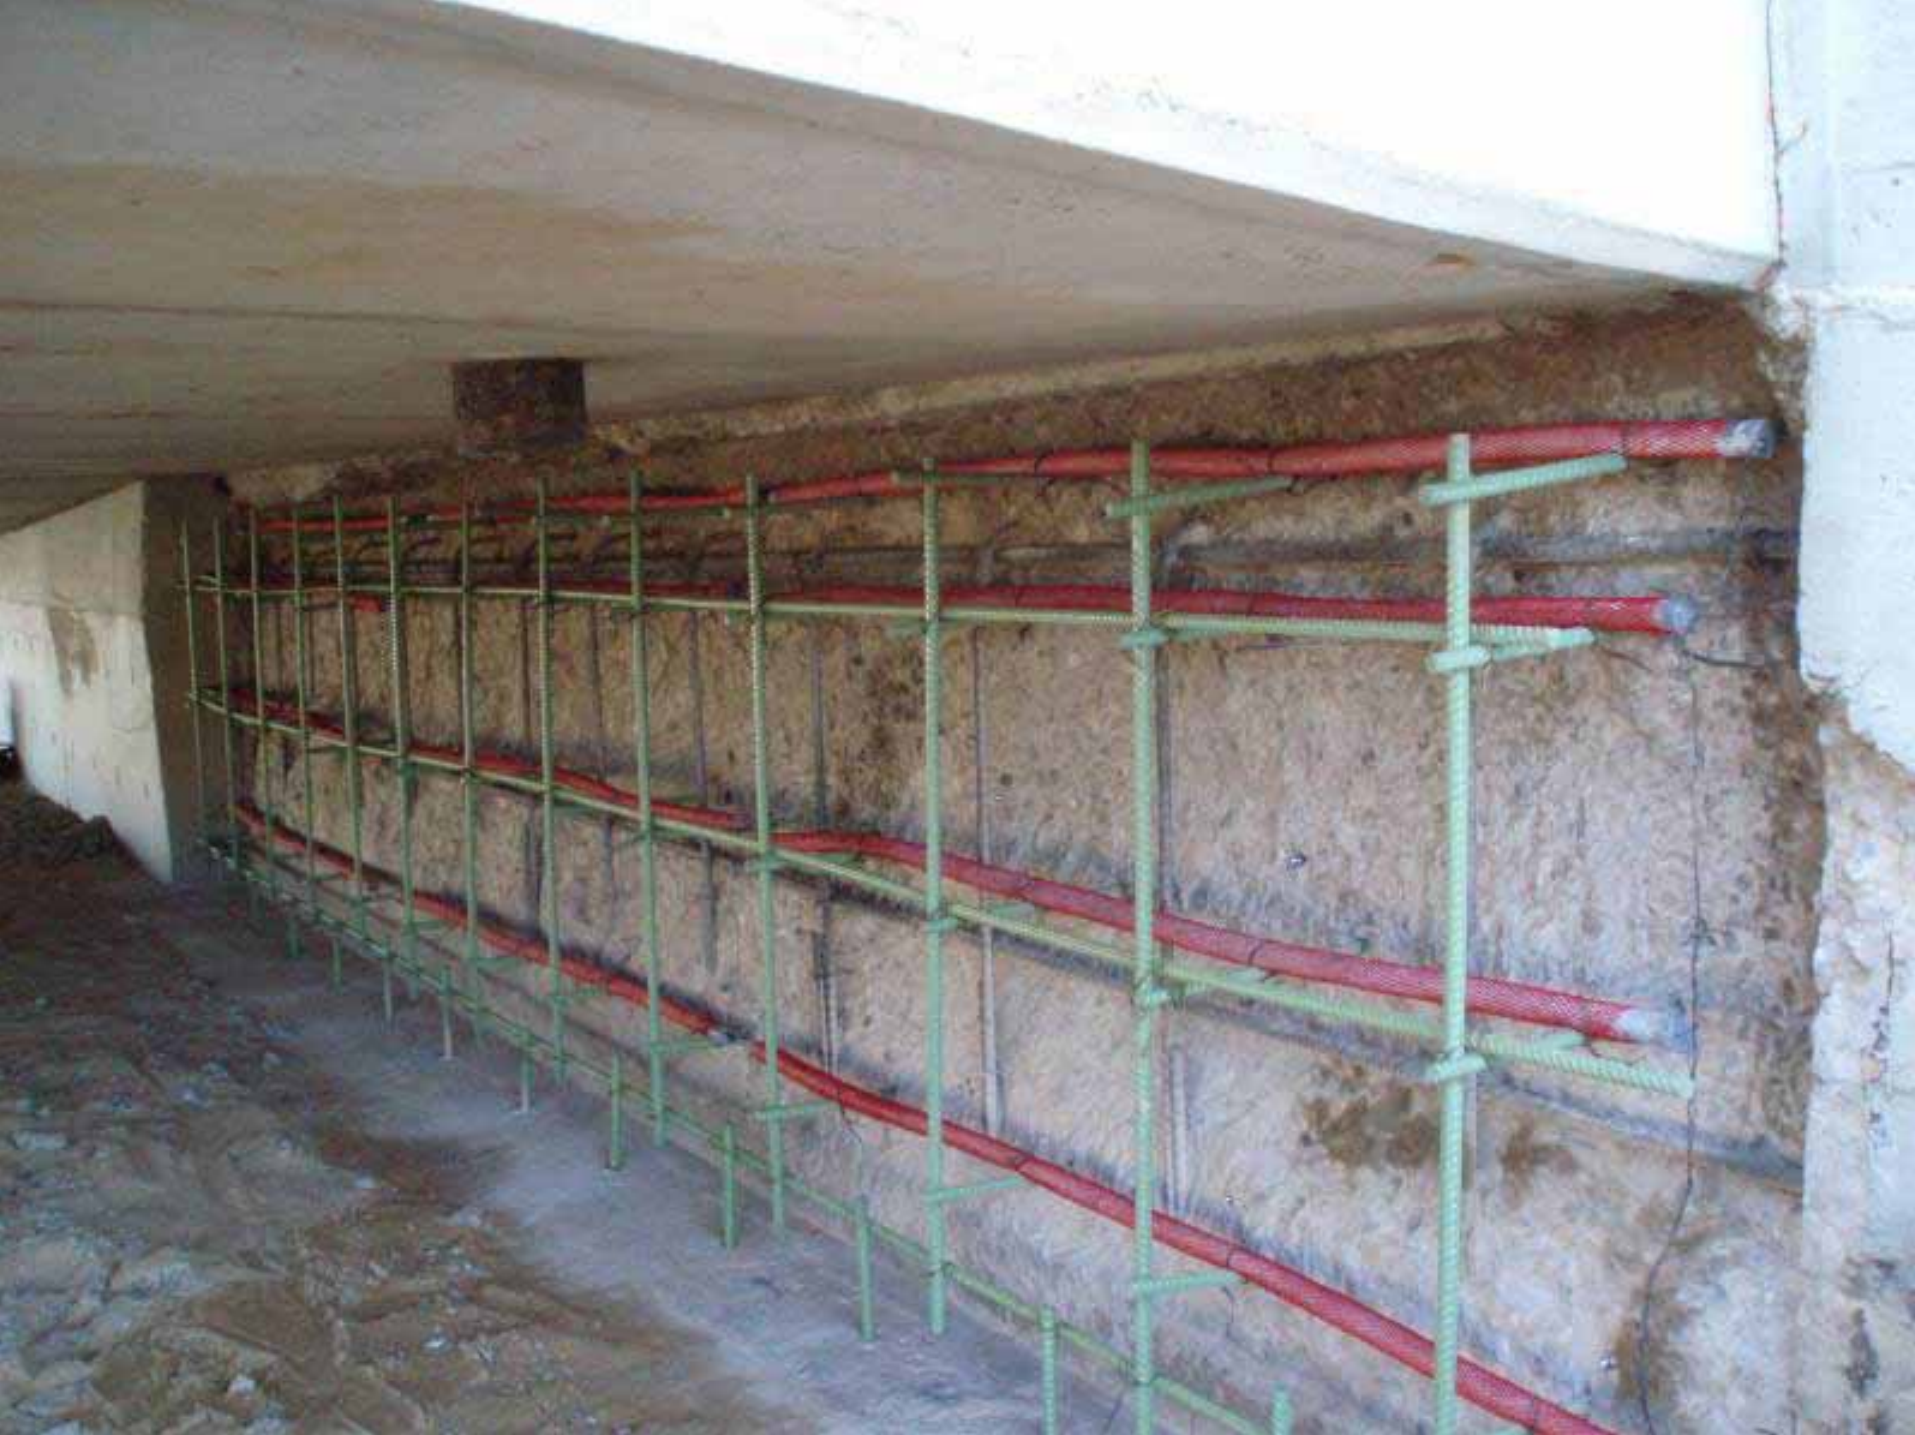
Strip Anodes

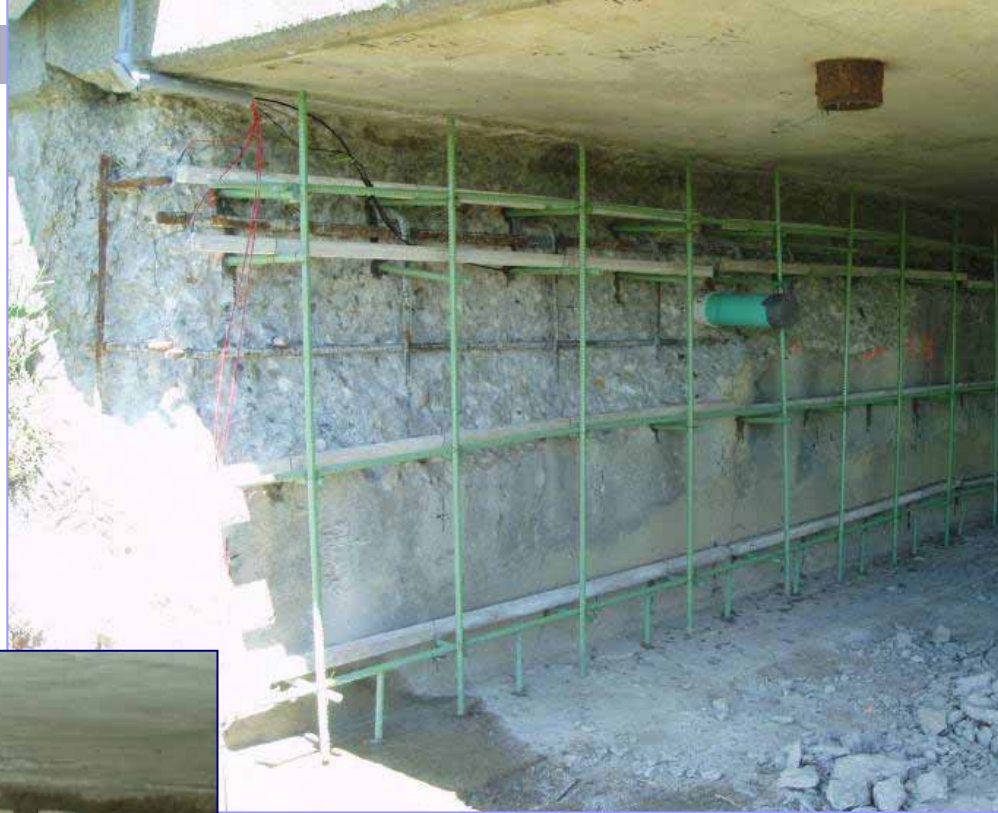
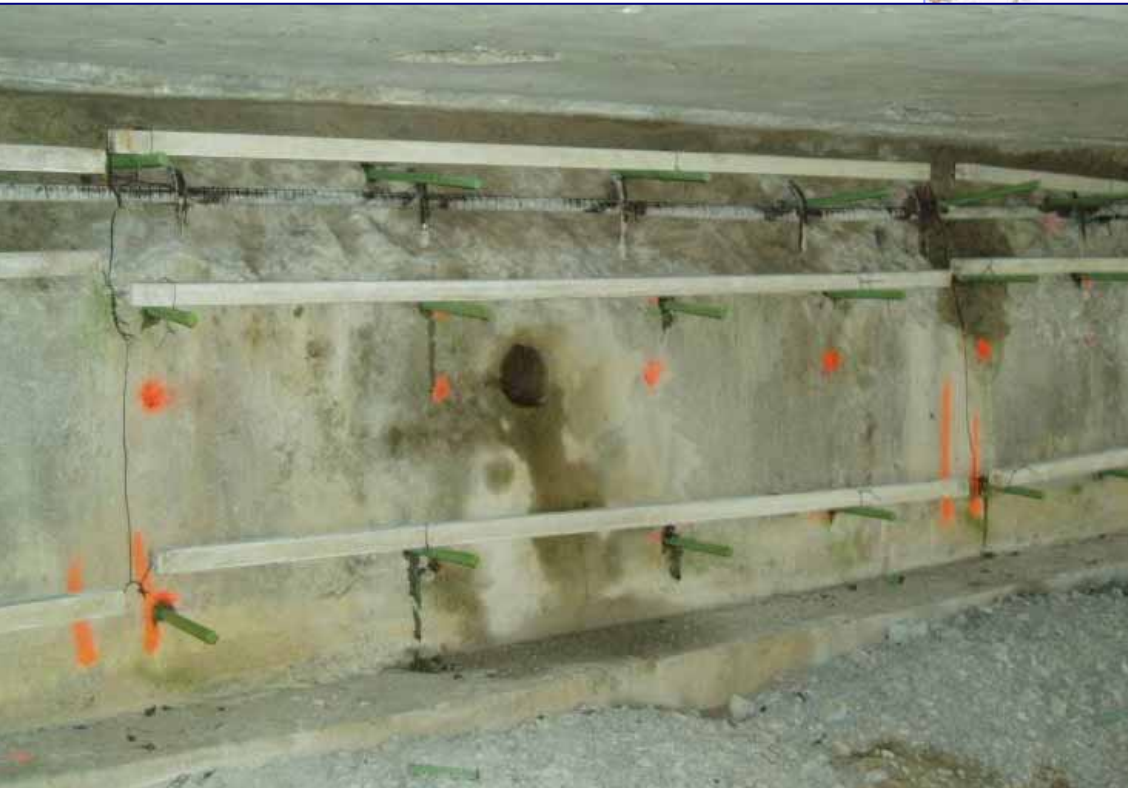
Elevation View with Anodes

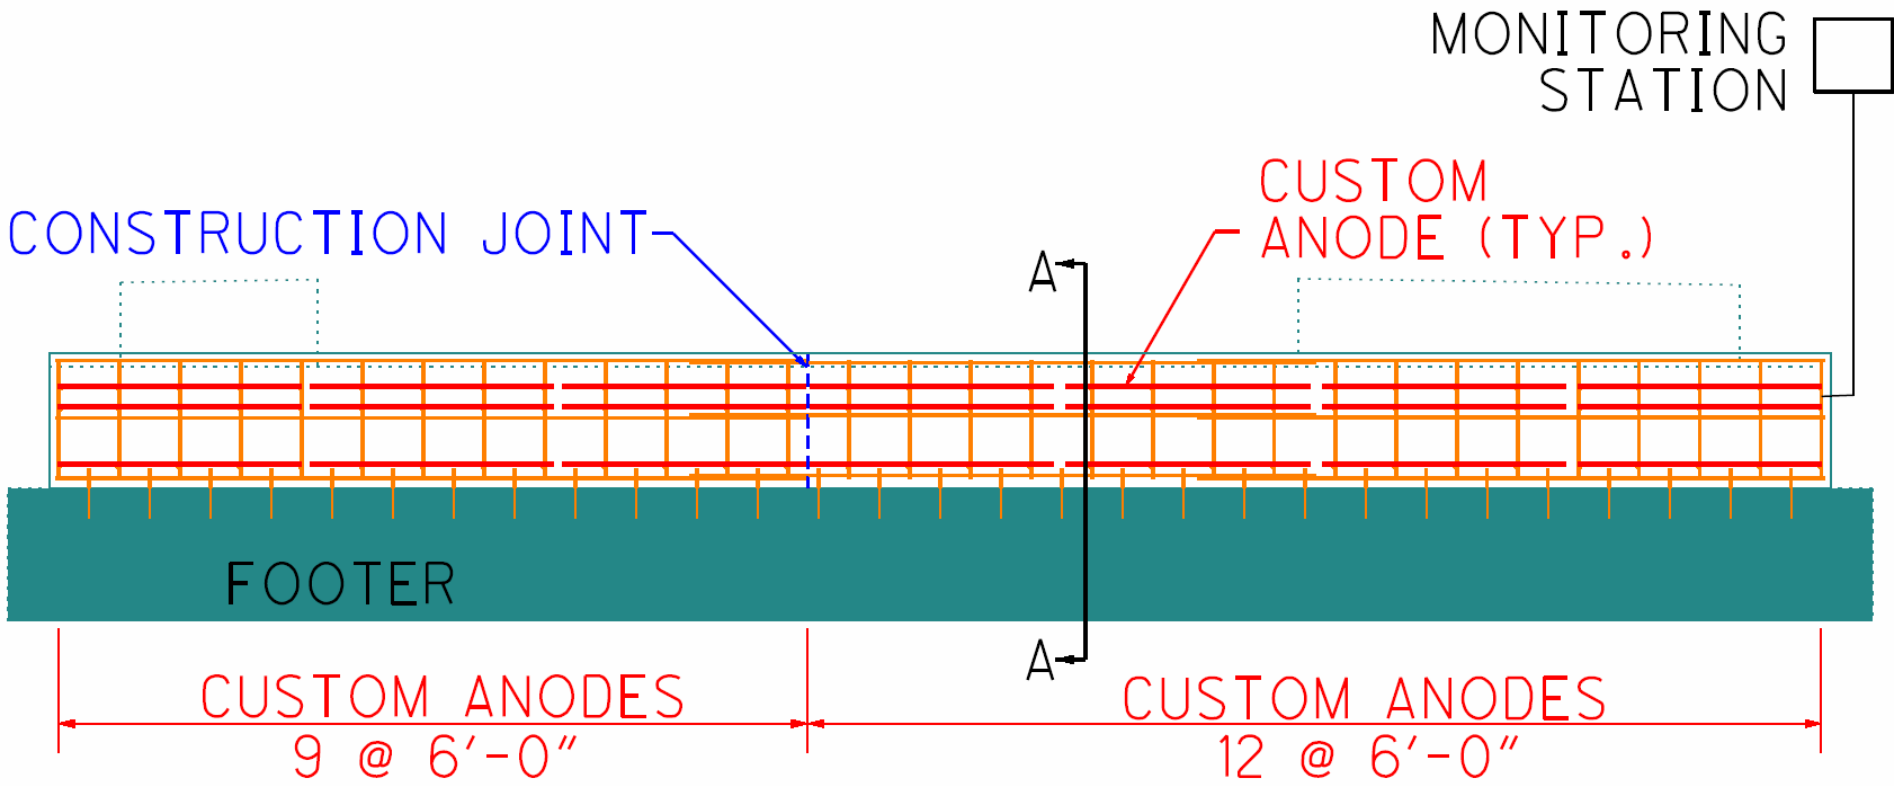
Cross Sections with Anodes

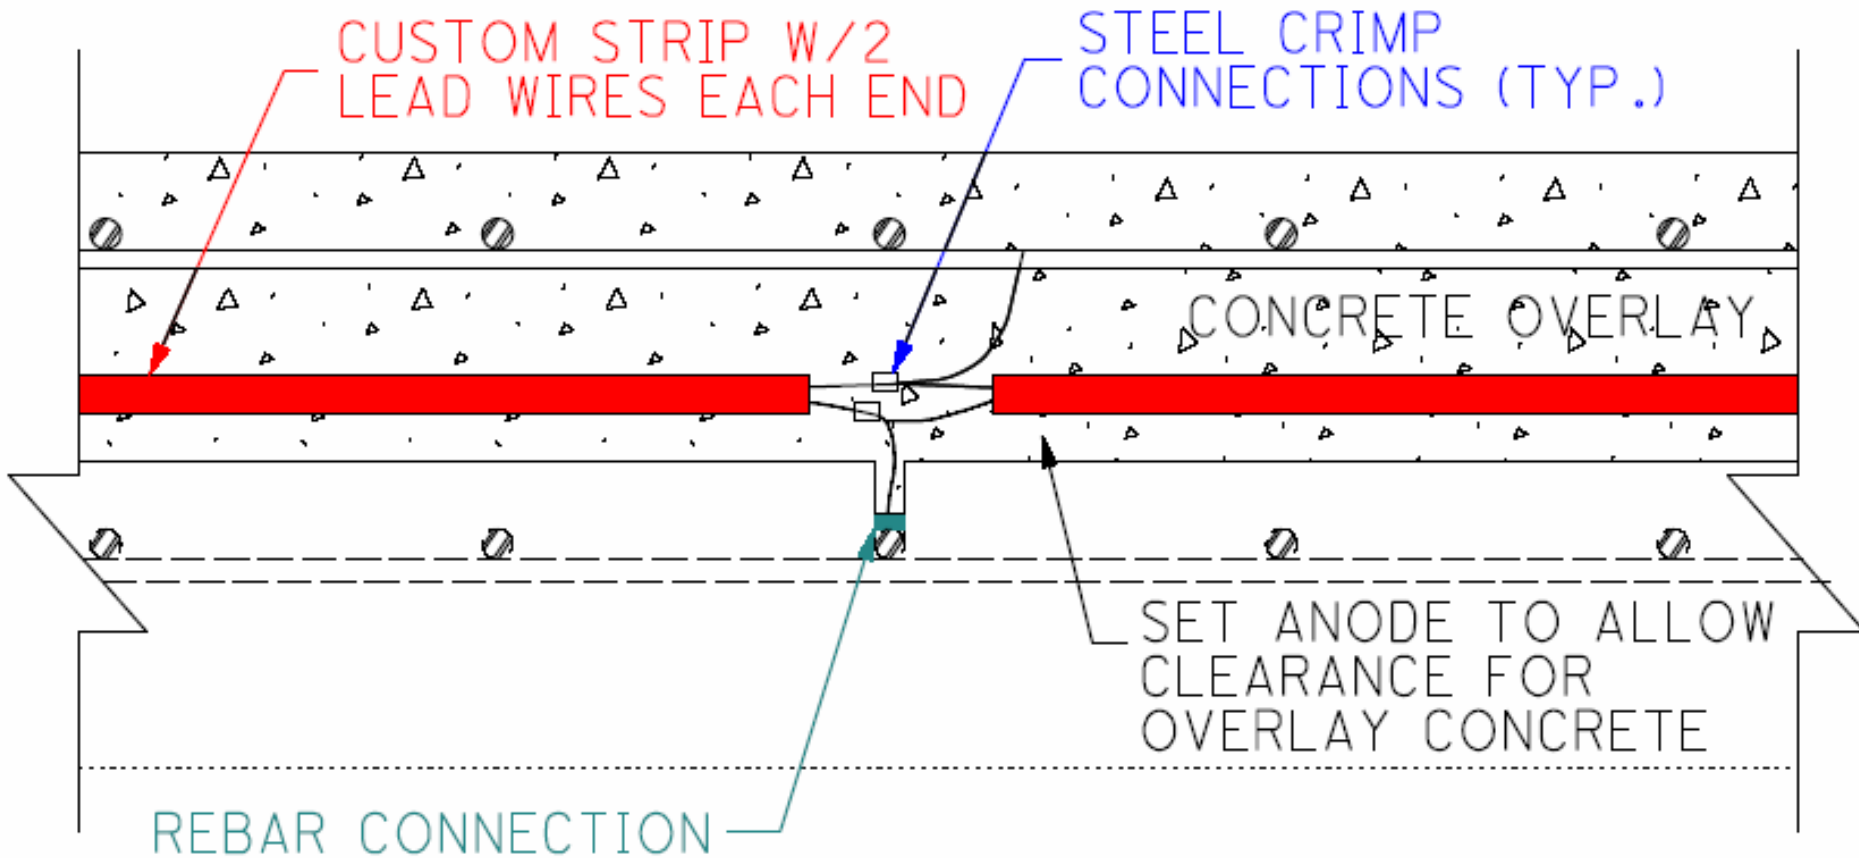
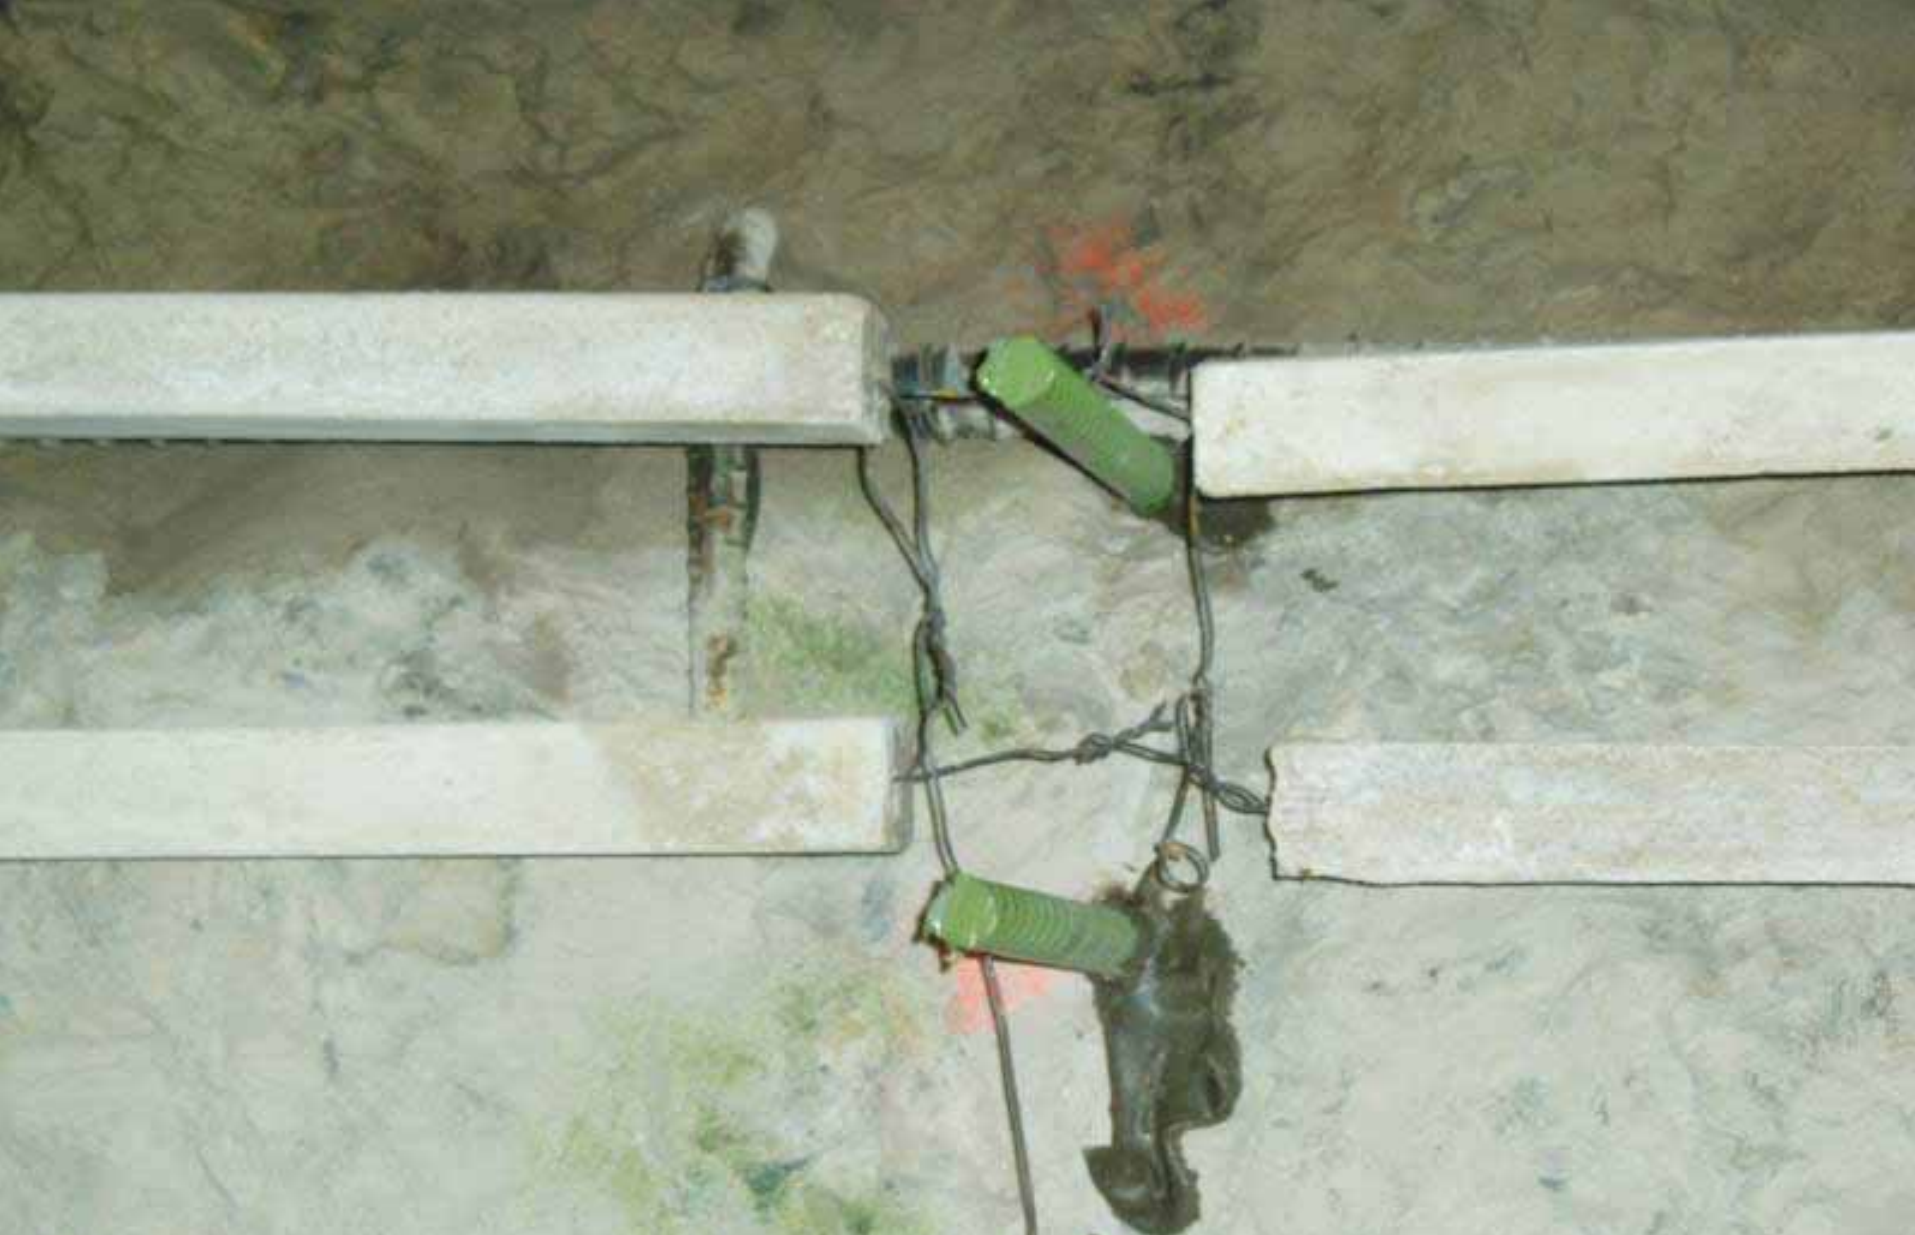
TYPICAL EMBEDDED GALVANIC ANODE TO REINFORCING STEEL ATTACHMENT DETAIL

Connection of Anodes to Rebar
