FINAL REPORT

Project Title: "Evaluation of Composite Post-Tensioning Systems on
Bridge COS 79-0955, Coshocton County"

Authors:	Dr. William E. Wolfe Dr. Henry R. Busby Dr. Tarunjit S. Butalia
Research Agency:	The Ohio State University Research Foundation
Date:	March, 2003
Sponsoring Agencies:	Ohio Department of Transportation Federal Highway Administration

1. Report No. FHWA/OH-2003/004		2. Government Accession No.		3. Recipient's Catalog No.	
4. Title and subtitle Evaluation of Composite Post-Tensioning System on Bridge COS-79-0955, Coshocton County				5. Report Date March 2003

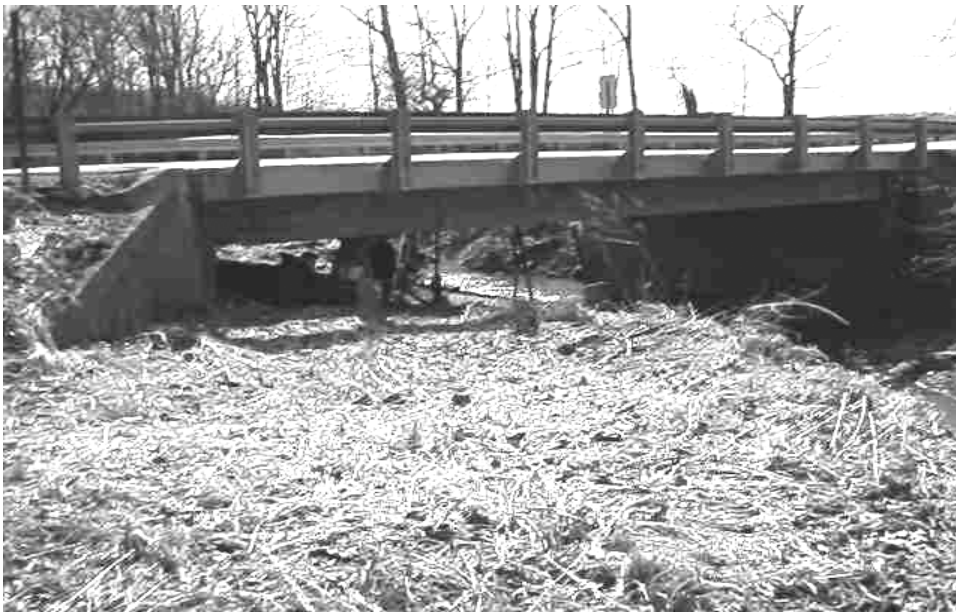
Figure 1 Bridge COS-79-0955. (Looking East)

long as measured from bracket to bracket. Design tension was 35.6 kN (8,000 lbs) per rod. Figure 1 is a photograph of the bridge taken during testing. Figure 2 shows the position of two of the installed rods. The rods were attached to steel brackets as shown in Figure 3. The brackets were bolted to the beams of the bridge and the rods tensioned by tightening the nut with a torque wrench (Figure 4).

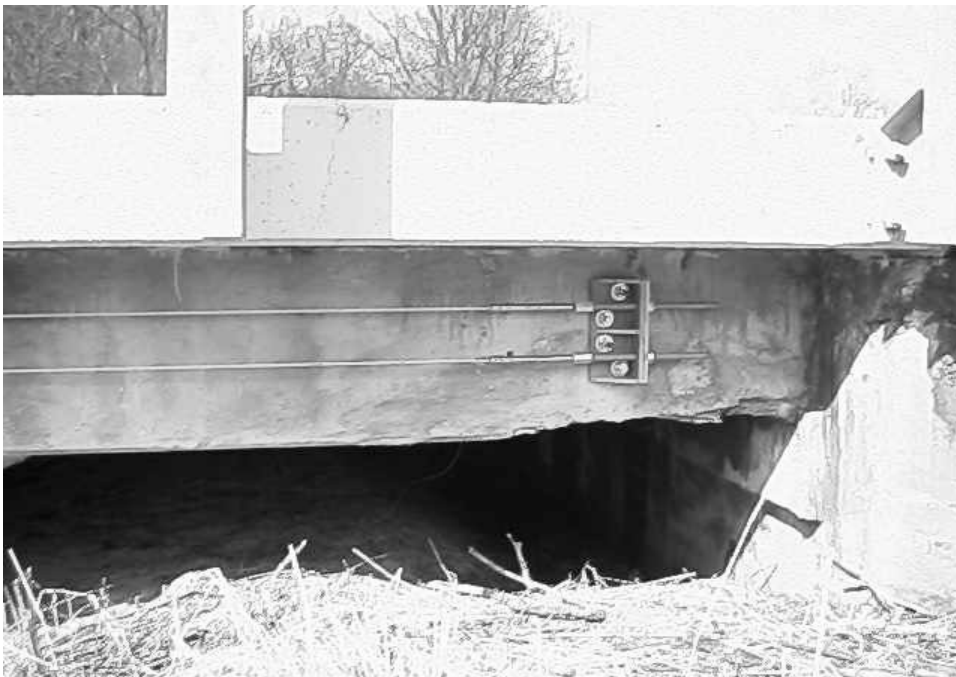
Figure 2 Typical Reinforcement Placement

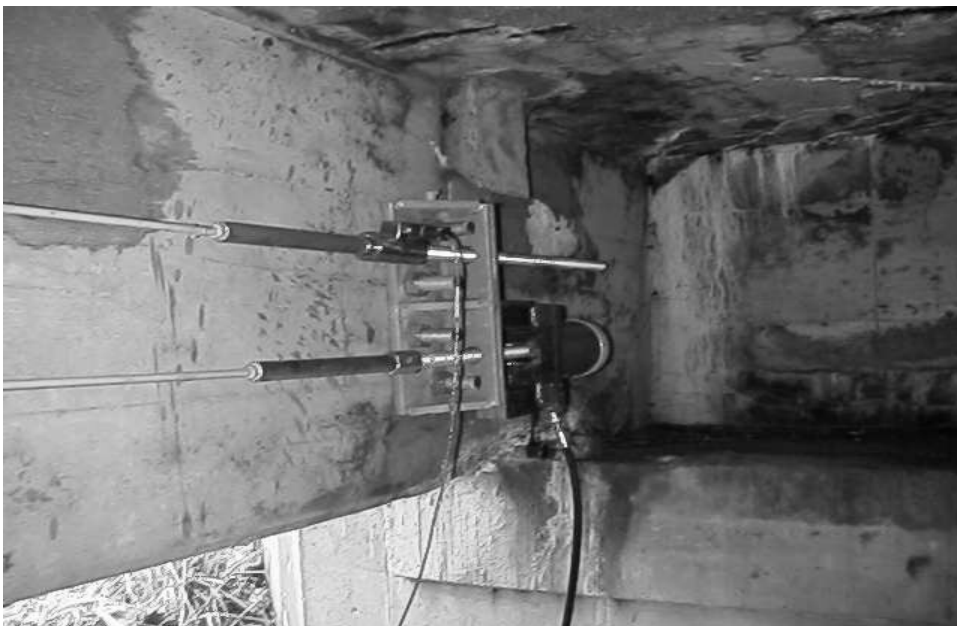
Figure 4 Tensioning the Rods.

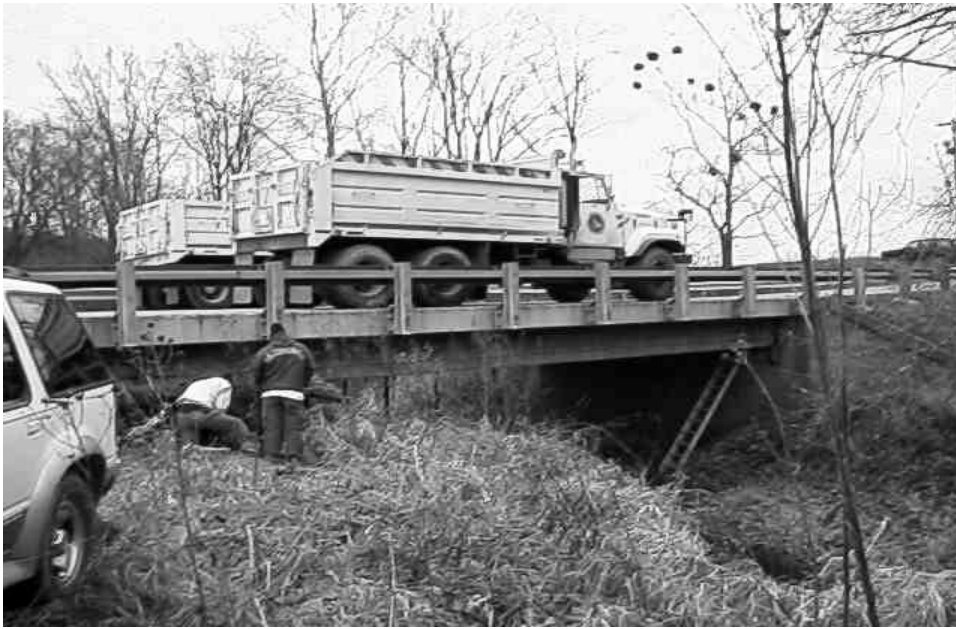
Figure 5 Side-By-Side Static Load Test

Static and dynamic load tests were performed on the bridge before and after tensioning the composite rods. The loading consisted of two ODOT trucks with measured axle spacings and estimated weight distributions. Both static tests (the trucks were placed at specific locations on the bridge) and dynamic tests (the trucks were driven across the bridge at a specified speed) were conducted. The location of the applied load was recorded for the static tests and the vehicle speed and truck locations relative to each other were monitored and recorded for each dynamic test. Table 2 lists the protocol details. Figure 5 shows the tandem dump trucks used to load the bridge. Figure 6 is a photograph of a side-by-side dynamic test while Figure 7 is an example of a front-to-back static test and Figure 8 shows the trucks during a front-to-back dynamic test.

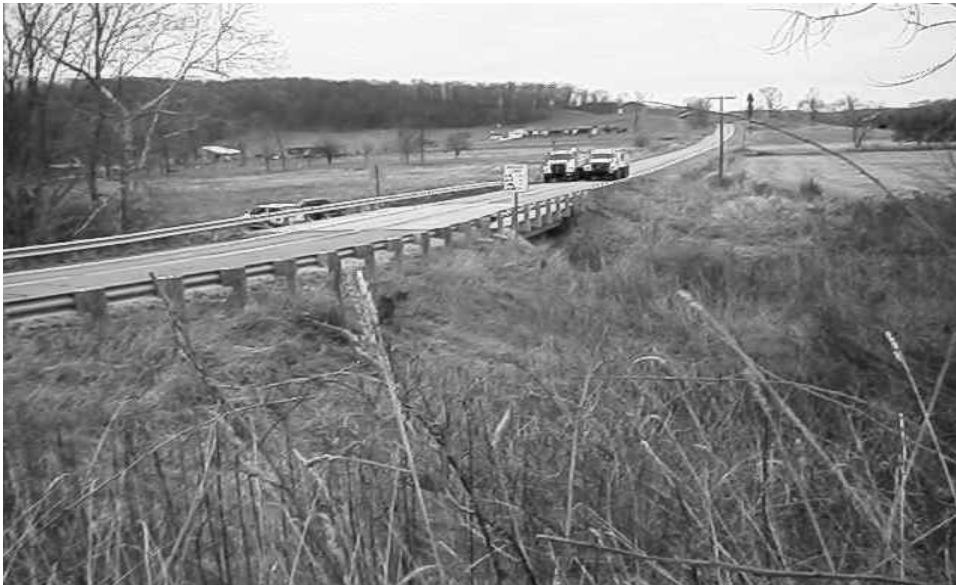
Figure 6 Side-By-Side Dynamic Test. Trucks Are Southbound

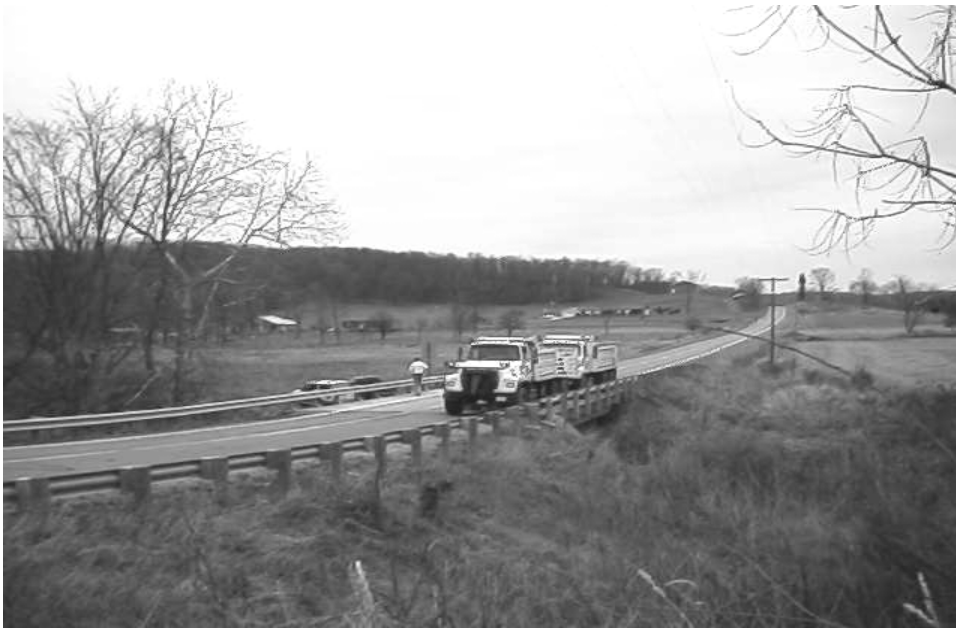
Figure 7 Front-To-Back Static Load Test. Trucks Are In Northbound Lane.

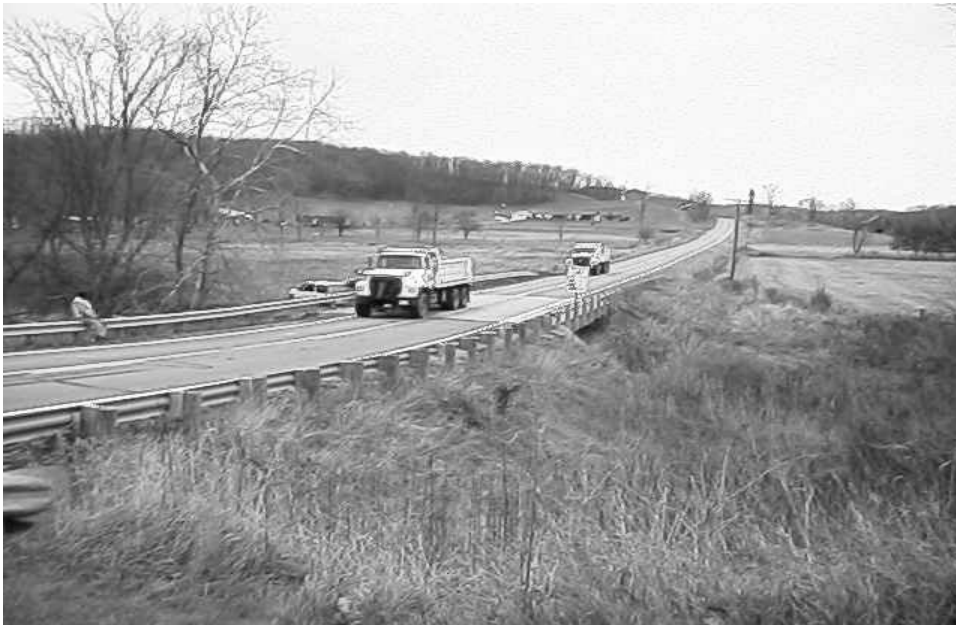
Figure 8 Front-To-Back Dynamic Load Test. Trucks Are Southbound.

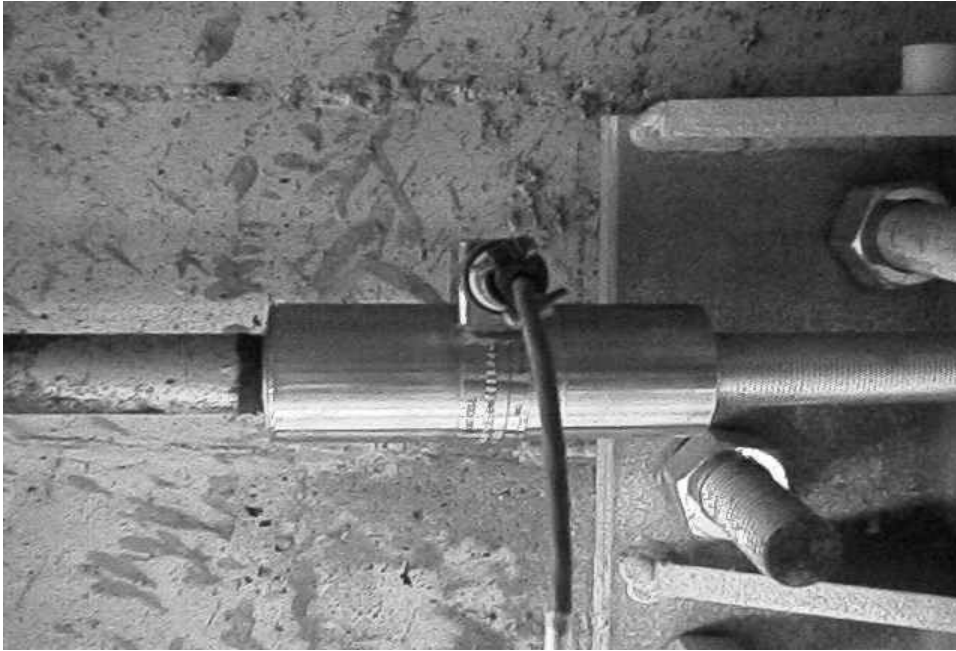
Figure 10 Load Cell Attached to Composite Rod.

Figure 10 shows one of the load cells in place on the top rod inside each of the outer beams of the bridge. Notice the end of the composite rod is screwed directly into the load cell. Load was recorded over a period of several months to determine whether the rods maintained the design tension.

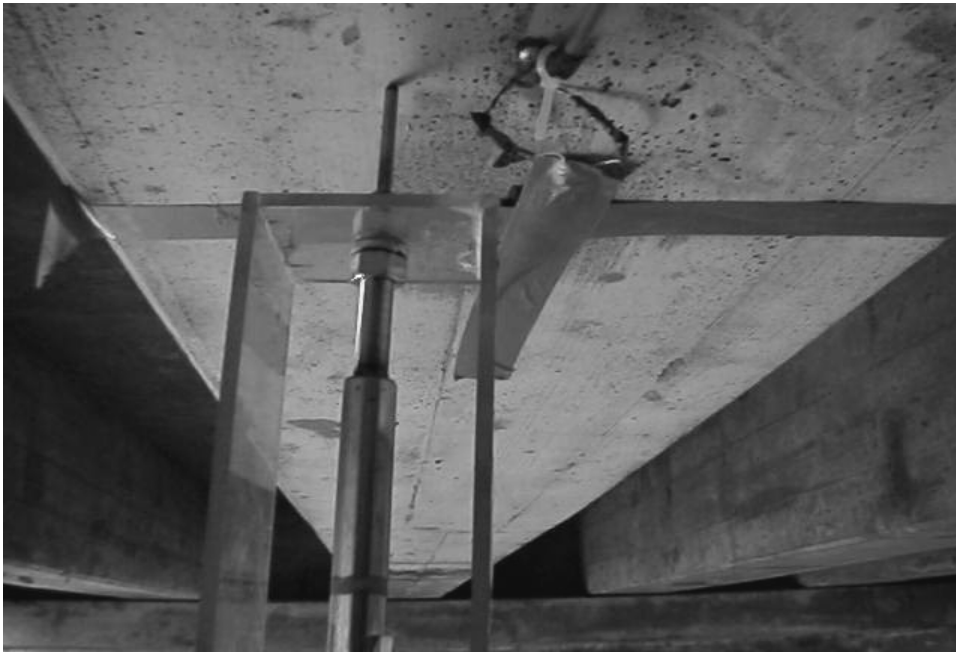
Figure 11 Typical LVDT Installation.

The LVDTs were mounted to a steel frame beneath the two innermost beams at the mid-span (adjacent to the strain gauges) to measure the deflection of the bridge deck. As shown in Figure 11, the spring-loaded tip of the LVDT was placed in contact with the bottom of the concrete bridge beam.
