FINAL REPORT

Project Title: "Evaluation of Composite Post-Tensioning Systems on
SCI-23-0096, Scioto County"

Authors:	Dr. Henry R. Busby Dr. William E. Wolfe Dr. Tarunjit S. Butalia
Research Agency:	The Ohio State University Research Foundation
Date:	March, 2003
Sponsoring Agencies:	Ohio Department of Transportation Federal Highway Administration

1. Report No. FHWA/OH-2003/005		2. Government Accession No.		3. Recipient's Catalog No.	
4. Title and subtitle Evaluation of Composite Post-Tensioning System on Bridge SCI-23-0096, Scioto County				5. Report Date March 2003

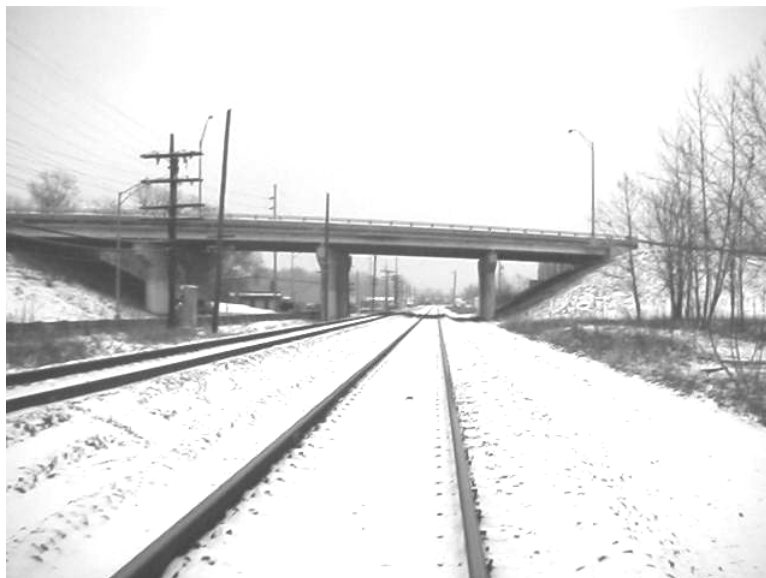
Figure 2 Bridge SCI-23-0096. (looking East)

moment. Figure 2 is photograph of the bridge looking east. Table 1 is a summary of the characteristics of the Portsmouth bridge.

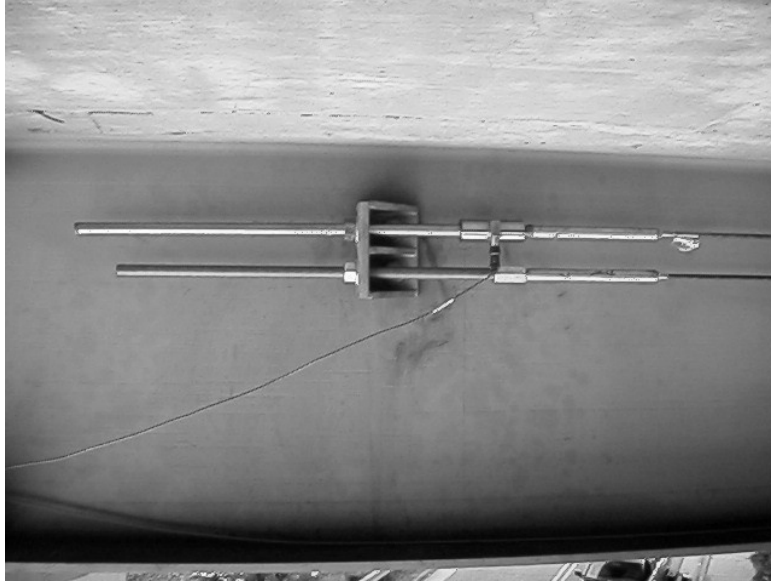
Figure 3 Rod placement

The rods were attached to steel brackets. Figure 3 is a typical bracket assembly. The brackets were welded to the girders of the bridge and the rods tensioned by tightening the nut, shown in Figure 3 to the left of the bracket, with a torque wrench.

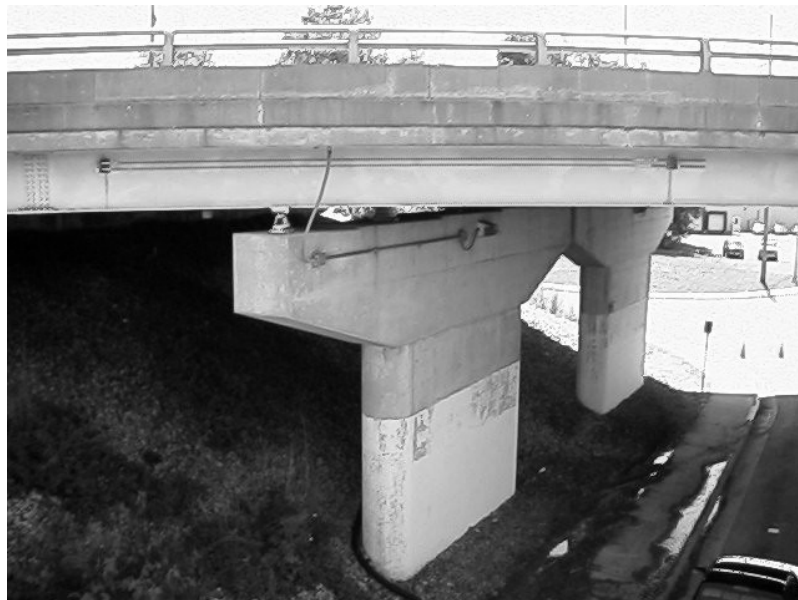
Figure 4 Rod layout.

This study focused on measuring the effects of the attachment of glass fiber tension rods to an existing reinforced concrete bridge subjected to various types of static and dynamic traffic loads and environmental conditions. The rods at Portsmouth were located at the top of the web, as shown in Figure 3, to reduce the negative moment over the piers. Two rods were placed on each side of the web of every beam above each pier (Figure 4) – a total of 120 rods. All rods at this site were made of CFRP and were 20-feet long with 3/8-inch diameter. The design tension of these rods was 58.2 kN. The brackets were welded to the girders.

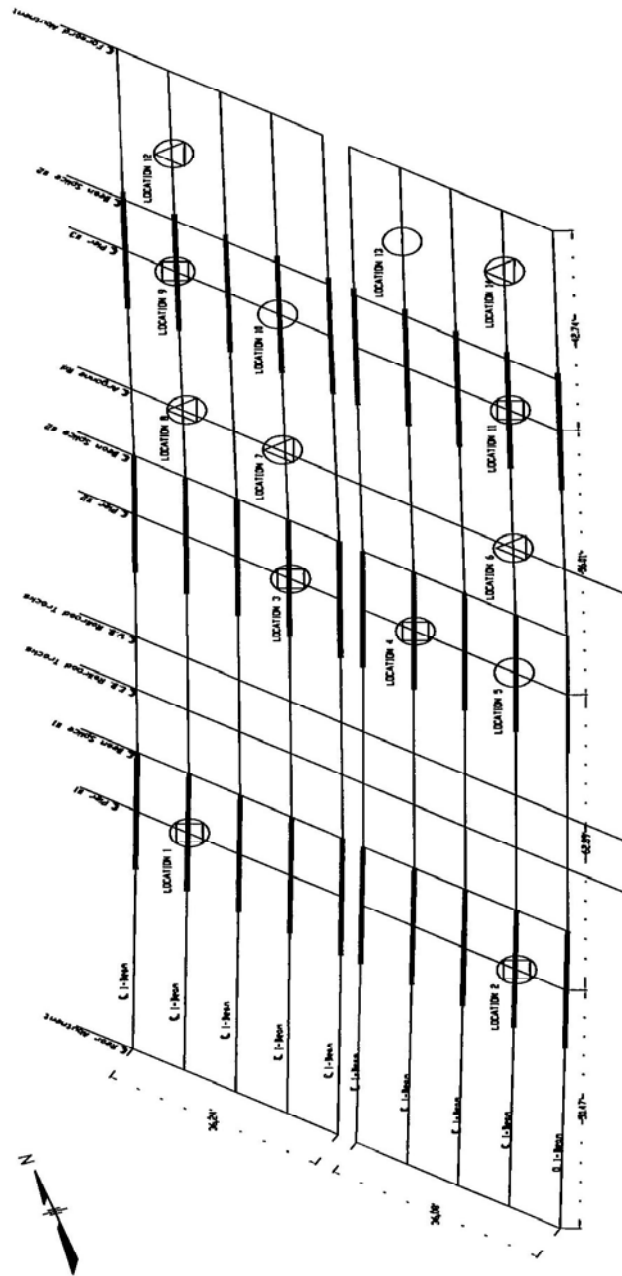
Figure 5 Instrumentation Layout of Portsmouth Bridge

The loads in selected rods, deflection at mid span, and strain at selected locations were measured. Load cells, linear variable differential transformers (LVDTs), and strain gauges were the transducers used to measure these quantities. Figure 5 gives the bridge instrumentation layout for SCI-23-0096. The data collection rate for each test was 100 samples per channel. The key for the Portsmouth layout is given in Table 3.

Typical strain gauges were installed as shown in Figure 5. The typical location of the strain gages on the top flange and bottom of the deck is shown in Figure 7 and on the bottom of the flange in Figure 8.

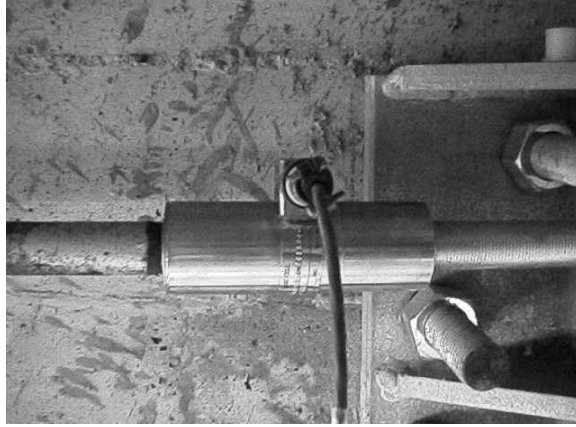
Figure 6. Typical Load Cell installation

Figure 6 shows a typical load cell in place on the top rod inside each of the outer beams of the bridge. Notice the end of the composite rod is screwed directly into

the left end of load cell. Two load cells were installed at each set of piers (six total). Load was recorded over a period of months to determine whether the rods maintained the design tension.

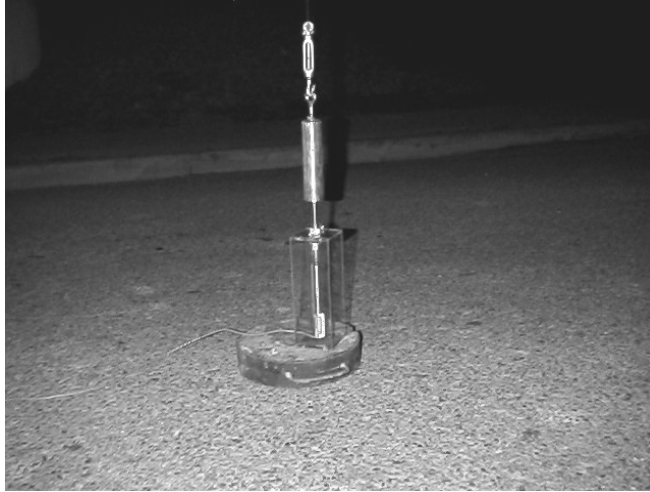
Figure 9. Typical LVDT installation

The LVDTs were mounted to a steel frame beneath the two innermost beams at the midspan (adjacent to the strain gauges) to measure the deflection of the bridge deck. The steel frame served as the stationary or reference point for the LVDT. As shown in The spring-loaded tip of the LVDT was placed in contact with the bottom of the steel bridge beam. The bridge deck was the moveable point but the stationary point (the ground) was 23 feet below the deck. A permanent attachment would have interfered with local traffic under the bridge and invited vandalism; therefore, a removable setup was required. The distance from the deck to the ground created a challenge for installation and removal of the LVDTs for subsequent tests (once the man-lifts used to install the instrumentation were no longer on site). The solution employed a wire extending down from the steel beam with a weight attached to the end. The weight then moved with the motion of the bridge deck. The frame of the LVDT was attached to a weight on the ground to make it stationary and the movable rod was attached to the weight suspended from the bridge (Figure 9). In this way, relative displacements were accurately measured even though the LVDTs were physically located on the ground and not immediately under the deck.

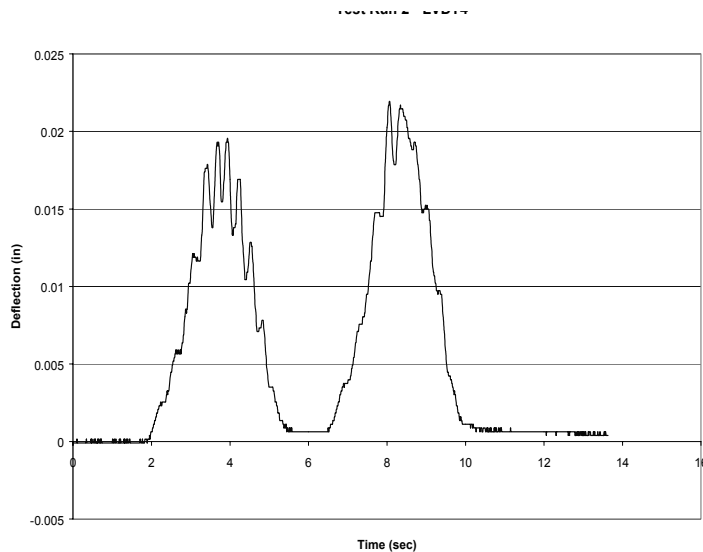
Figure 10 Typical field deflection data

Plots of the measured response time histories for each test are compiled in the appendix. Summaries of those tests are presented in this section. Tables 4 and 5 are a listing of selected maximum deflections recorded during each load test. Where two values are given they represent the peak responses of each LVDT for tests where trucks crossed the bridge one after the other. The first value is the maximum deflection due to the first truck (less heavily loaded) and the second value corresponds to the second truck (greater load). Figure 10 is an example of one of these deflection time histories. The mean decrease in deflection for all speeds and LVDT locations was 0.04 mm or about 4%. The standard deviation for the deflections was 0.05 mm, which is greater than the decrease. Therefore, although there appears to be a slight decrease in the deflections after the composite rods were tensioned that decrease is less than the variability in the data.

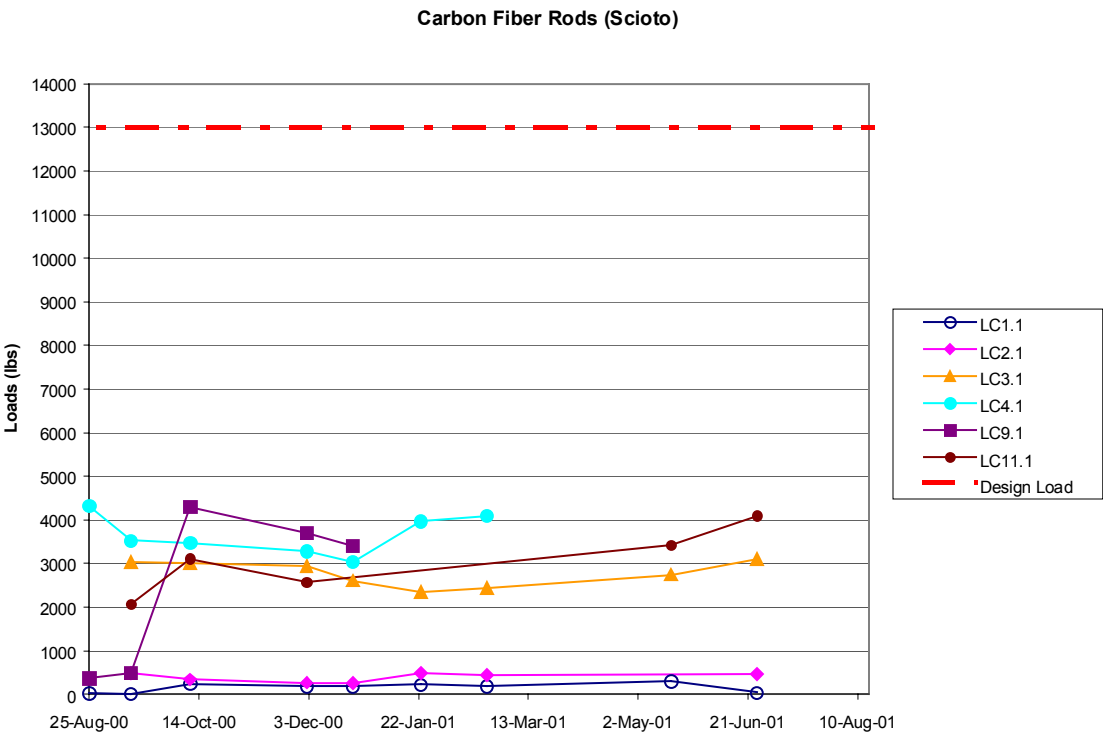
Figure 11 Summary of monthly readings

Figure 11 is a summary of the monthly readings to date of load on the rods for both bridges. As demonstrated in the table, the rods have maintained the load or shown a slight increase. The temperature was just above freezing when the rods where initially

tightened in November, therefore any deviations above or below freezing could result in different expansion or contraction of the rods relative to the concrete beams. These results suggest that relaxation of the fiberglass rods should not be a concern.

Monthly load readings for the composite rods show the rods have not maintained their initial tension.

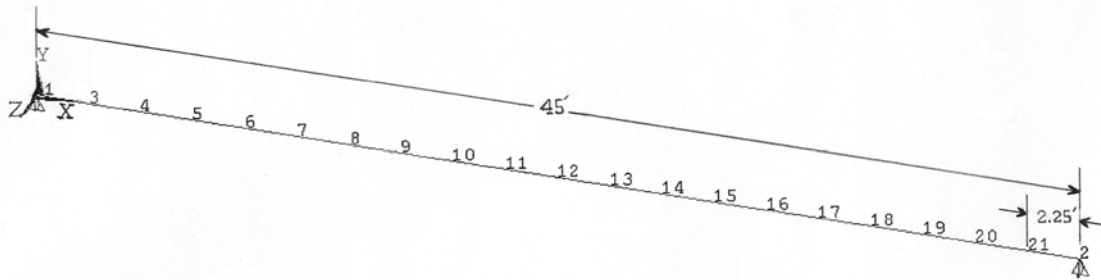
Figure 12. 20-element simply supported model.

In order to perform an independent check of the field measurements and to suggest an approach to predicting the effect of external reinforcements on similar bridges, a finite element model using the commercial software package, ANSYS, was developed. To compare the measurements recorded during the load tests with a computed dynamic deflection, the bridge was modeled as a twenty element, two-dimensional beam using standard elements included in the ANSYS library (see Figure 12). Each node had three degrees of freedom, translation along the length of the bridge, vertical translation, and rotation in the plane of the allowed translations. End conditions were modeled by allowing limited rotation of the bridge deck by adding vertical beam elements to the node at each end of the bridge to simulate the abutments. The two end elements were fixed at their bases resulting in bending being allowed at the node connected to the bridge deck but restricted by the beam stiffness. Figure 13 is a detail of one end of the bridge showing one of the vertical elements. The response of the structure to load was assumed to be linear and elastic.

For a linear elastic beam element, the stiffness (K) is a function of the elastic modulus (E), the moment of inertia (I), and the beam length (L). Since the length of the bridge was known, stiffness was evaluated in terms of the effective modulus and moment of inertia (I_e).

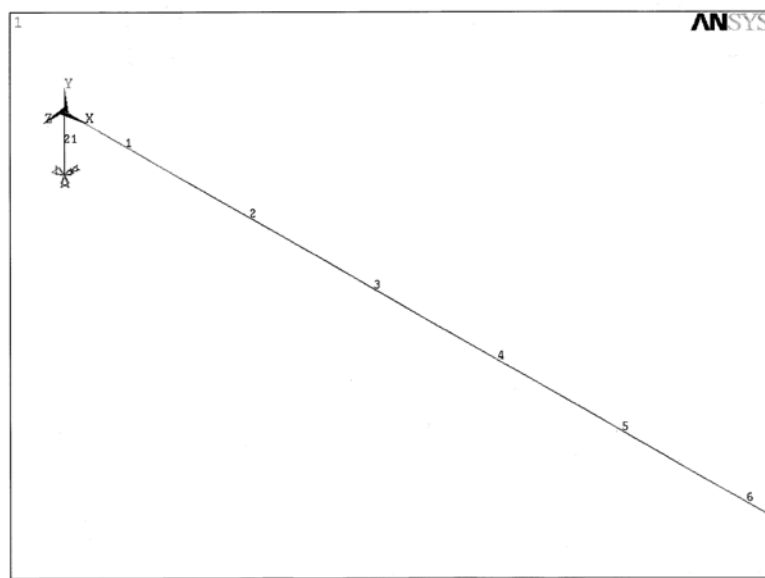
Figure 13. Model Abutment Detail

Since no truck load data were available for the COS-79-0955 tests, the loads to simulate the test trucks as they moved across the bridge were taken from the axle weights obtained for the trucks used to load SCI-23 . The front axle weight was taken to be 75 kN and for the rear axle the load was 180 kN. Since the load tests before and after tensioning were conducted on the same day with the same trucks, any effects of small discrepancies between assumed and actual weights should be expected to be negligible. The loading time step (the increment of time required to reach the peak value) was taken to be equal to the time required for the truck to travel the distance of one element. Therefore different time steps were used for the load function in order to represent different truck speeds. The load ramped up at the first node to simulate the truck approaching that point and then decreased to simulate unloading. While the load ramped down at the first node it simultaneously ramped up at the next node. See Figure 14 for the graphical representation of the loading. In this way, the full force of each axle was continuously applied to the bridge.

The amount of end constraint had the greatest effect on the calculated response to loading so the vertical beam stiffness was adjusted until the predicted deflections of the pre-tensioned bridge agreed with the measured values. With the properties of the bridge thus determined, the effects of the tensioned composite rods on the response of bridge to loads were considered. The effect of the rods was taken to be primarily due to the compressive load and

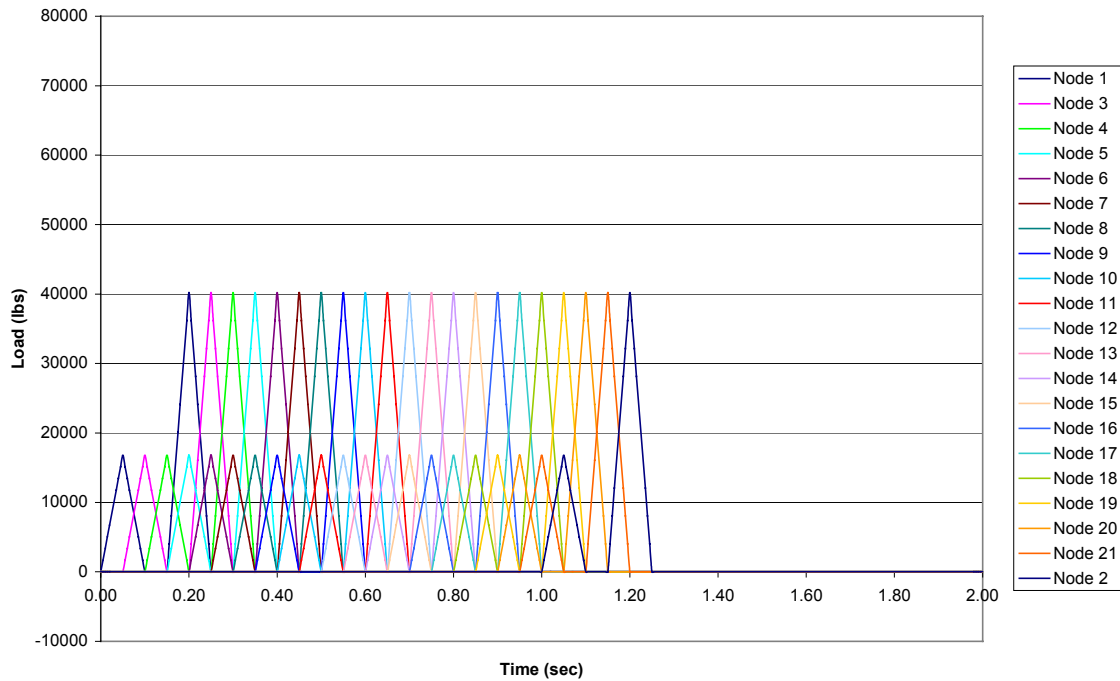
Figure 14 Ramped load function.

The composite rods were modeled as an applied compressive load and moment. The load was applied as a 285 kN force (8 rods x 36 kN design load) at the nodes representing the bracket locations. A moment of 46.5 kN·m, (285 kN x 0.163m) was applied to the same nodes. Both the moment and the force remained constant for the duration of the simulated truck loading.
