Evaluation of Overhead Support Inspection Program

The Ohio Department of Transportation,
Office of Statewide Planning & Research

January 2015

Final Report

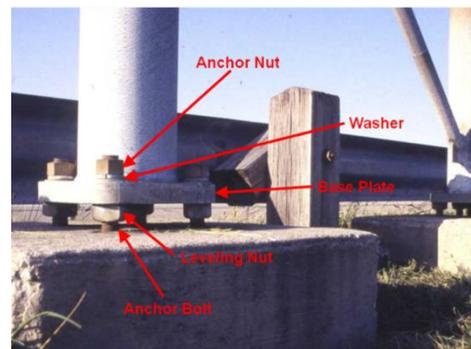
Figure 4.4 Anchor bolt assemblies

4 – Base plate and anchor bolts & nuts in good condition (Figure 4.4) or like new.

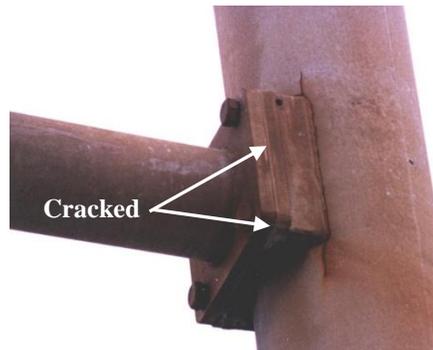
Figure 4.6 End post connection

- 4 – Connection(s) in good condition, no observable deficiencies.
- 3 – Minor corrosion, loss of galvanization, loose bolt, minor cracking or minor gap.
- 2 – Moderate corrosion, section loss, missing bolts, two or more cracks;
- 1 – Severe deterioration, section loss, cracking, missing or broken bolts (Figure 4.6).

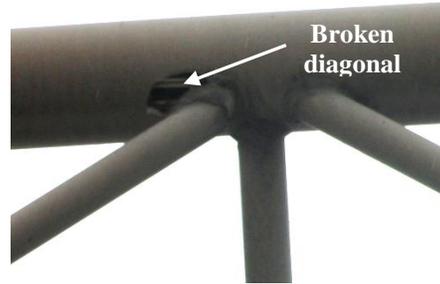
Figure 4.7 Truss assembly

- 4 – Connection(s) and truss members in good condition, no observable deficiencies.
- 3 – Minor loss of galvanization, minor corrosion, minor impact damage or misaligned connection(s),
- 2 – Serious corrosion to more than one member, medium impact damage, missing nut(s) or bolt(s), missing connection hardware.
- 1 – Cracked chord, broken diagonal, severe impact damage or misalignment (Figure 4.7).

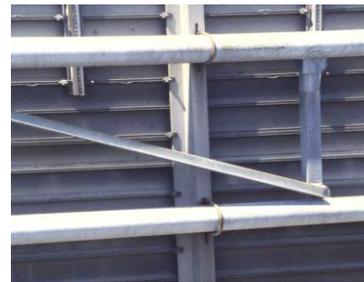
Figure 4.8 Sign attachment assemblies

4 – Panels in good condition, no missing hardware (Figure 4.8) or like new.

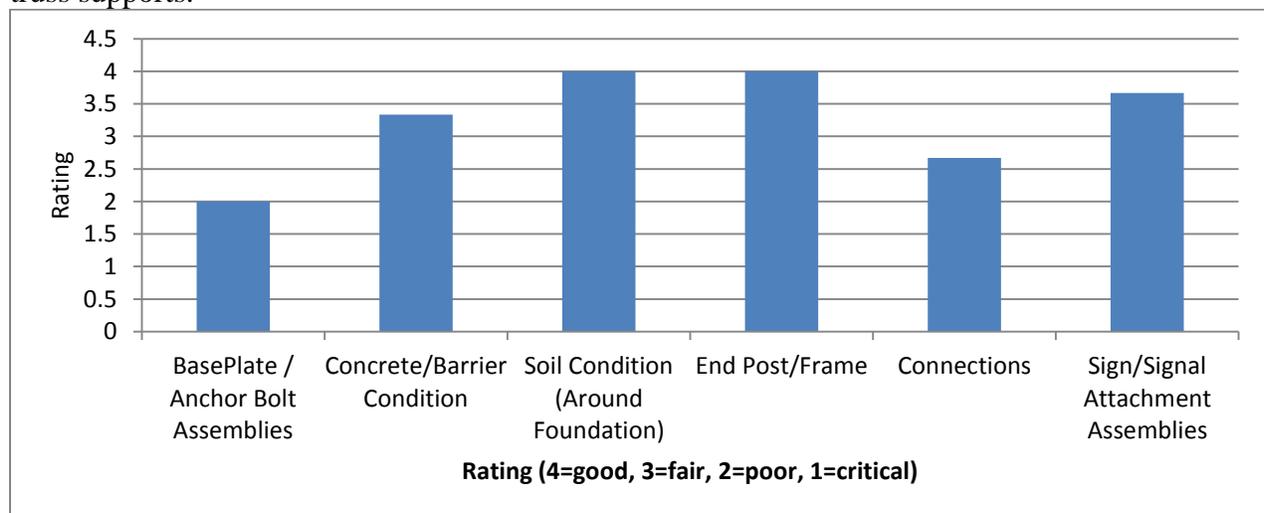
Figure 5.1 Cantilever arm supports: Average component rating (District 1)

Figure 5.1 shows that most of structural components of dual arm cantilever supports were in good condition. The deficiencies most observed for dual arm connections were the gaps between plates at the mast arm connection, and loss of galvanization.

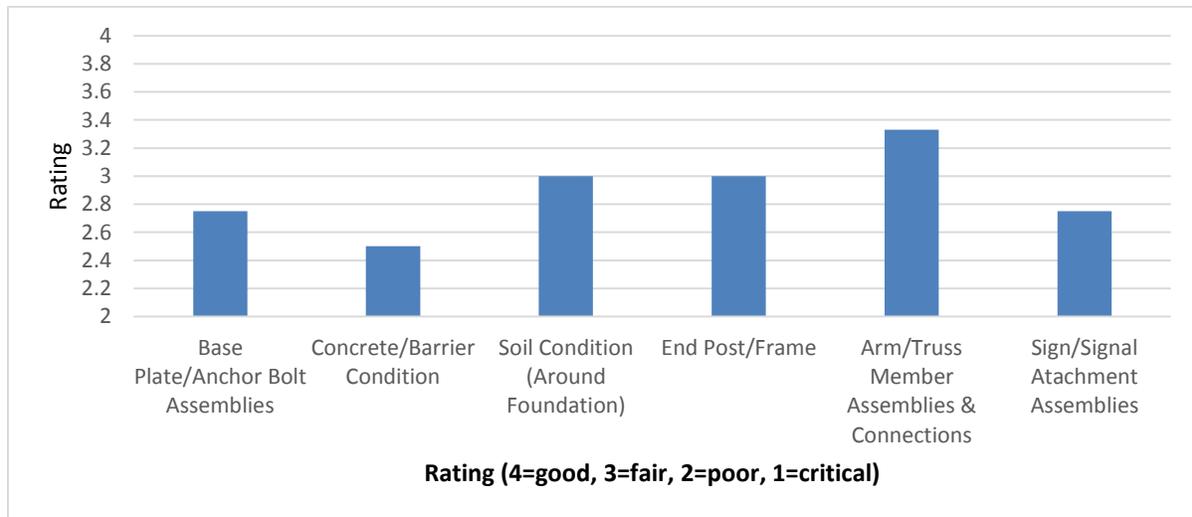
Figure 5.2 Box truss supports: Average component rating (District 1)

Figure 5.2 indicates that box truss supports are performing fairly well. The foundation had a few deficiencies observed and included loose nuts/bolts, loss of galvanization on anchors, and voids/honeycombing of concrete footing.

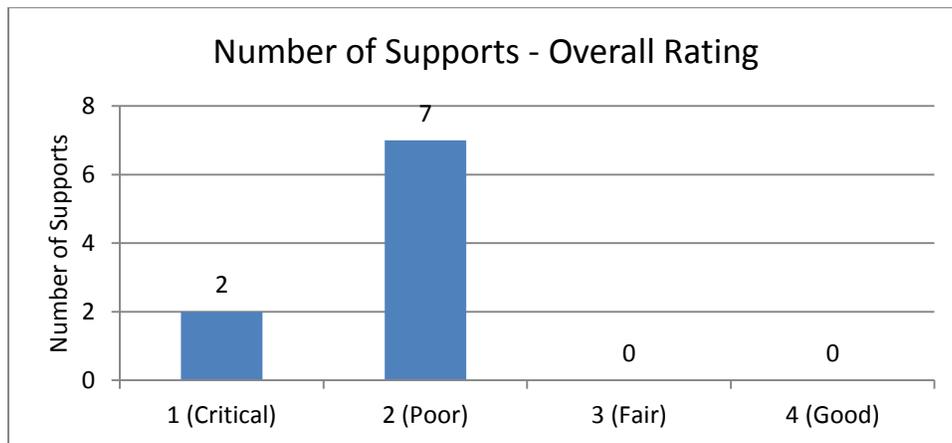
Figure 5.3 Number of supports for each overall rating (District 1)

The overall rating (Figure 5.3) is based on the rating found from the rating of each individual component. Conservatively, the research team selected the lowest rated component rating as the overall condition rating of support. The overall rating of “2” for eight of the supports in the sample is mainly due to gaps noticed between the plates and mast arm connections. This might be considered conservative but a gap may indicate loss of pretension.

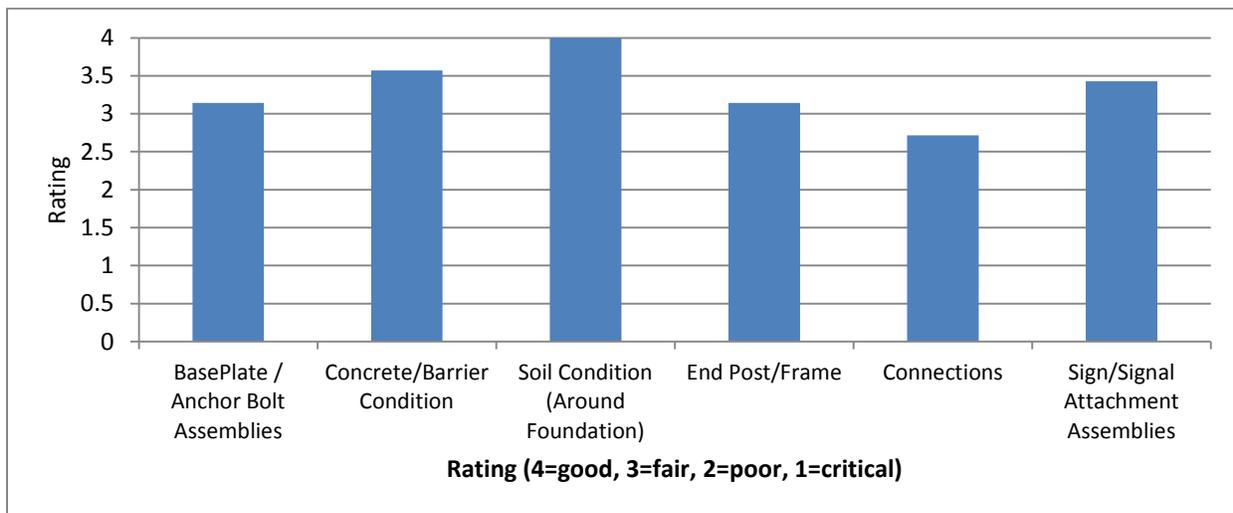
Figure 5.4 Cantilever arm supports: Average component rating (District 2)

Figures 5.4 and 5.5 summarize the rating of each support component of cantilever arm and box truss supports respectively. Figure 5.4 shows that most of structural components of dual arm cantilevers are in good condition or better. The most observed deficiencies with dual arm connections were loose nuts/bolts, lack of thread engagement (i.e. less than one anchor bolt thread above the top of the anchor nut), and gaps between plates at the mast arm connection.

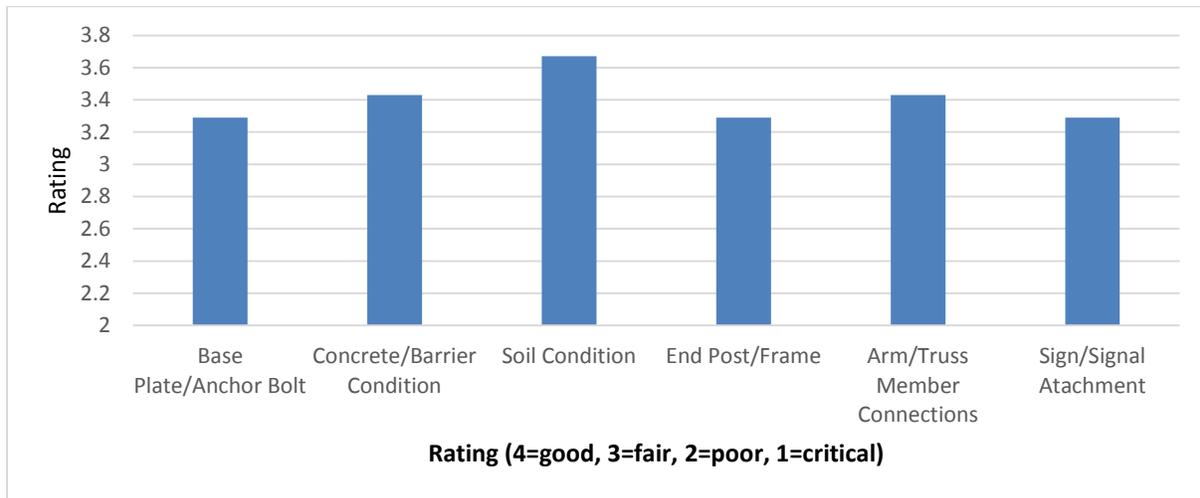
Figure 5.5 Box Truss supports: Average component rating (District 2)

Figure 5.5 indicates that the box truss supports are performing well and that there were no components with any significant deficiency observed. Two fairly new supports in the sample used an aesthetic tubular design (supports 20204 and 40203).

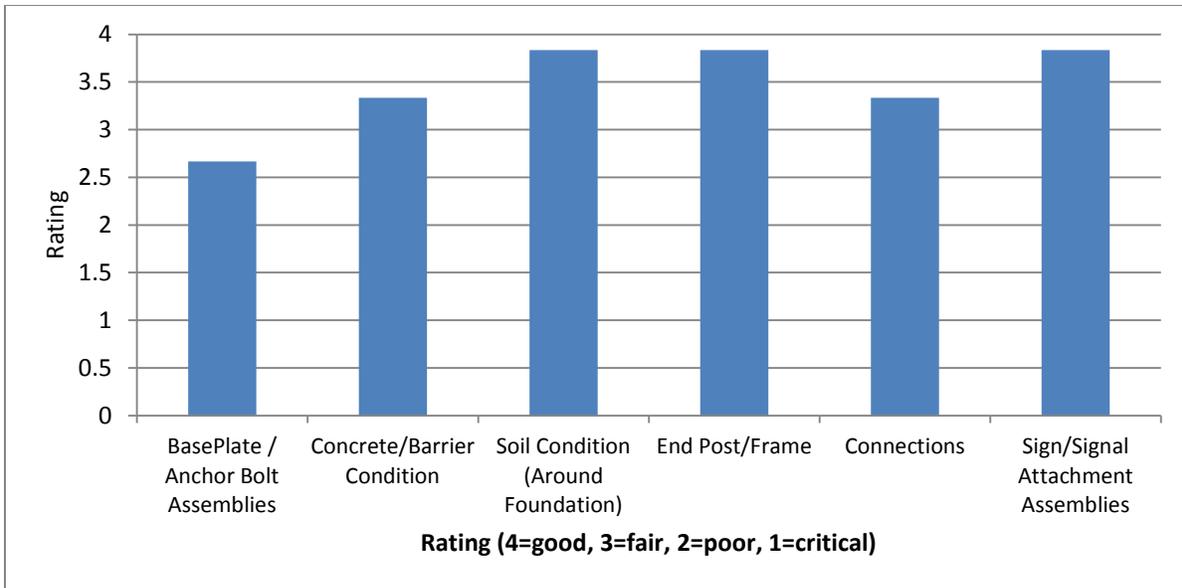
Figure 5.7 Cantilever arm supports: Average component rating (District 3)

The cantilever arm supports were determined to be in a fairly good shape. ODOT records indicated deficiencies in the foundation, especially with the anchor bolts and nuts. All cantilever arm supports had tightness and passed the sounding test based on ODOT inspection reports. These results matched with Mistras inspection report findings (Figure 5.7). The overall condition of the cantilever arm supports from both Mistras reports and ODOT records were very similar and shows that the members have not seen any significant degradation since the last ODOT inspection.

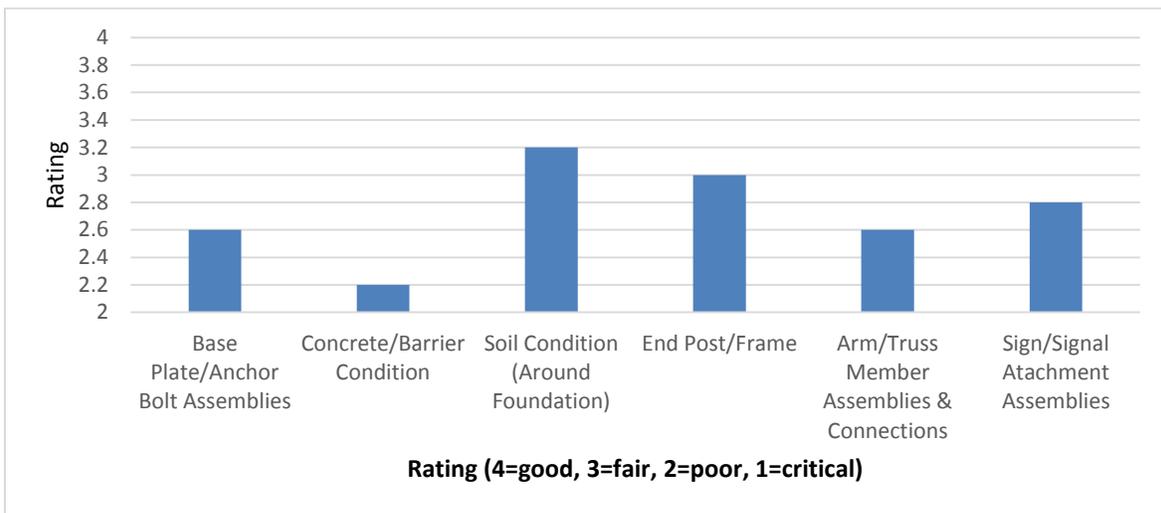
Figure 5.8 Box truss supports: Average component rating (District 3)

The same could not be said for the box truss supports (Figure 5.8). Although the Mistras inspection reports indicate similar deficiencies, such as with the anchor bolts, tightness of the nuts, and loss of galvanization on frame, new deficiencies were observed. These included development of new concrete spalls, increased vegetation growth, and advancement in the loss of galvanization on the support. This shows increasing degradation of the support since the last ODOT inspection.

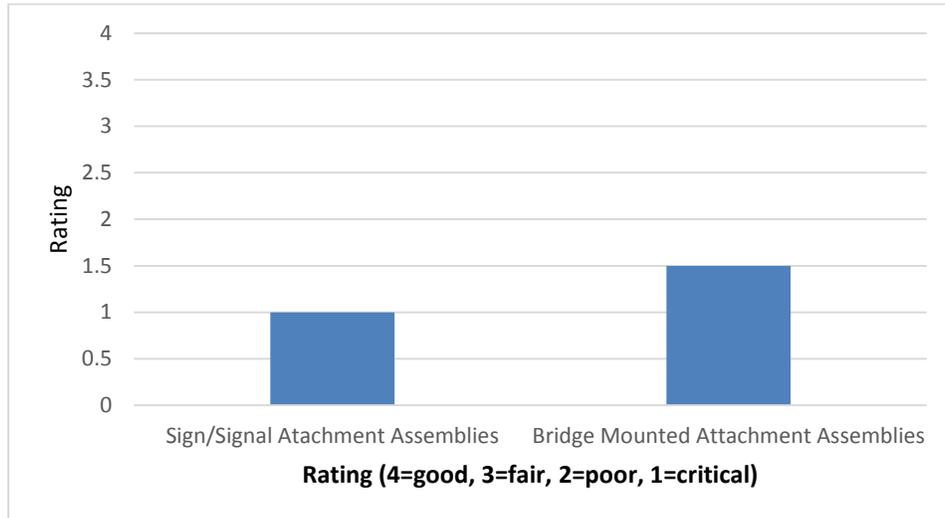
Figure 5.9 BMS (flushed/skewed): Average component rating (District 3)

Following the same process for the flush bridge mounted supports, ongoing degradation of the supports was observed (Figure 5.9). Previous ODOT records showed deficiencies with anchorage tightness in the supports. Mistras inspection reports indicated a significant amount of deficiencies for the flush bridge mounted supports that included corrosion and pitting, and advanced degradation of the anchor bolts and tightness of the nuts. These deficiencies led to a critical rating of the flush bridge mounted supports.

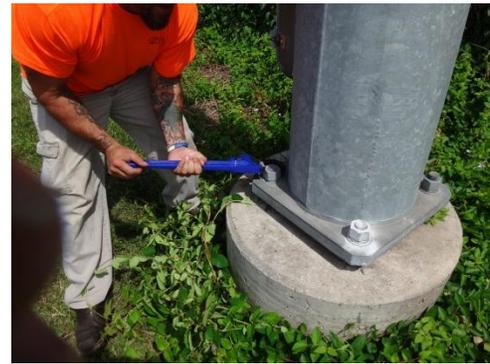
Figure 6.2 Checking looseness of anchor bolt - 24" wrench (District 2)

Table 6.1 summarizes the results of the HMLS performed in District 2. A total of 34 anchor bolts, distributed amongst six poles, were inspected. Of the 34 anchor bolts inspected, 1 bolt location had a loose anchor nut. The nut was judged loose due to the fact that the inspector was able to turn the nut with a wrench. Of the six supports inspected, four supports received a rating of 4, and two supports received a rating of 3. No supports were found to be in poor or critical condition. Other minor issues, such as clogged drainage channels on foundations, and some soil overtopping were also noted during the inspections. The overall rating is provided in Figure 6.4.

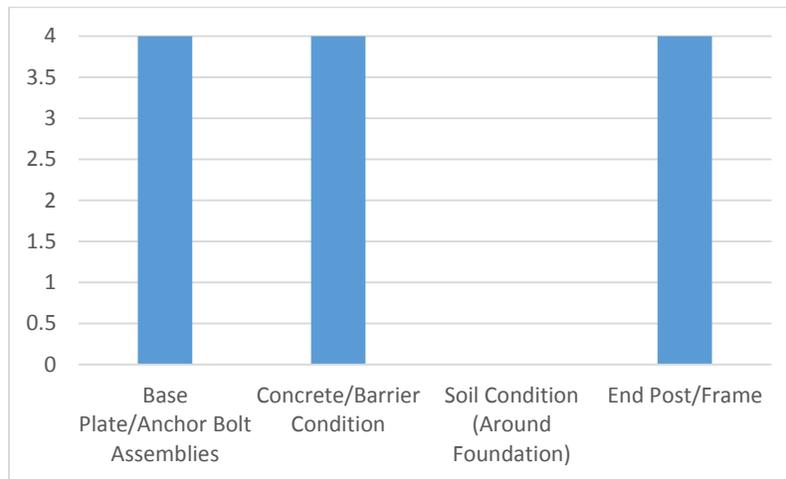
One high mast light supports was inspected in District 6. The inspection was unique in that the high mast light had been lowered to the ground in order for a contractor to dig a deep hole next to the foundation in order to inspect a gas line. The advantage of inspecting the high masts while it had been lowered allowed the pole to be fully inspected. The disadvantage was that the tightness of the bolts of the 4-bolt pattern at the foundation could not be checked. No deficiencies were found on the high mast light. Figure 6.7 provides the results on the inspection components. Note that the soil condition around the foundation was not rated due to the excavation that was taking place at the time of inspection.

Figure 6.7 Component Rating of High Mast Lighting (District 6)

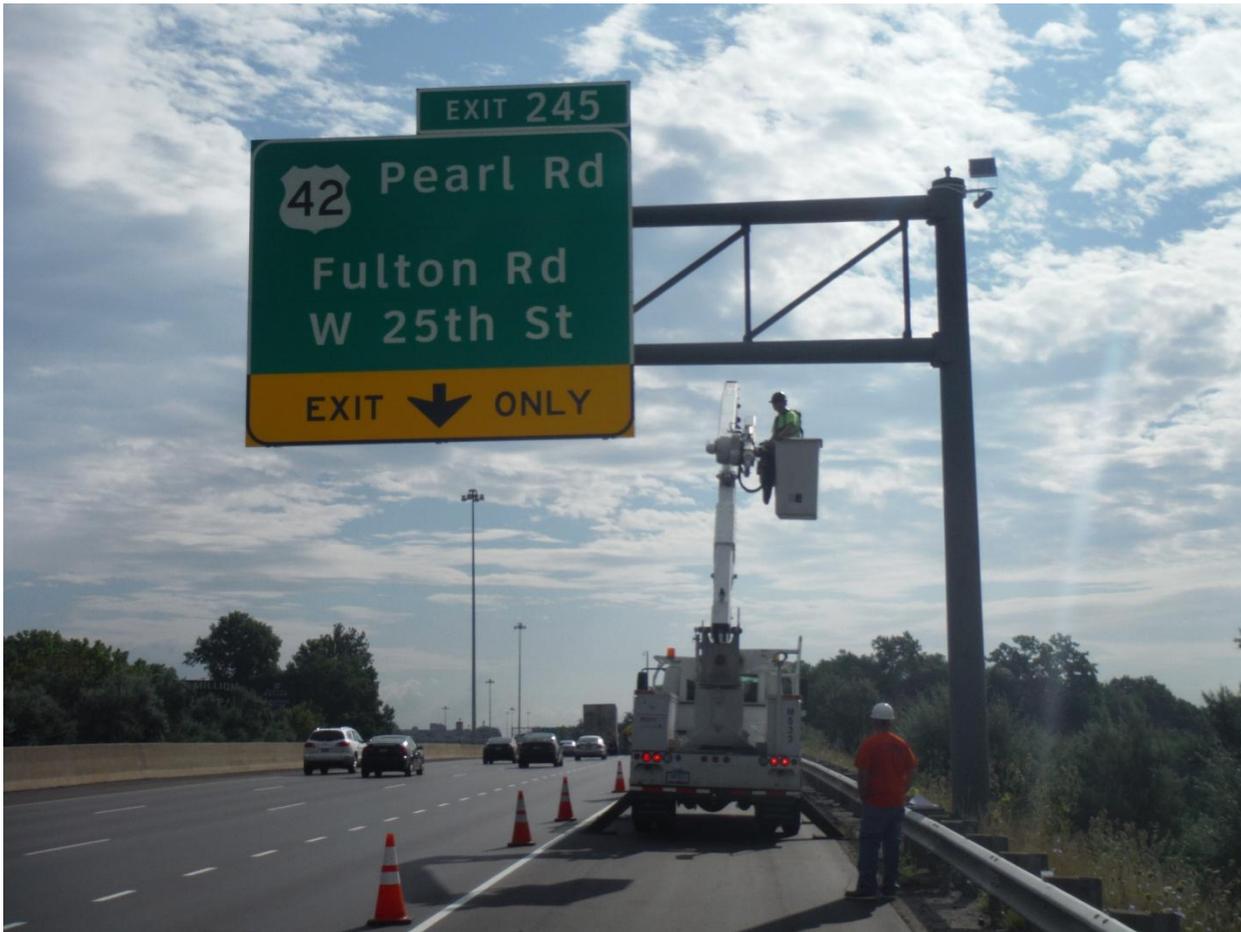
Figure A.2- Dual arm cantilever support (ID# 11209)

- Location: 71 northbound @ exit 245
- Design: #11209
- Type of method: VT
- Date: 8/2/2013

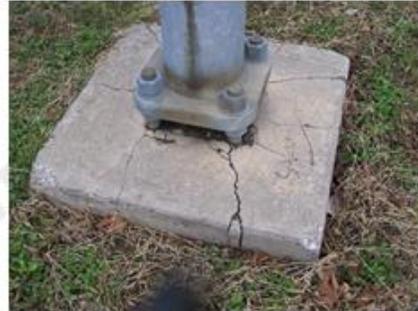
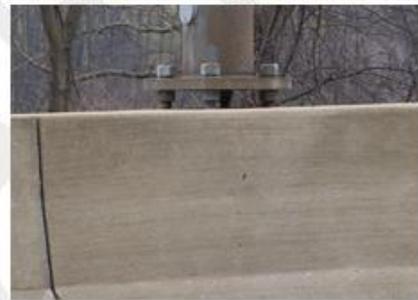
- Cracks in concrete foundation or barrier wall;
- Rust stains;
- Concrete spalling;
- Vegetation growth thru cracks;
- Overtopping of foundation by soil (clear away soil);
- Conduct (light) tapping test with hammer to determine extent of spalling or other potential damage. Unsound concrete will produce a “hollow” sound when tapped;
- Record comments/observations on OSS Inspection Form.

- 4 - No cracking, spalling, staining – like new.
- 3 - Very minor cracking, spalling and or staining.
- 2 - Significant deterioration, heavy cracking and spalling.
- 1 - Severe deterioration, foundation may not be performing as designed.

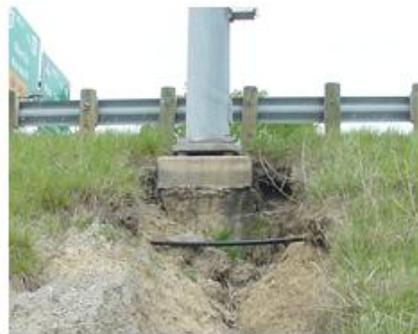
- 4 - No erosion.
- 3 - Minor erosion (around 1 side).
- 2 - Significant erosion (around 2 or more sides)
- 1 - Severe erosion, footing undermined, tipping.

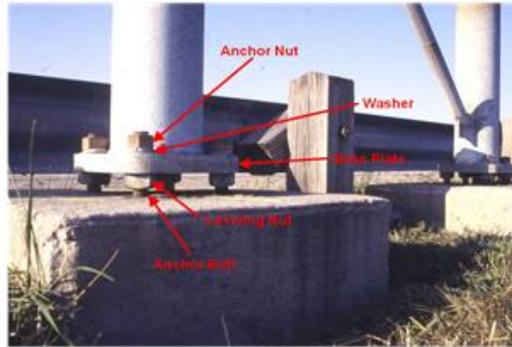
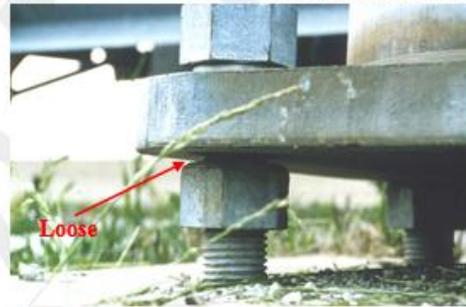
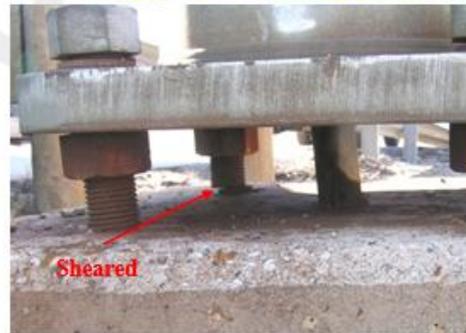
2.7.3 BASE PLATE, ANCHOR BOLT ASSEMBLIES

- Corrosion of anchor bolts (due to existing covers – remove and leave off);
- Inspect base plate weld for cracks, condition of galvanizing. Visually mark observed cracks, perform additional NDT (UT, PT, EC) to determine size of crack, and then photograph. Record position and orientation;

- 4 – Base plate and anchor bolts/nuts in good condition – like new.
- 3 – Loose nut(s), minor corrosion of base plate, anchor bolt assembly.
- 2 – Heavy corrosion, loss of galvanization.
- 1 – Missing nuts or anchor bolts, sheared bolts, cracked weld(s) or baseplate.

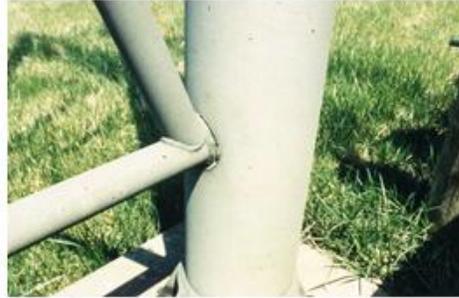
- Inspect end post and web assemblies for bent, or damaged members due to impact;
- Inspect for cracked members;
- Inspect for cracked welds;
- Check for corrosion, pitting, or loss of section;
- Check condition of galvanizing;
- Record comments/observations on OSS Inspection Form.

- 4 – End posts in good condition – like new.
- 3 – Minor corrosion of end post, minor loss of galvanizing with no section loss or medium corrosion of web members;
- 2 – Heavy corrosion, or loss of galvanization with section loss (localized);
- 1 – Severe deterioration, section loss, crack(s) in welds or web members, loss of structural integrity.

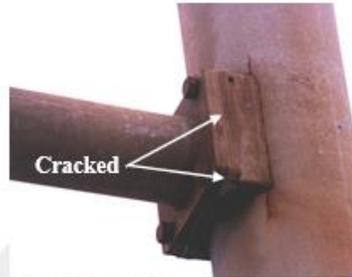
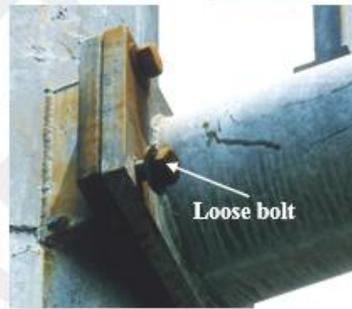
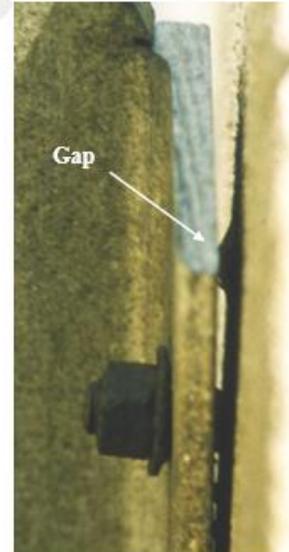
2.7.5 CONNECTION OF ARM, TRUSS TO END POST

2 – Moderate corrosion, or loss of galvanization with section loss;

1 – Severe deterioration, section loss, crack(s) in welds, missing or broken bolts.

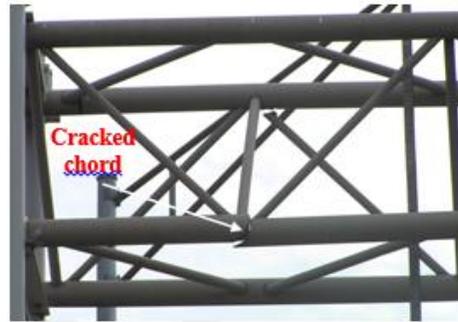
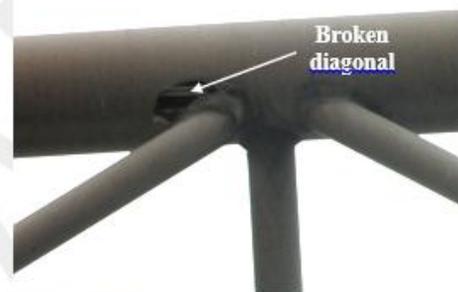
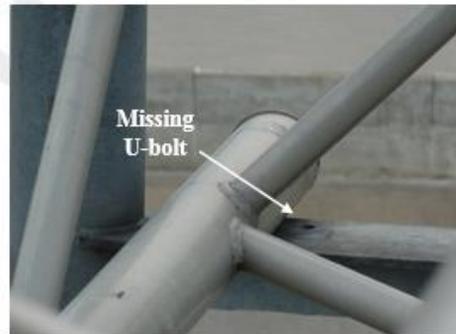
2.7.6 ARM/TRUSS MEMBER ASSEMBLIES

2 – Serious corrosion to one or more member, medium impact damage, or missing bolts/nuts, connection hardware;

1 – Cracked chord, broken diagonal, severe impact damage, or severe misalignment.

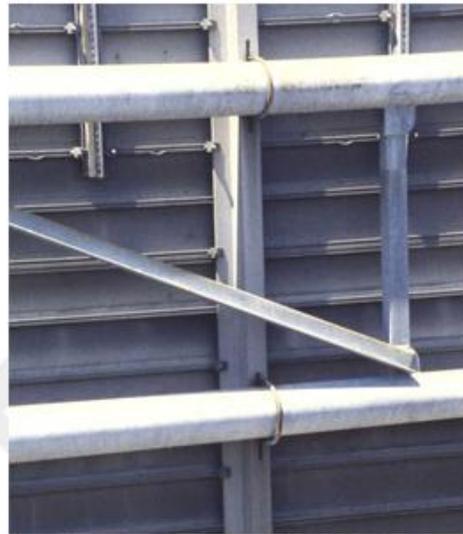
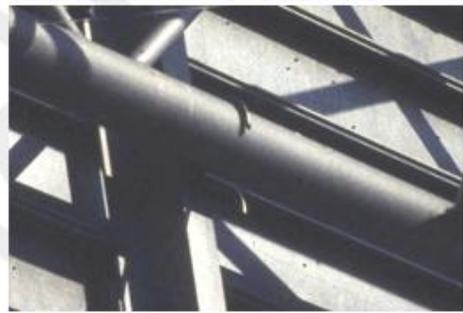
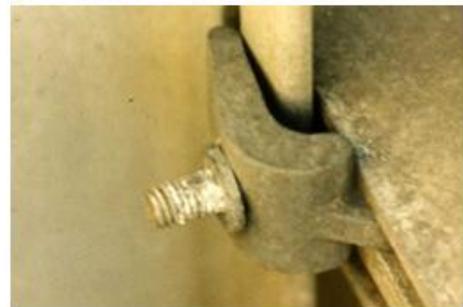
2.7.7 SIGN ATTACHMENT ASSEMBLIES

2 – Serious impact damage, or missing bolts/nuts, connection hardware;

1 – Sign attachment in state of potential collapse.
