MUS-93-12.84
Mine Grouting Project

A Straightforward Enigma

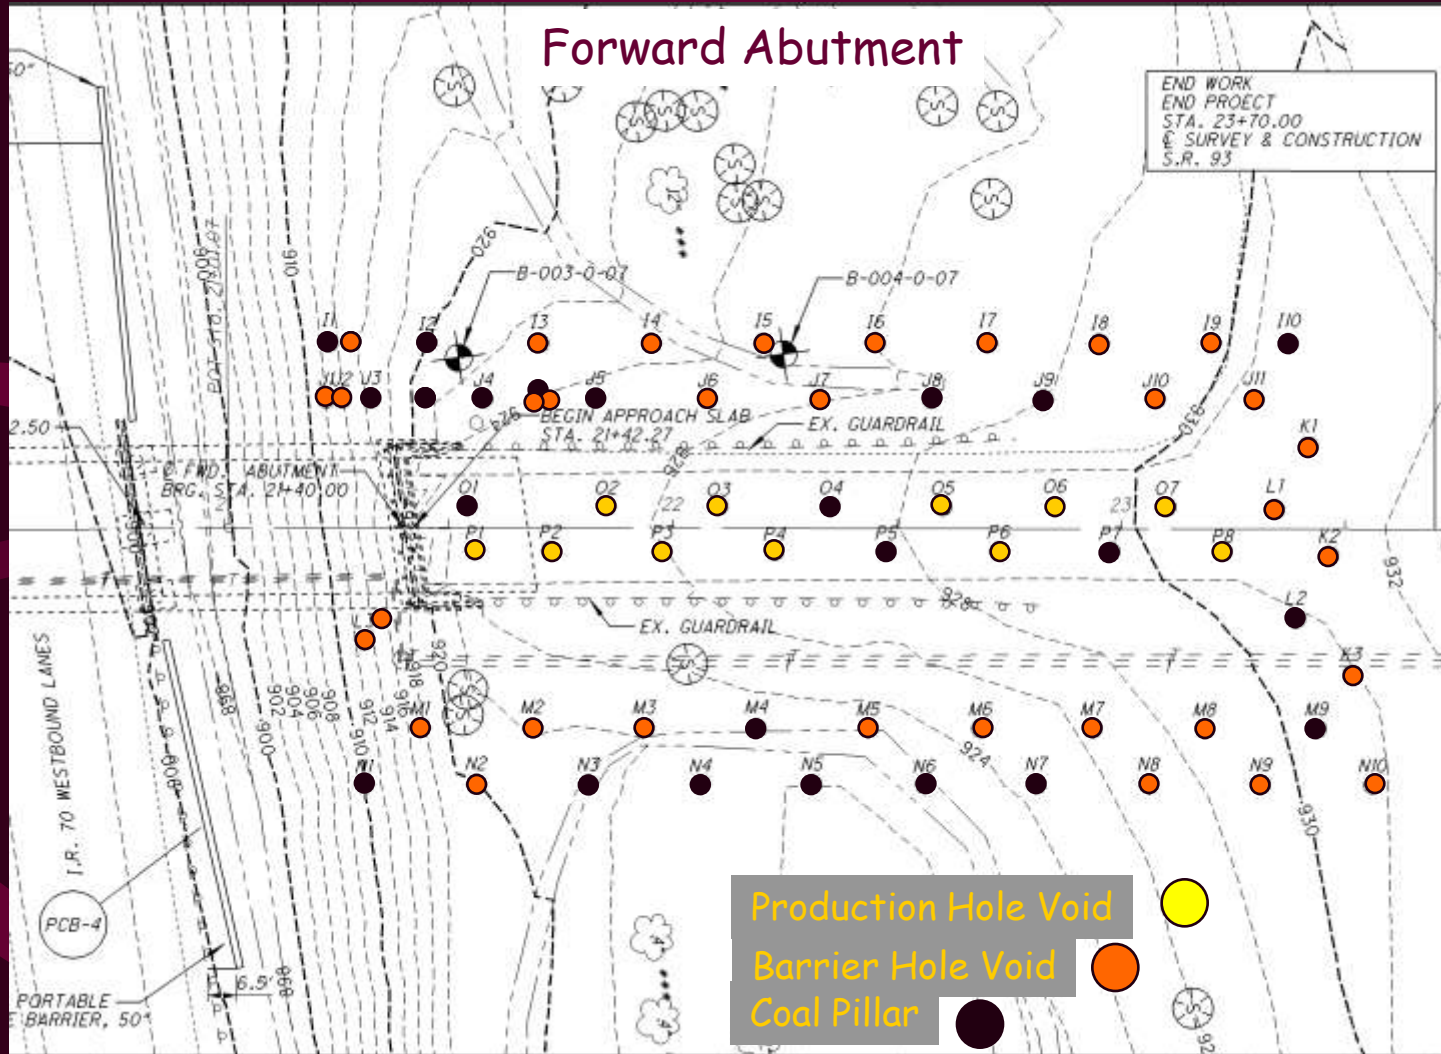
Grouting Plan/Results

- Drilled 2,000 If injection holes.
- Placed about 2,000CY of Barrier Grout.
- Placed about 250 CY of Production grout (virtually all on the north side).
- Began project Feb 14th, completed Mar 4th.
