Structural Design Methodology for Spray Applied Pipe Liners in Gravity Storm Water Conveyance Conduits

Prepared for:
 The Ohio Department of Transportation,
 Office of Statewide Planning & Research

Project ID Number: 103453

1. Report No. FHWA/OH-2021/10		2. Government Accession No.		3. Recipient's Catalog No.	
4. Title and Subtitle Structural Design Methodology for Spray Applied Pipe Liners in Gravity Storm Water Conveyance Conduits				5. Report Date April 2021

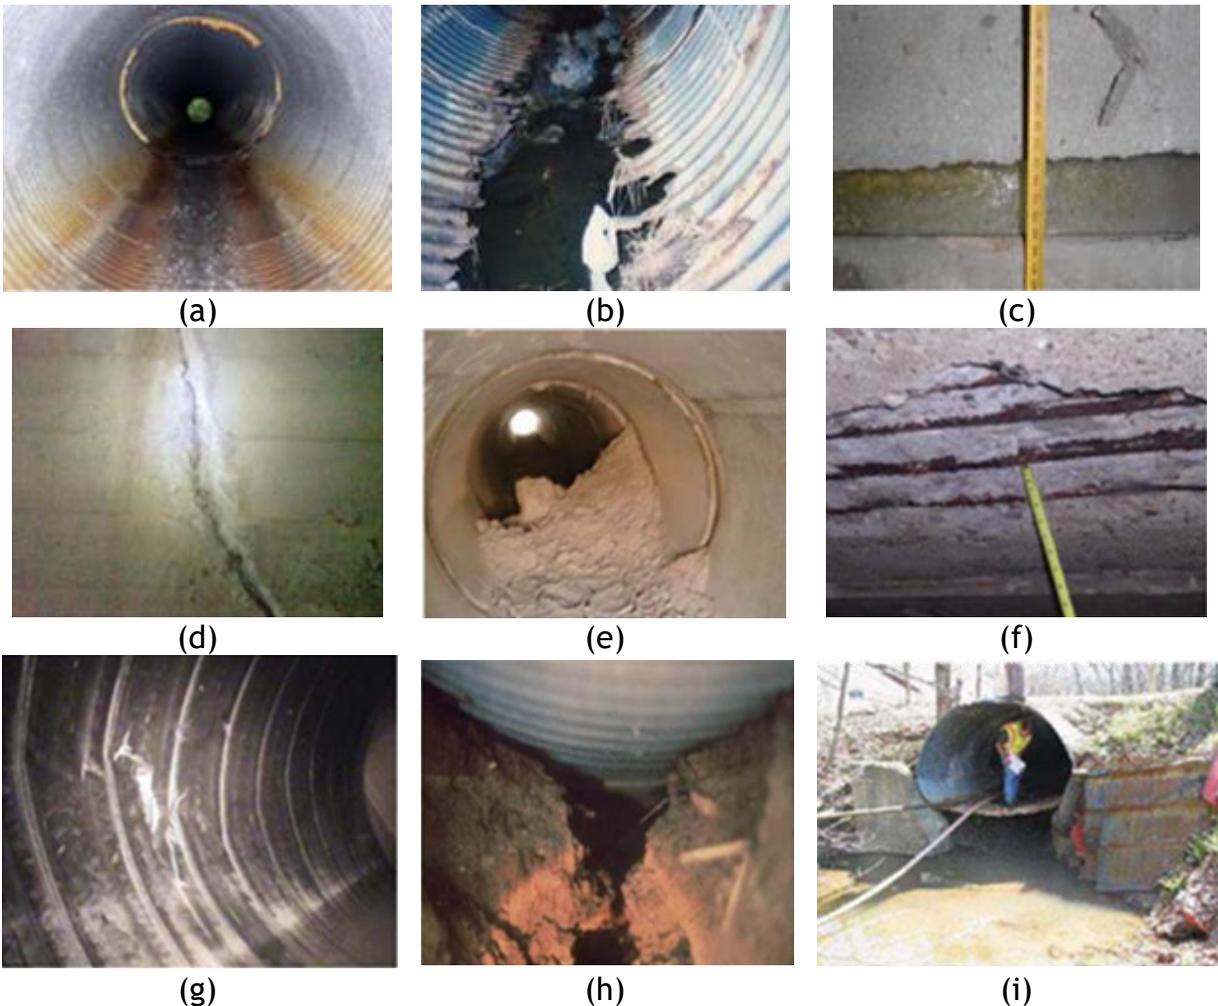
Figure 2-13. Common Defects of Culverts: (a) invert corrosion, (b) invert abrasion, (c) joint separation, (d) crack, (e) joint infiltration, (f) spalling in concrete culverts, (g) wall damages in plastic culverts, (h) piping beneath a culvert and (i) outlet scour (Piratla et al. 2017).

Common defects in culverts can include crack, corrosion, loss of pipe wall thickness, joint infiltration, joint exfiltration, invert deterioration, joint misalignment, shape distortion, debris, loss of wall thickness, and bedding voids, as illustrated in Figure 2-13 (Piratla et al. 2017).

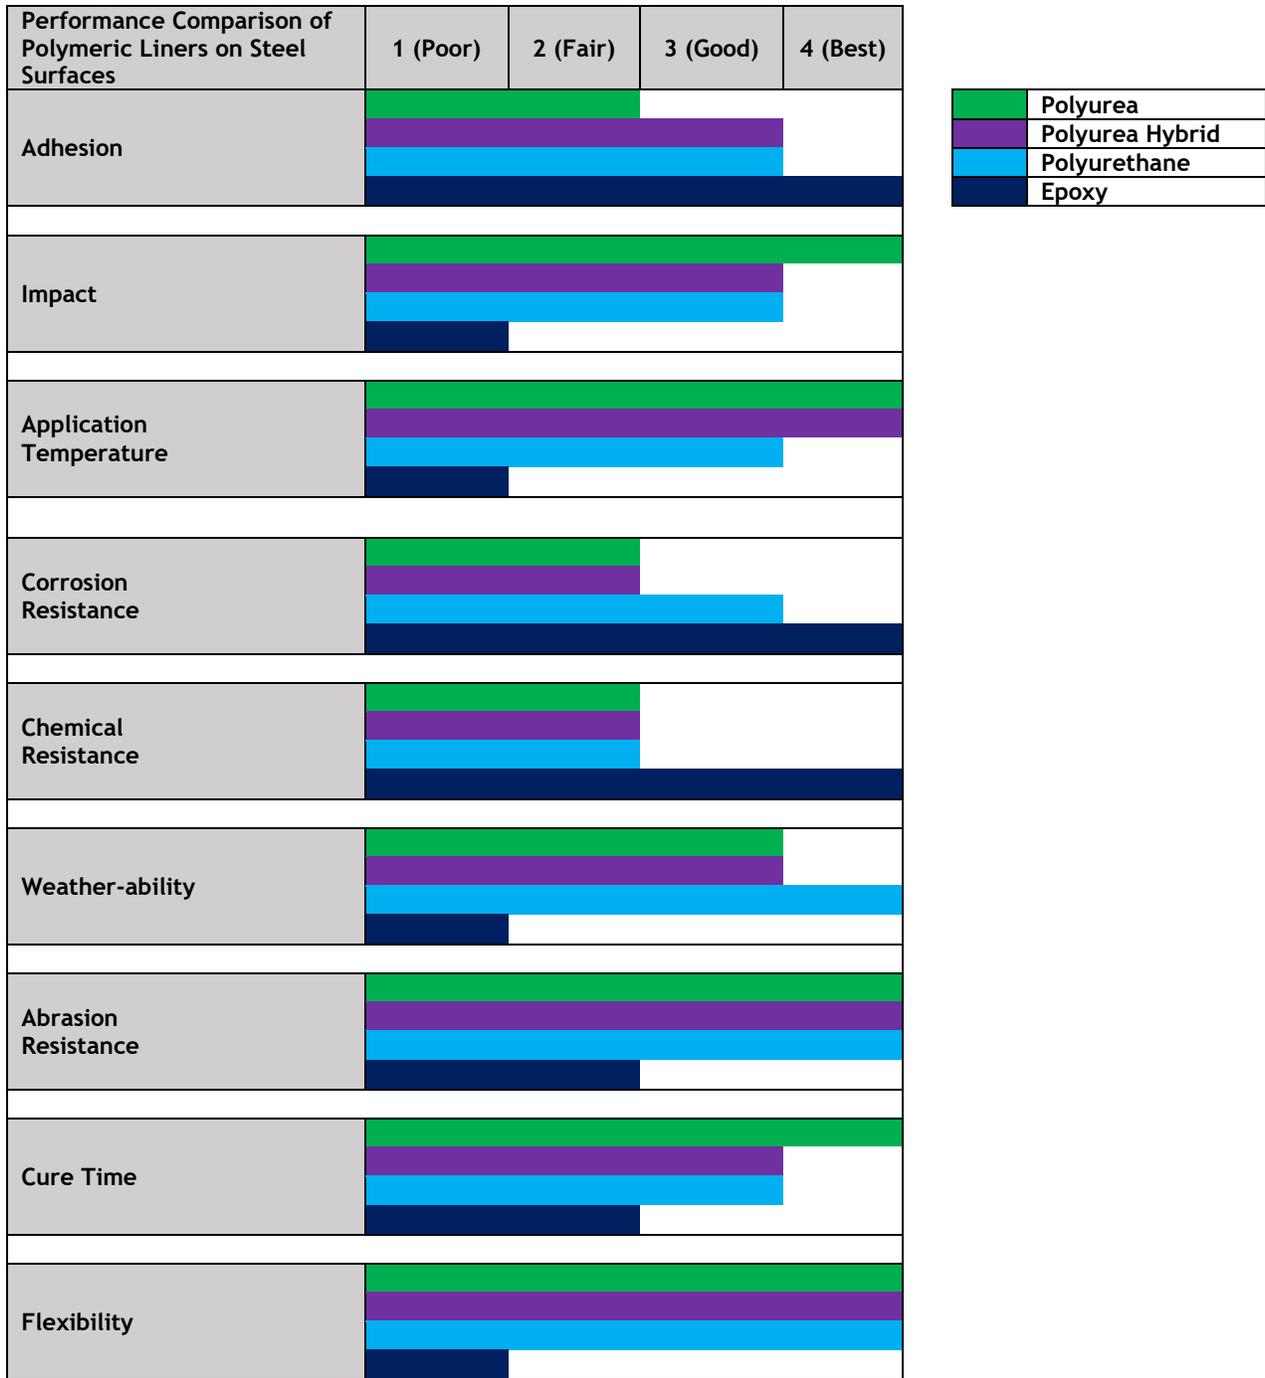
Figure 2-22. Performance comparison of polyurea, polyurea hybrid, polyurethane and epoxy coatings applied on steel substrate (Adapted from Cain 2016).

Polyureas can be applied at very high thickness, compared with polyurethane, and enhance the structural integrity of the substrate. Installation of polyurea coatings need the application of high-pressure, plural component sprayers, and a trained applicator. Polyurea elastomers are unsuitable for applications requiring less than 5 mil thickness coatings. Polyureas are used a replacement for epoxies in applications that mechanical properties such as elongation and impact resistance are important. A performance comparison using the mechanical properties of polyurea, polyurea hybrid, polyurethane and epoxy coatings applied on steel substrate is illustrated in Figure 2-22.

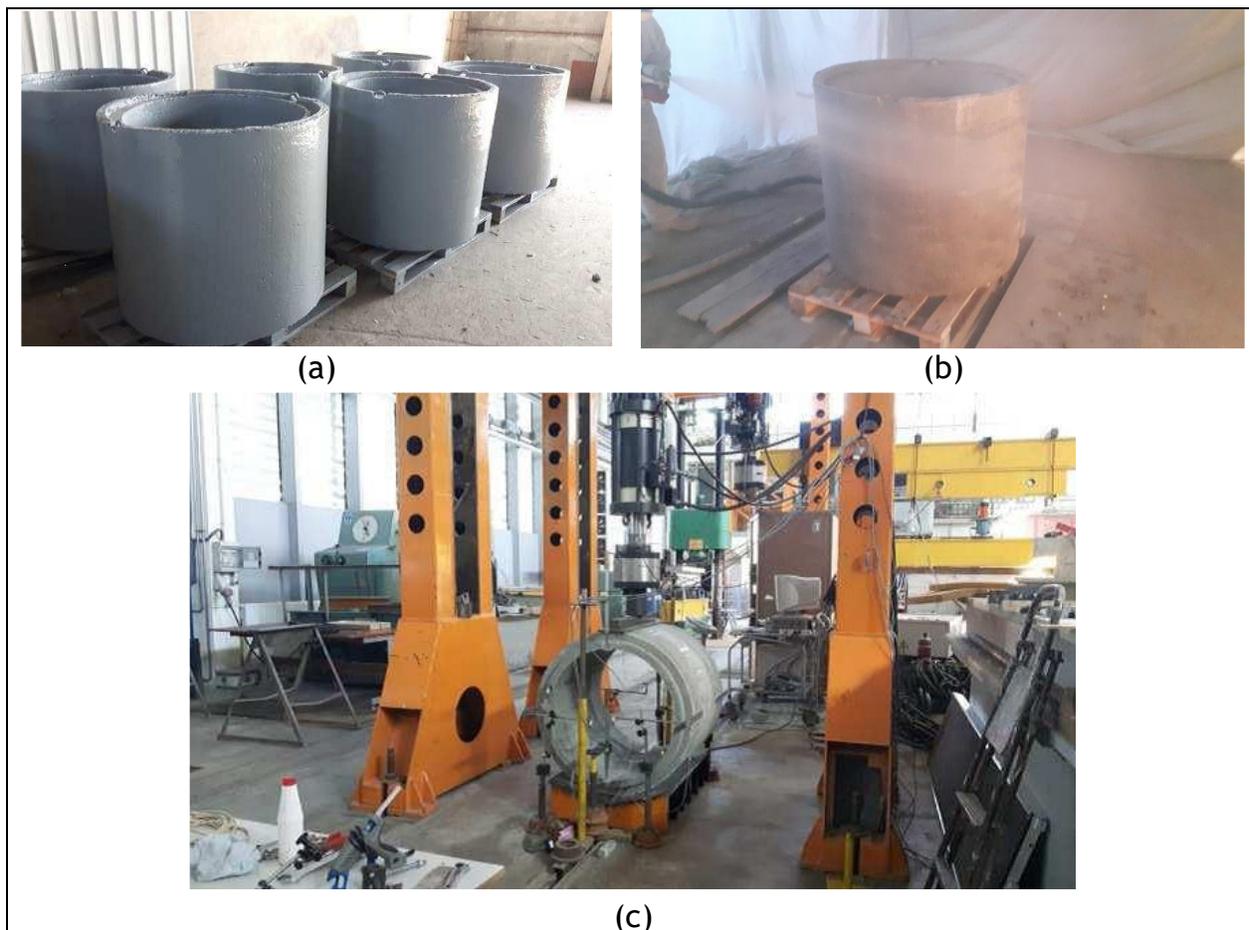
Figure 2-25. Dead-load testing of reinforced concrete pipes (RCPs) renewed with polymeric SAPLs: (a) tested concrete rings covered by polyurea coating, (b) spraying polyurea coating system on concrete ring, and (c) D-load testing frame (Szafran and Matusiak 2017).

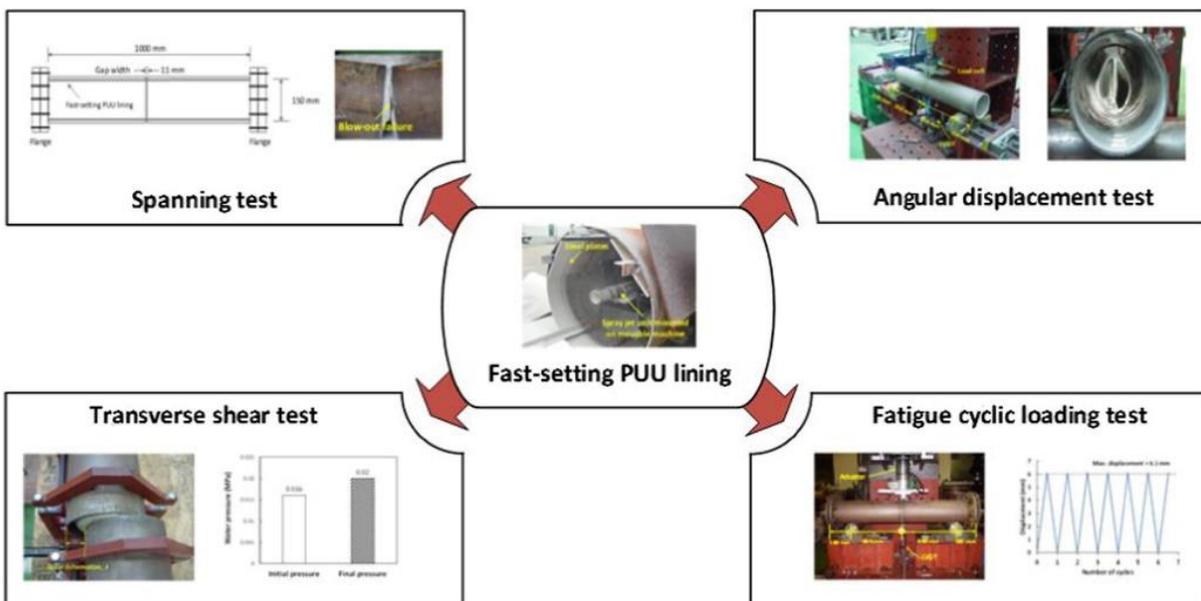
Figure 2-26. The structural behavior and performance of a fast-setting polyurea-urethane (PUU) SAPL as a structural lining material for rehabilitating water pipes (Ha et al. 2016).

bonding between a fast-setting PUU SAPL and steel specimens, the spanning capability of the lining on the water pipes, the bending and shear behavior of PUU lining, and the fatigue behavior of a renewed water pipe with PUU. Their methodology involved a series of experimental tests to assess the bond strength, hole and gap spanning capabilities, angular displacement ability, transverse shear resistance, and fatigue cyclic loading resistance. From these tests, the hole spanning capability of water pipe with 0.2 in. hole was observed to be 1,595 psi. Peel off failure of PUU occurred at an angular displacement capacity of 6.74° and no failure of PUU was observed at a transverse shear capacity of 25% of the diameter. The fatigue resistance of PUU in the range of 10^5 cyclic loadings was achieved. As the result, the authors found that the fast-setting PUU lining can be used in renewal of water pipes. Their paper ignored the impact of soil-pipe-structure interactions (Ha et al. 2016).

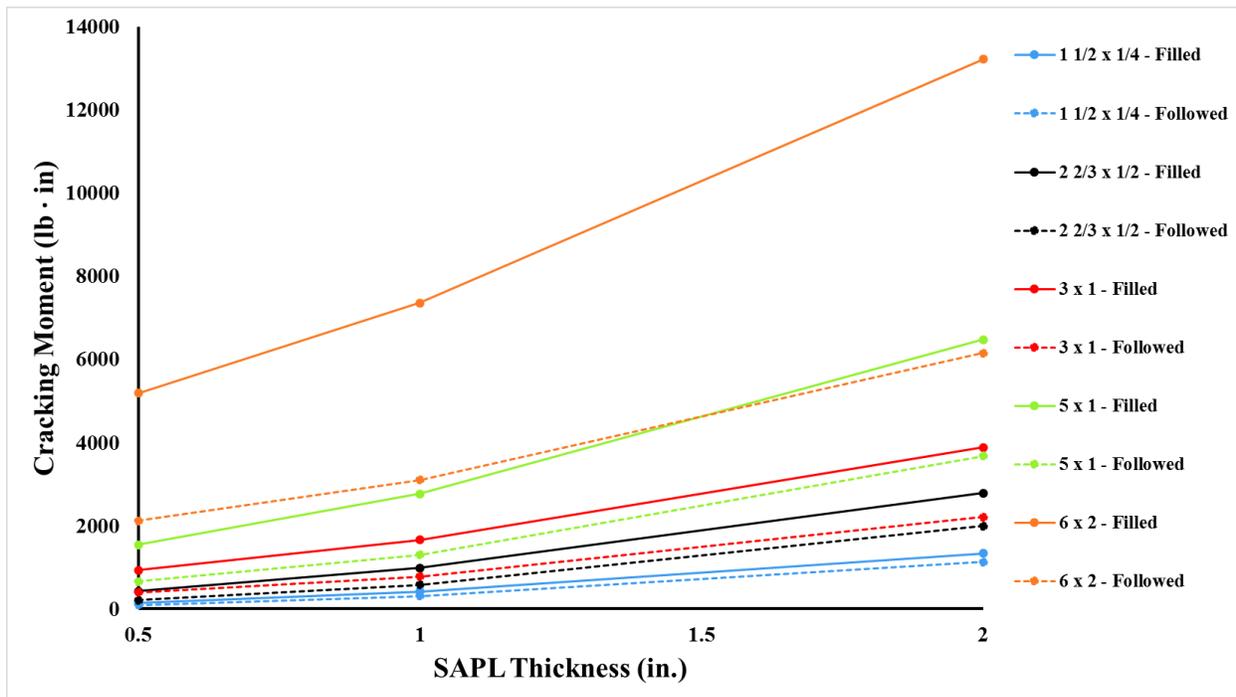
Figure 4-6. Cementitious SAPL thickness versus cracking moment.

Figure 4-6 illustrates a graphical representation of the increase in cracking moment with increases in the cementitious liner thickness for filling versus following the corrugations. In these plots the contribution from a composite action of the CMP with the new liner is considered. The relative separation between the followed and the filled cracking moments and the increase in separation between them are notable in the curves. Therefore, the filled corrugations provide a stronger, more robust design.

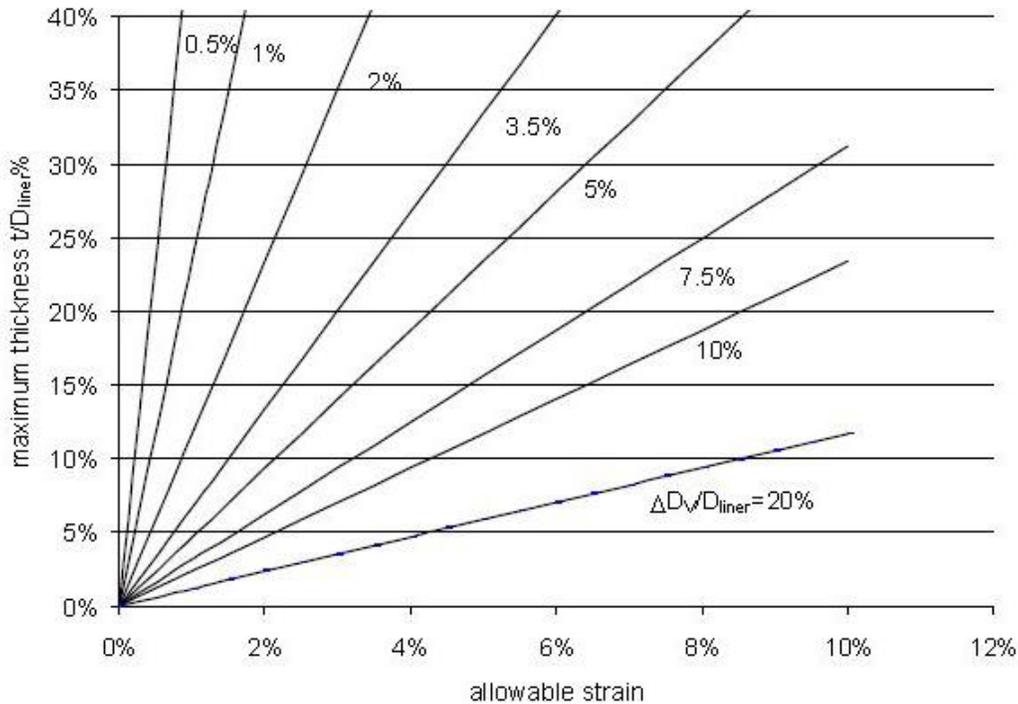
Figure 6-5. Bending limit state (Moore, 2008).

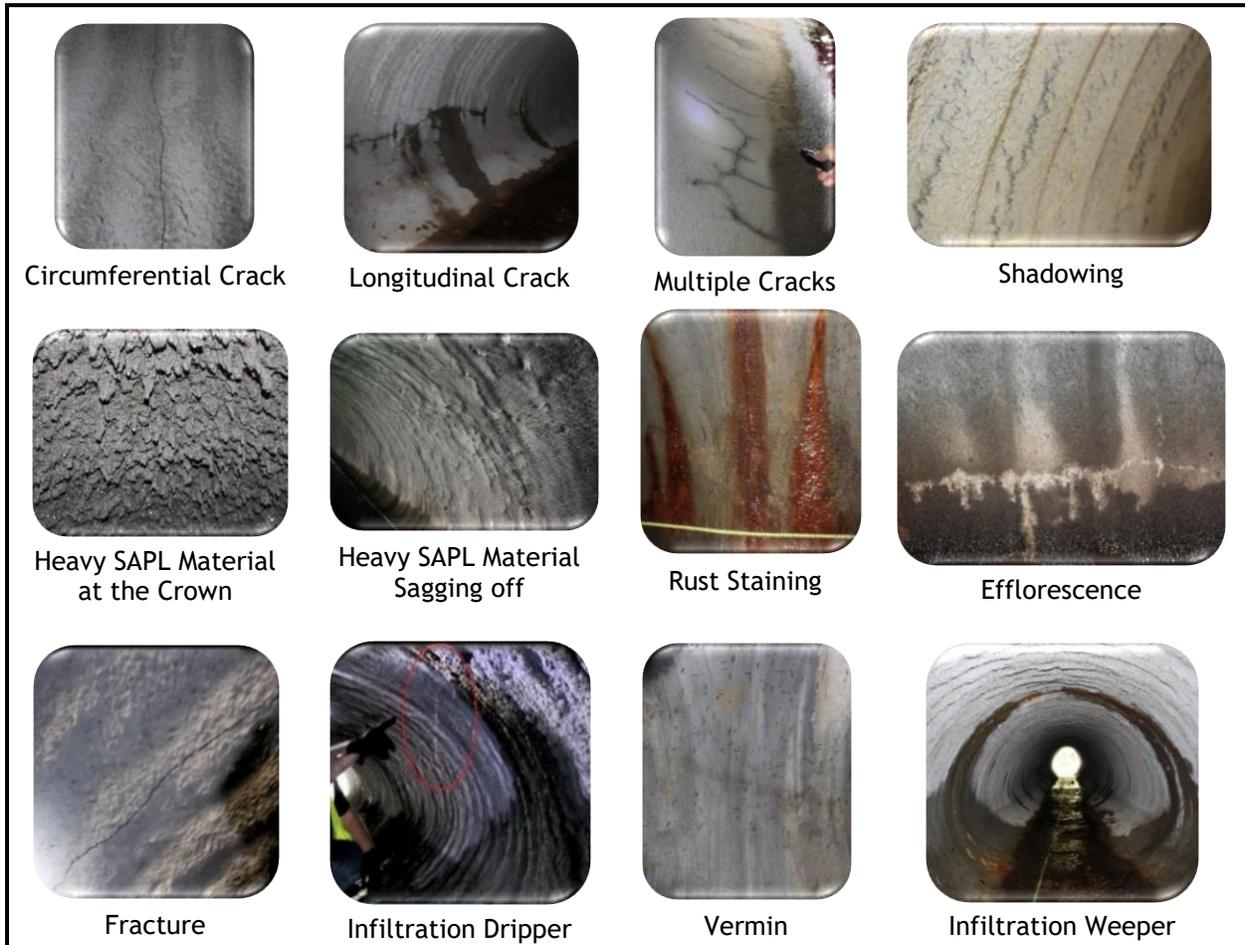
Figure 7-2. Issues found with SAPLs.

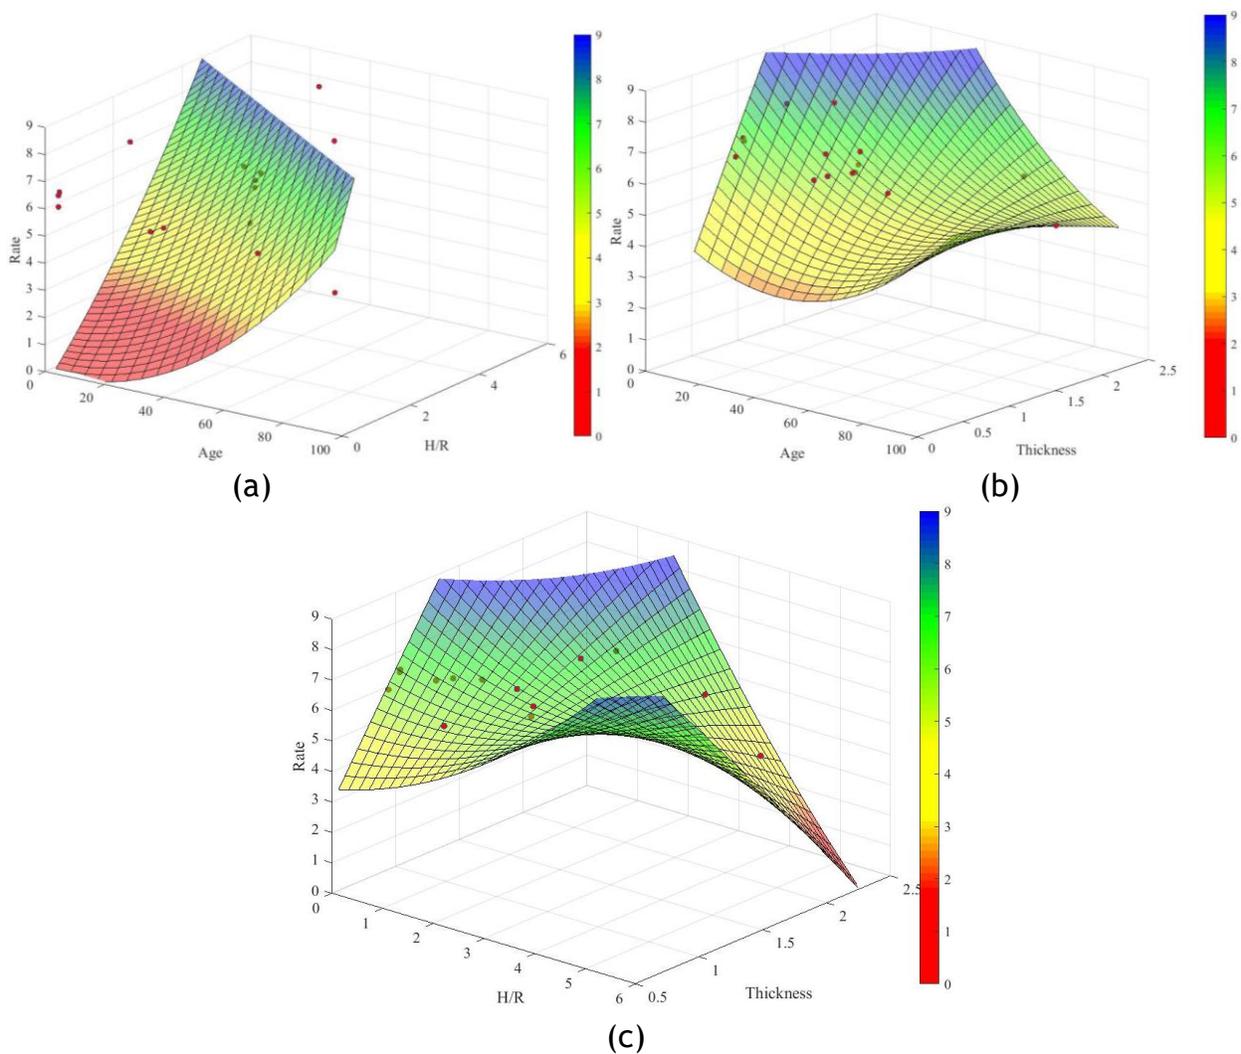
Figure 7-6. Correlation of Age, H/R, Thickness and AOR of SAPLs, (a) A, H/R and AOR (b) A, T and (AOR), (C) H/R, T and AOR.

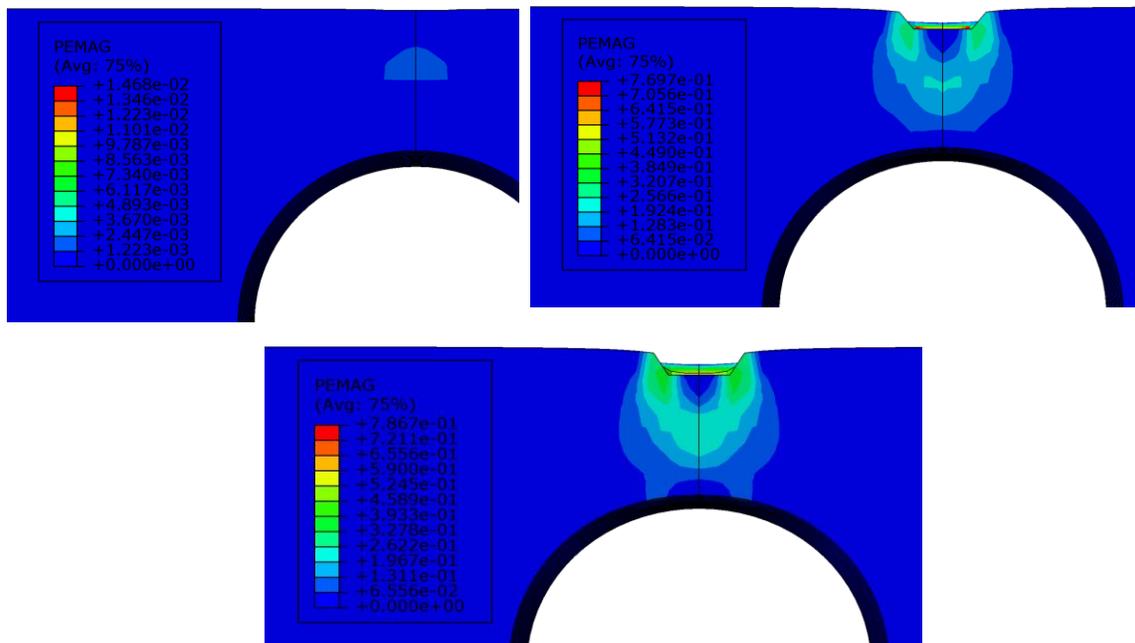
Figure 10-10. Progression of plastic strain under the load pad in soil ((a) at 1 in. settlement, (b) at 4 in. settlement (c) at 5 in. settlement

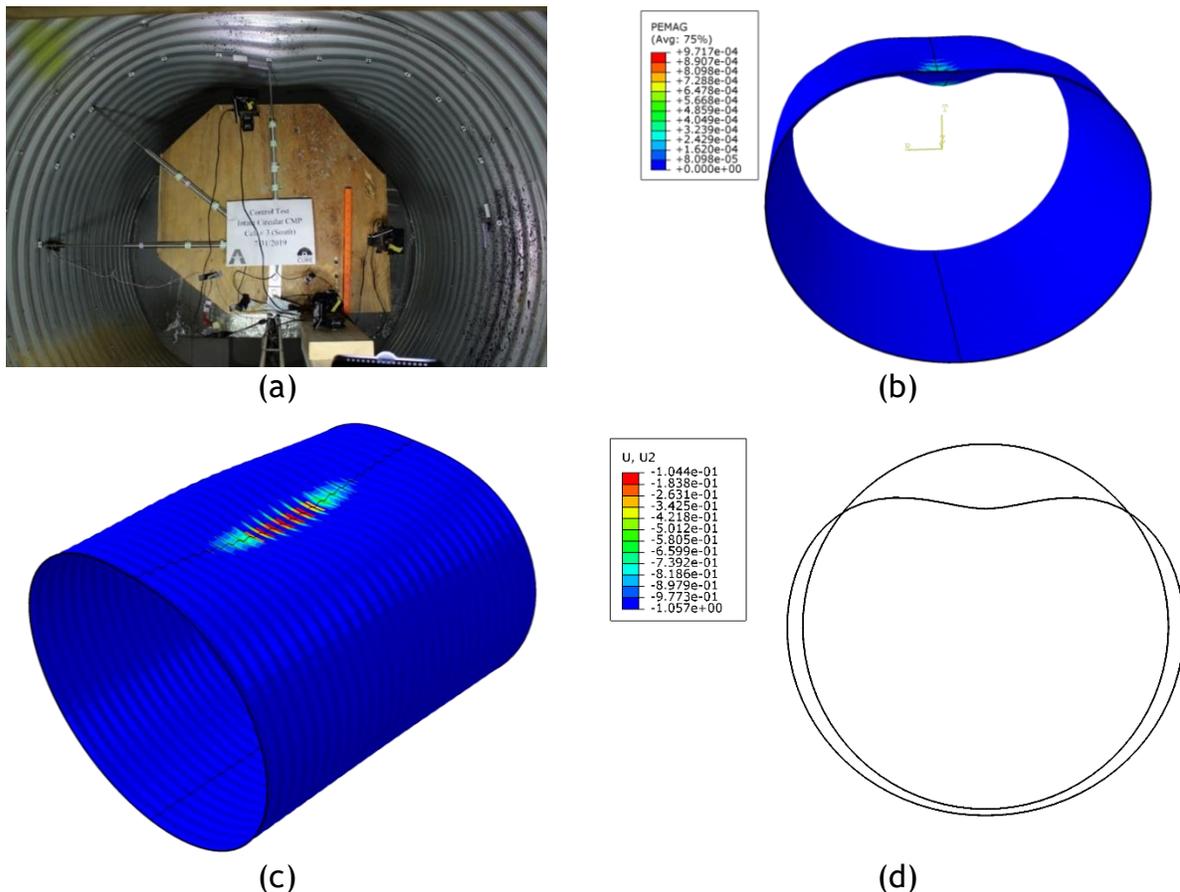
Figure 10-11. Plastic strain and deflection pattern in CMP (a) Experimental Result (b), (c) and (d)FEM Result (scaled up by 5 times).

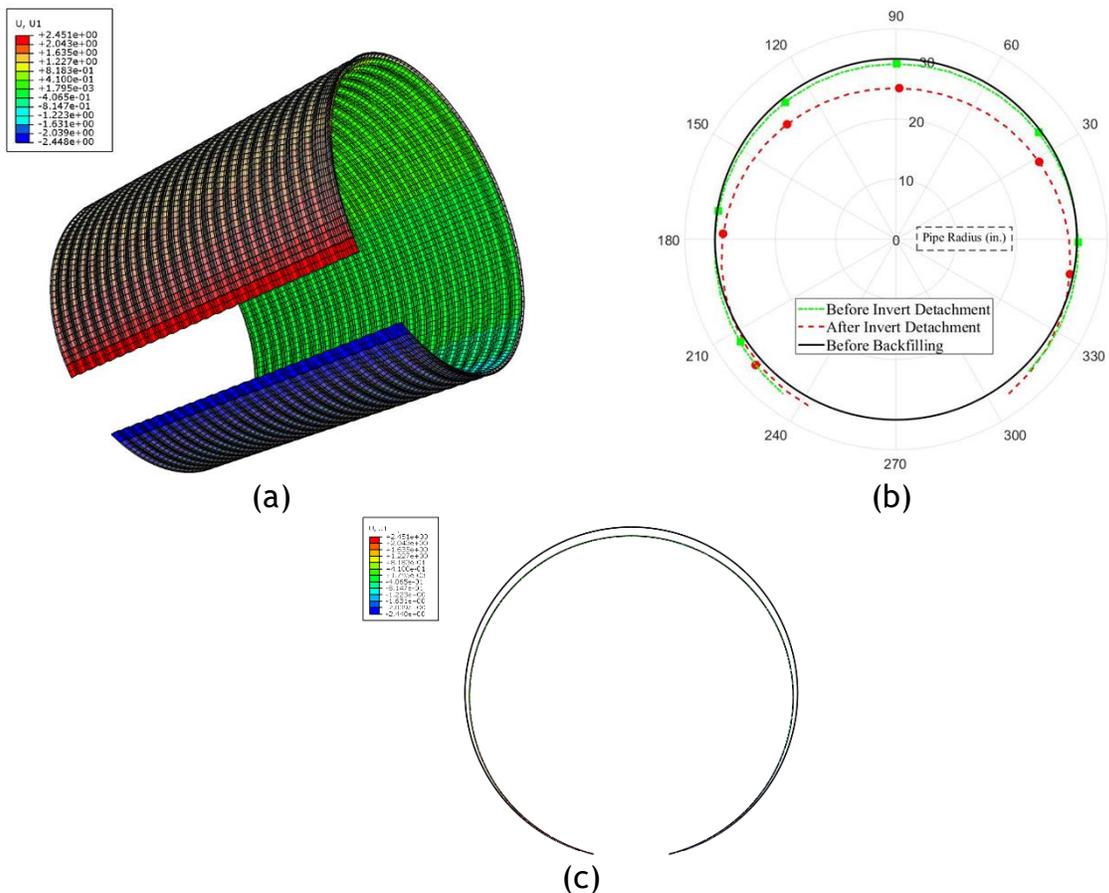
Figure 10-19. (a) Reduction in the invert gap from FEM (b) Experimental recording of the reduction in invert gap by Digital Image Processing (Darabnoush Tehrani, et al., 2020) (c) Vertical diameter change from FEM after invert removal.

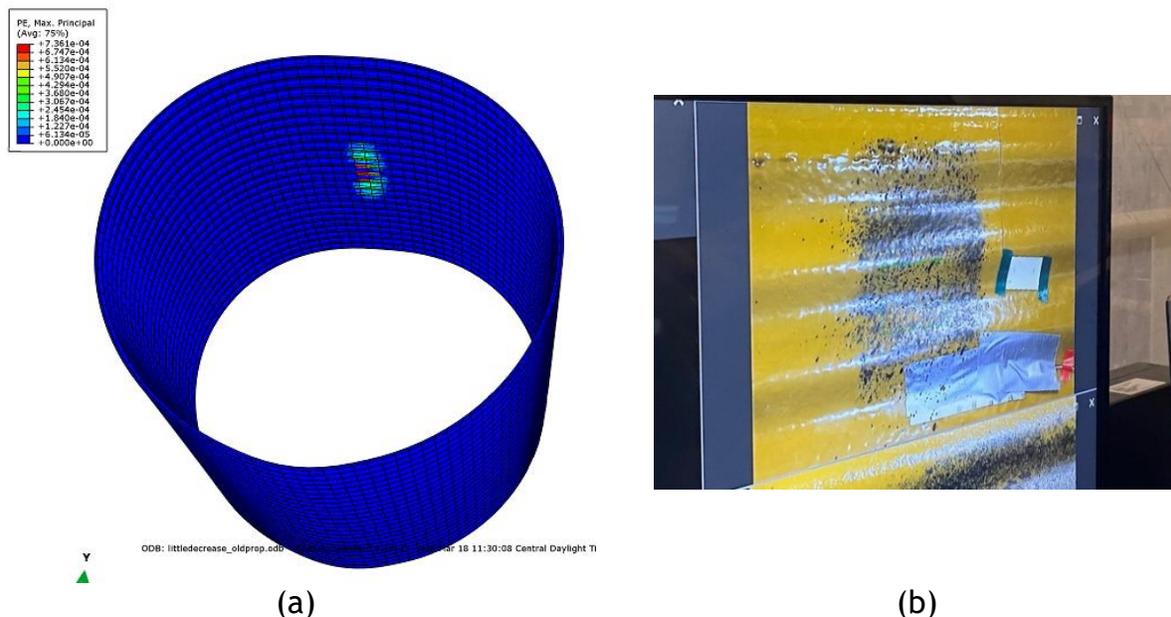
(a) (b)
 Figure 10-21. (a) 1st plastic strain in the CMP (b) 1st crack in the model for 0.25 in. thick polymeric SAPL

Figure 10-21. (a) 1st plastic strain in the CMP (b) 1st crack in the model for 0.25 in. thick polymeric SAPL 333

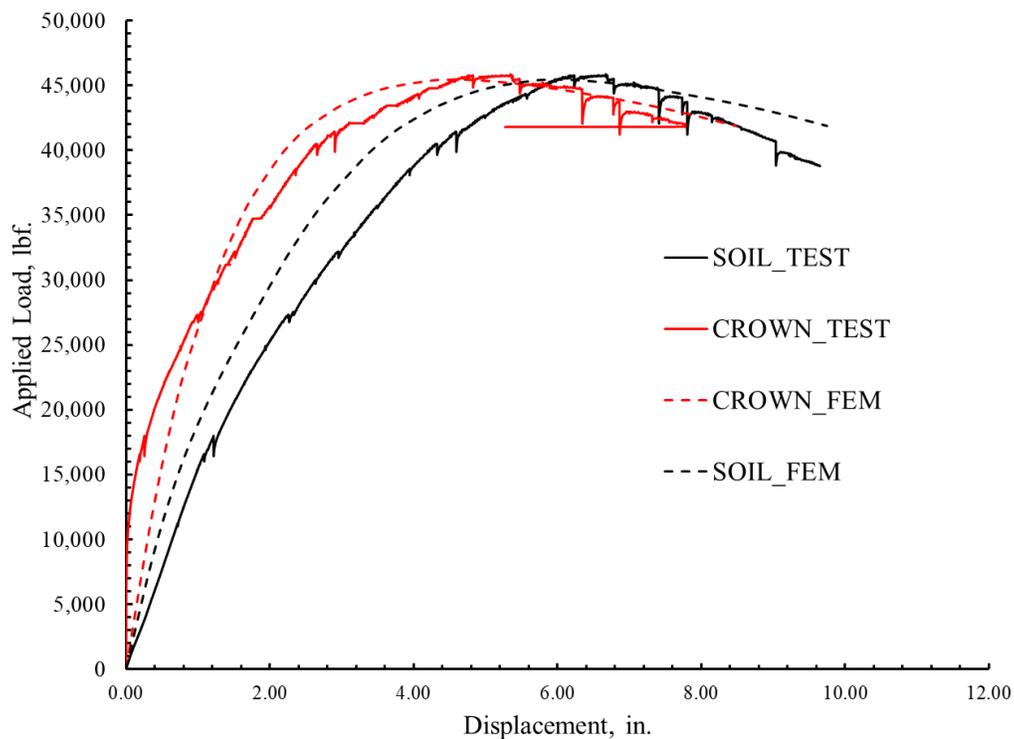
Figure 10-25. Comparison of the liner displacement at crown for 0.25 in. thick polymeric SAPL between experiment and FEM results.

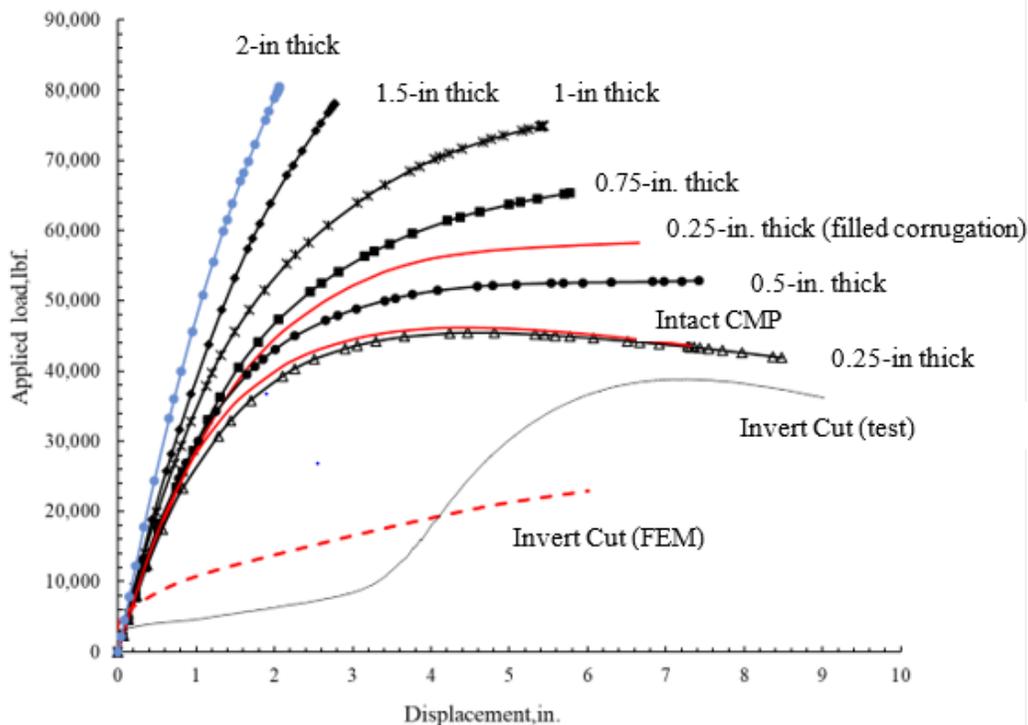
Figure 10-36. Comparison of the load-displacement plot at the crown obtained from all the FE results.

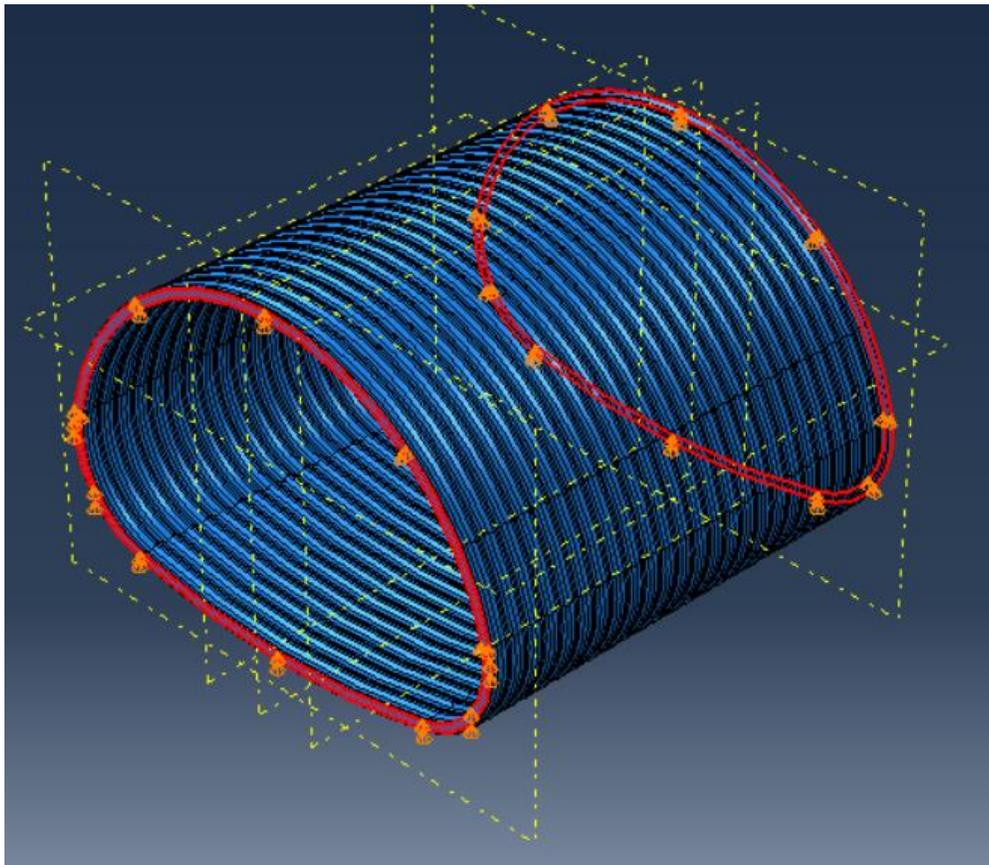
Figure 10-50. 1-in. thick polymeric SAPL liner showing the restriction of the vertical movement at two ends.

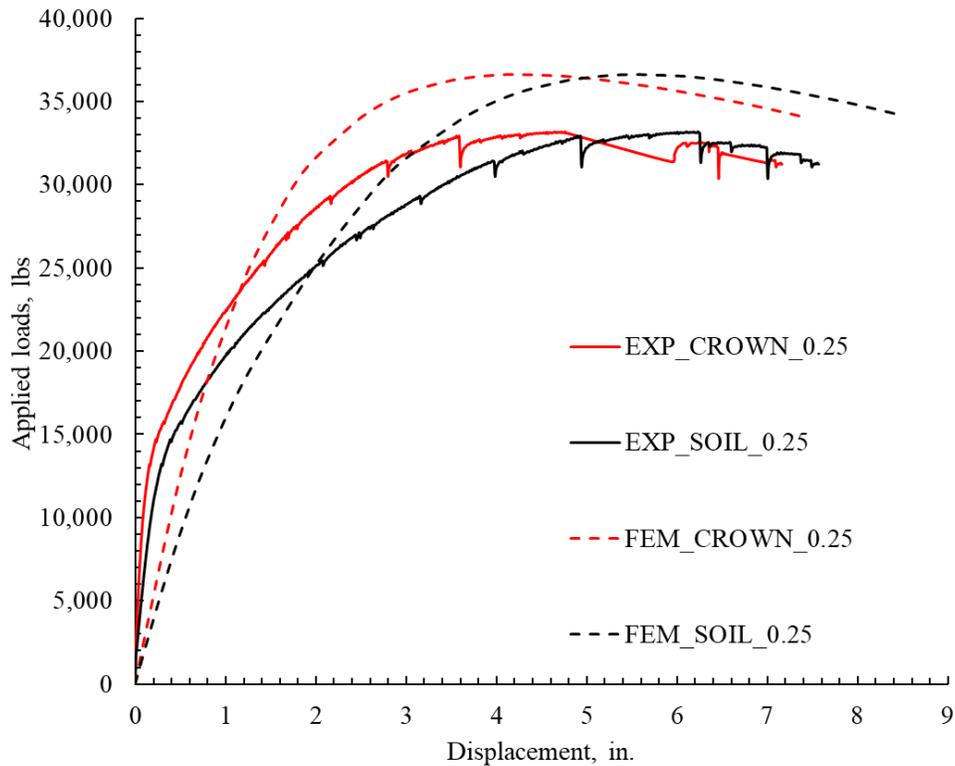
Figure 10-53. Load displacement curve comparison between FEM and Experiment for 0.5-in. thick polymeric SAPL with the boundary conditions at the end.

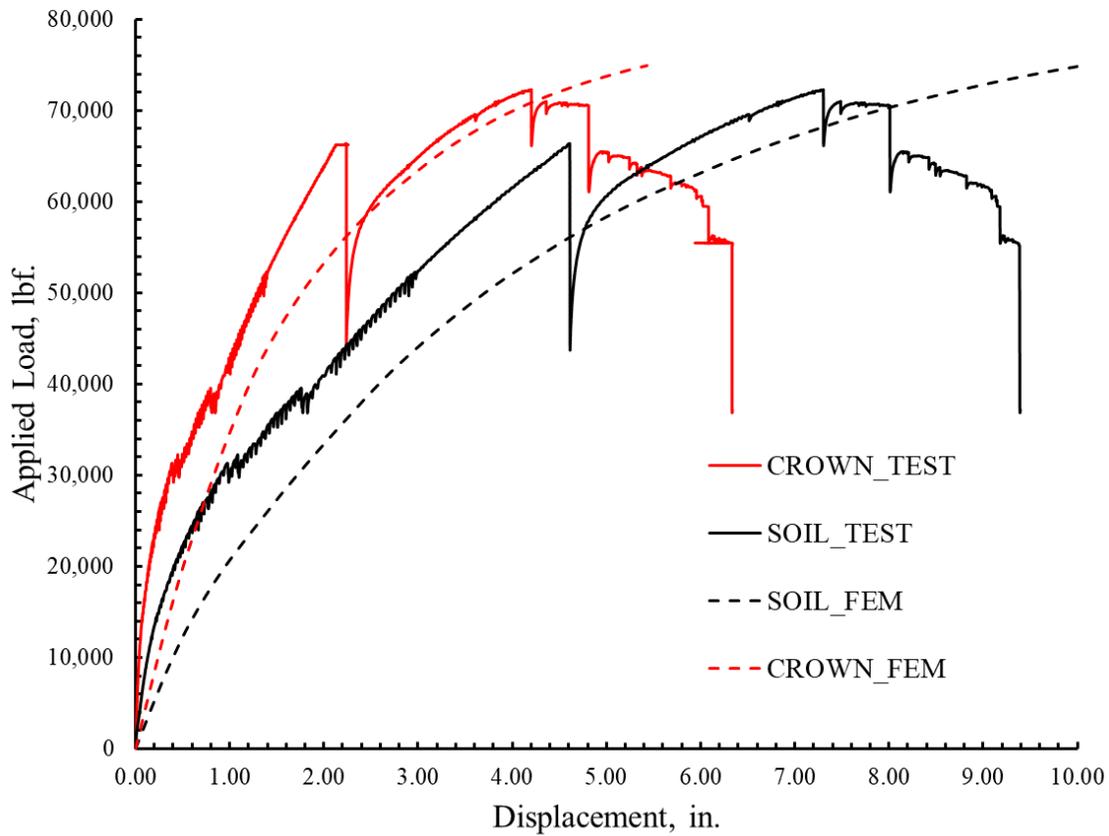
Figure 10B- 7. Load displacement comparison for FE and test results for 1-in. thick polymeric circular liner.

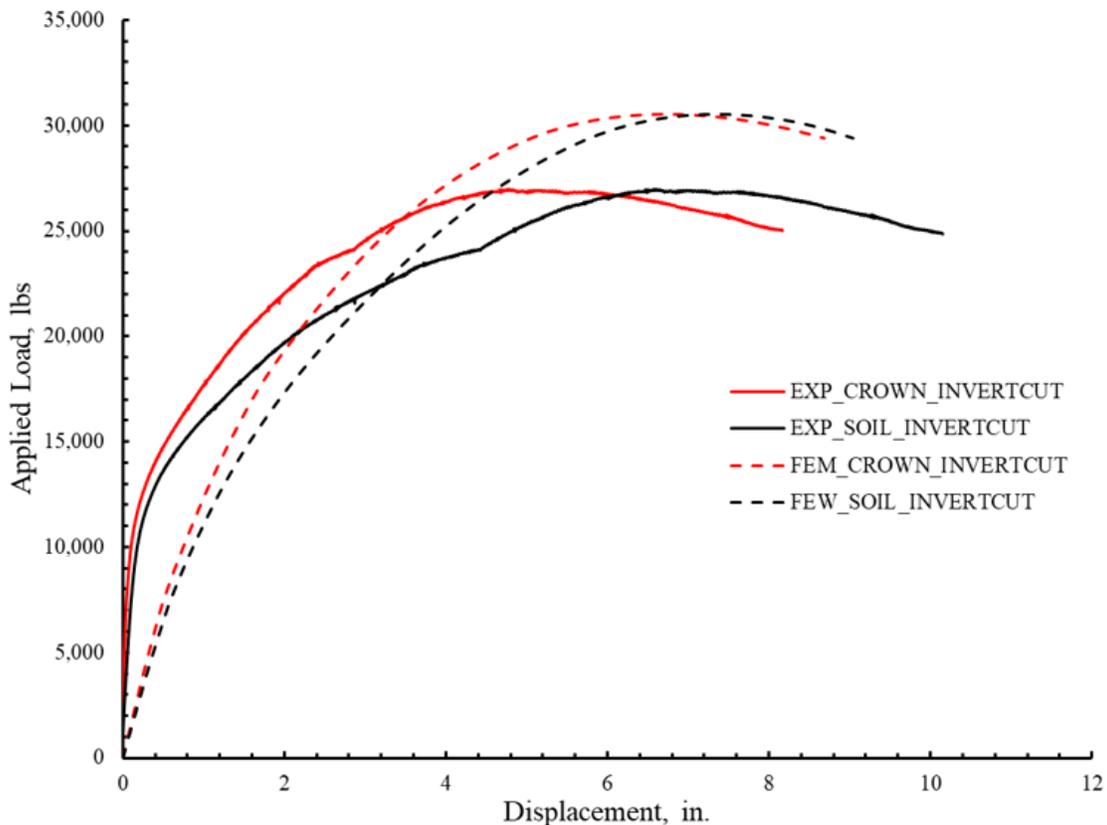
Figure 10C- 1. Load displacement plot for the movement of arch CMP's crown and settlement below load pad for invert cut arch CMP.

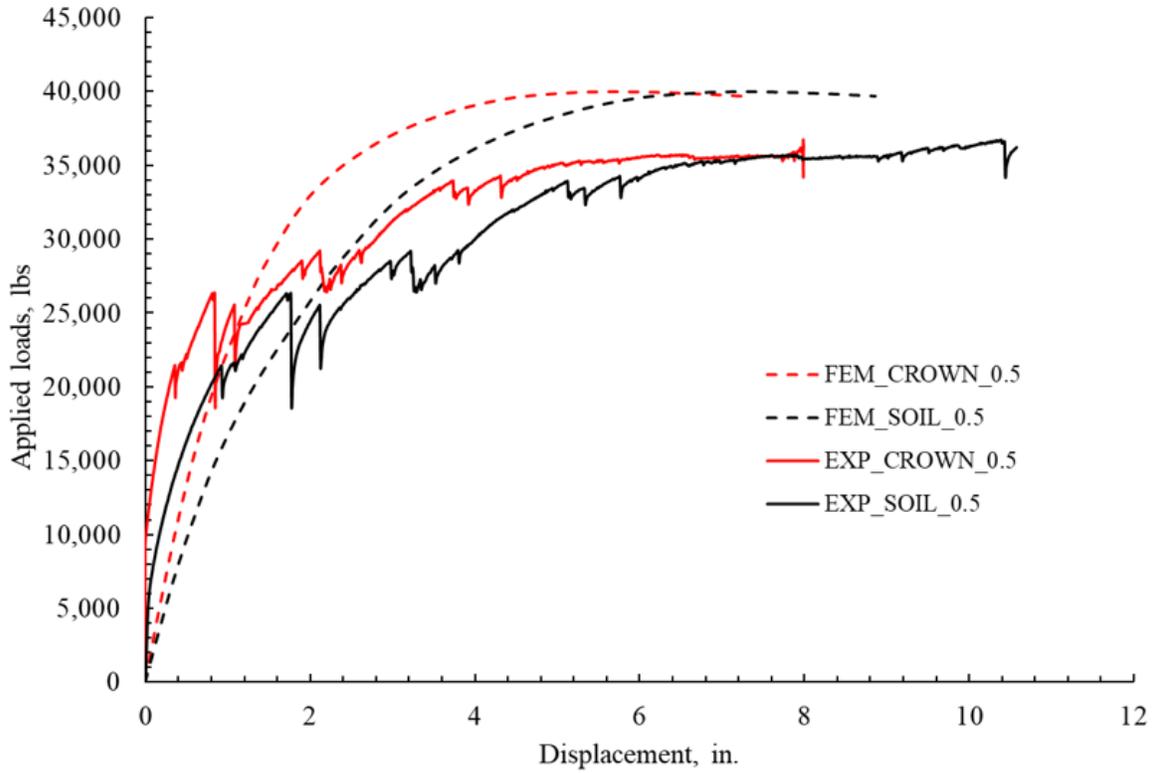
Figure 10E- 2. Comparison of load displacement plot for the 0.5-in. thick arch polymeric liner.

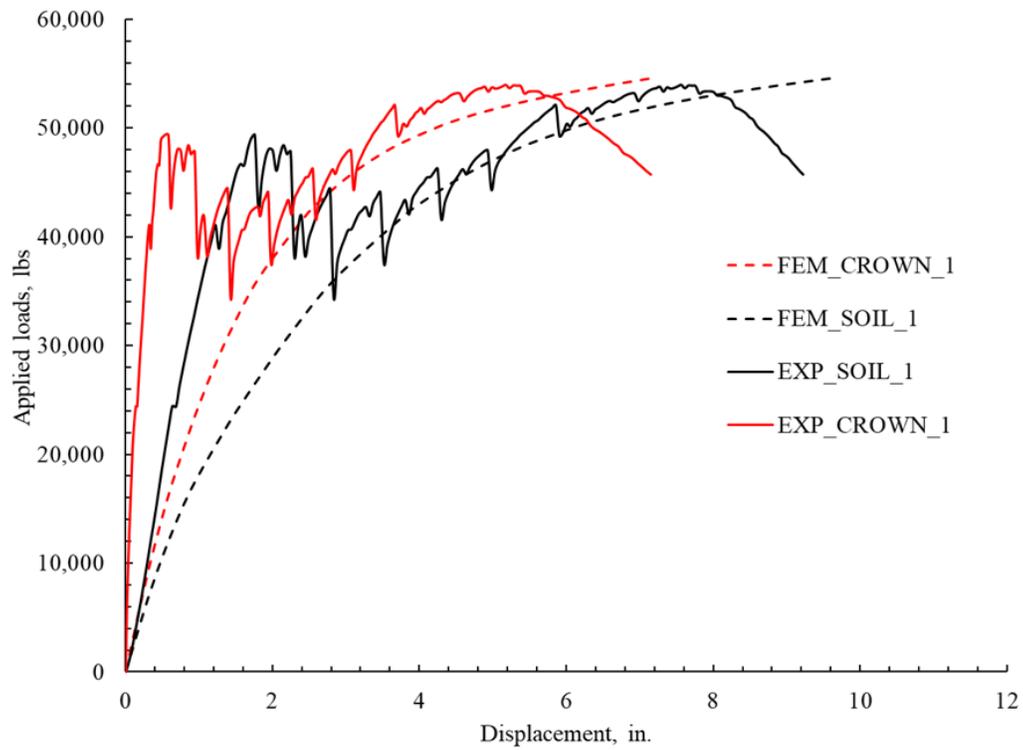
Figure 10E-7. Load displacement plot at the crown and settlement of soil below load pad for 1-in. thick arch polymeric liner.

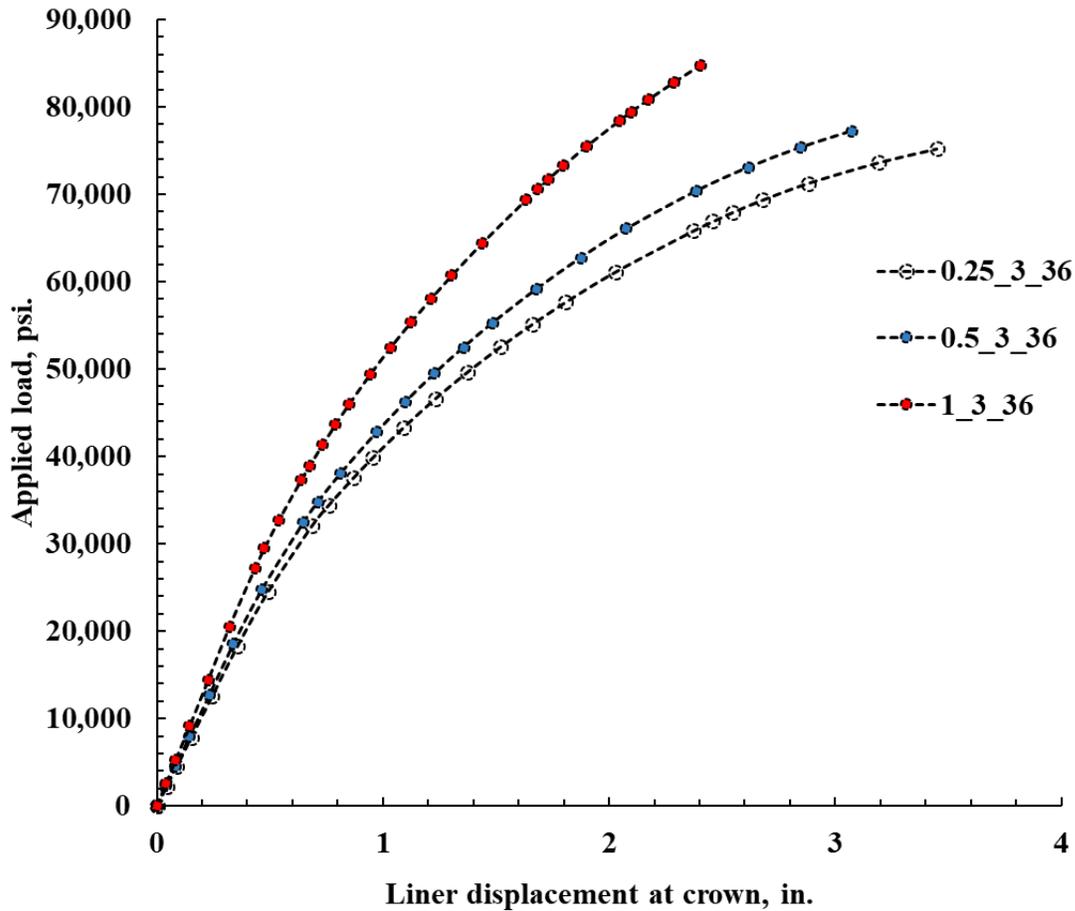
Figure 10E-19. Load displacement plot for invert-cut circular 36 in. CMPs with 3 ft cover and 0.25, 0.5, and 1 in. thick polymeric liner.

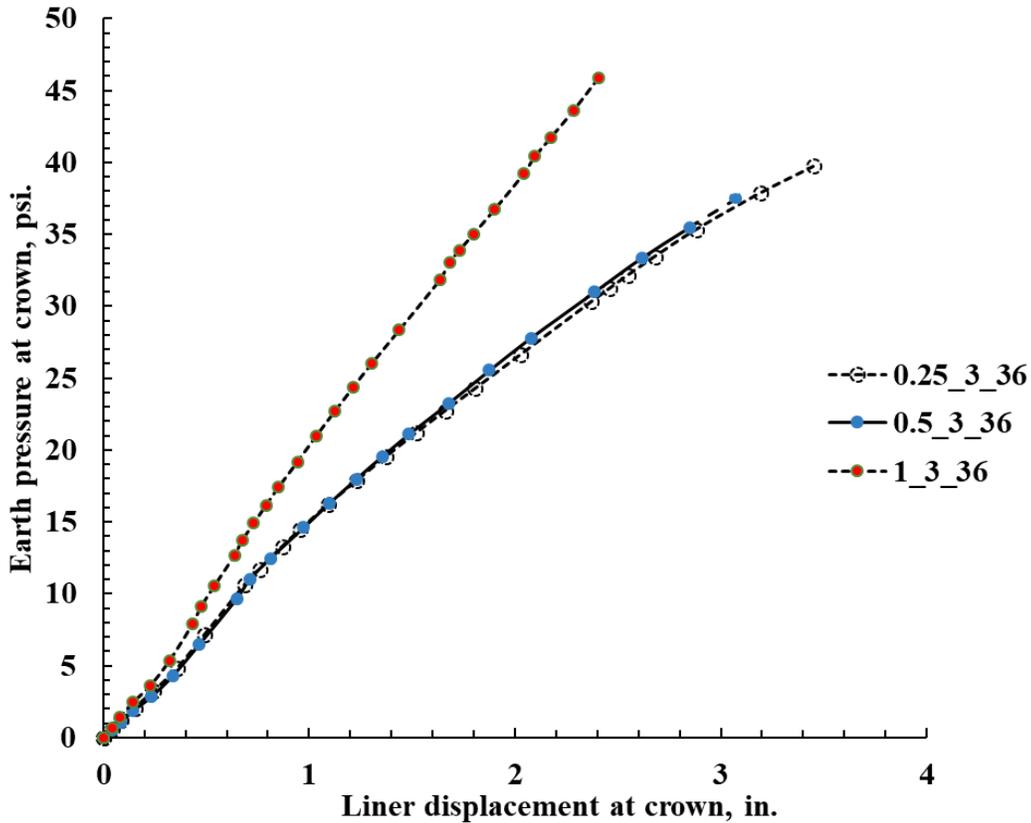
Figure 10E-20. Earth pressure at 4 in. above the crown vs. crown displacement for Invert-cut circular 36 in. CMPs with 3 ft cover and 0.25, 0.5, and 1 in. thick polymeric liner.
