Structural Design Methodology for Spray Applied Pipe Liners in Gravity Storm Water Conveyance Conduits

Prepared for:
 The Ohio Department of Transportation,
 Office of Statewide Planning & Research

Project ID Number: 103453

1. Report No. FHWA/OH-2021/10		2. Government Accession No.		3. Recipient's Catalog No.	
4. Title and Subtitle Structural Design Methodology for Spray Applied Pipe Liners in Gravity Storm Water Conveyance Conduits				5. Report Date April 2021

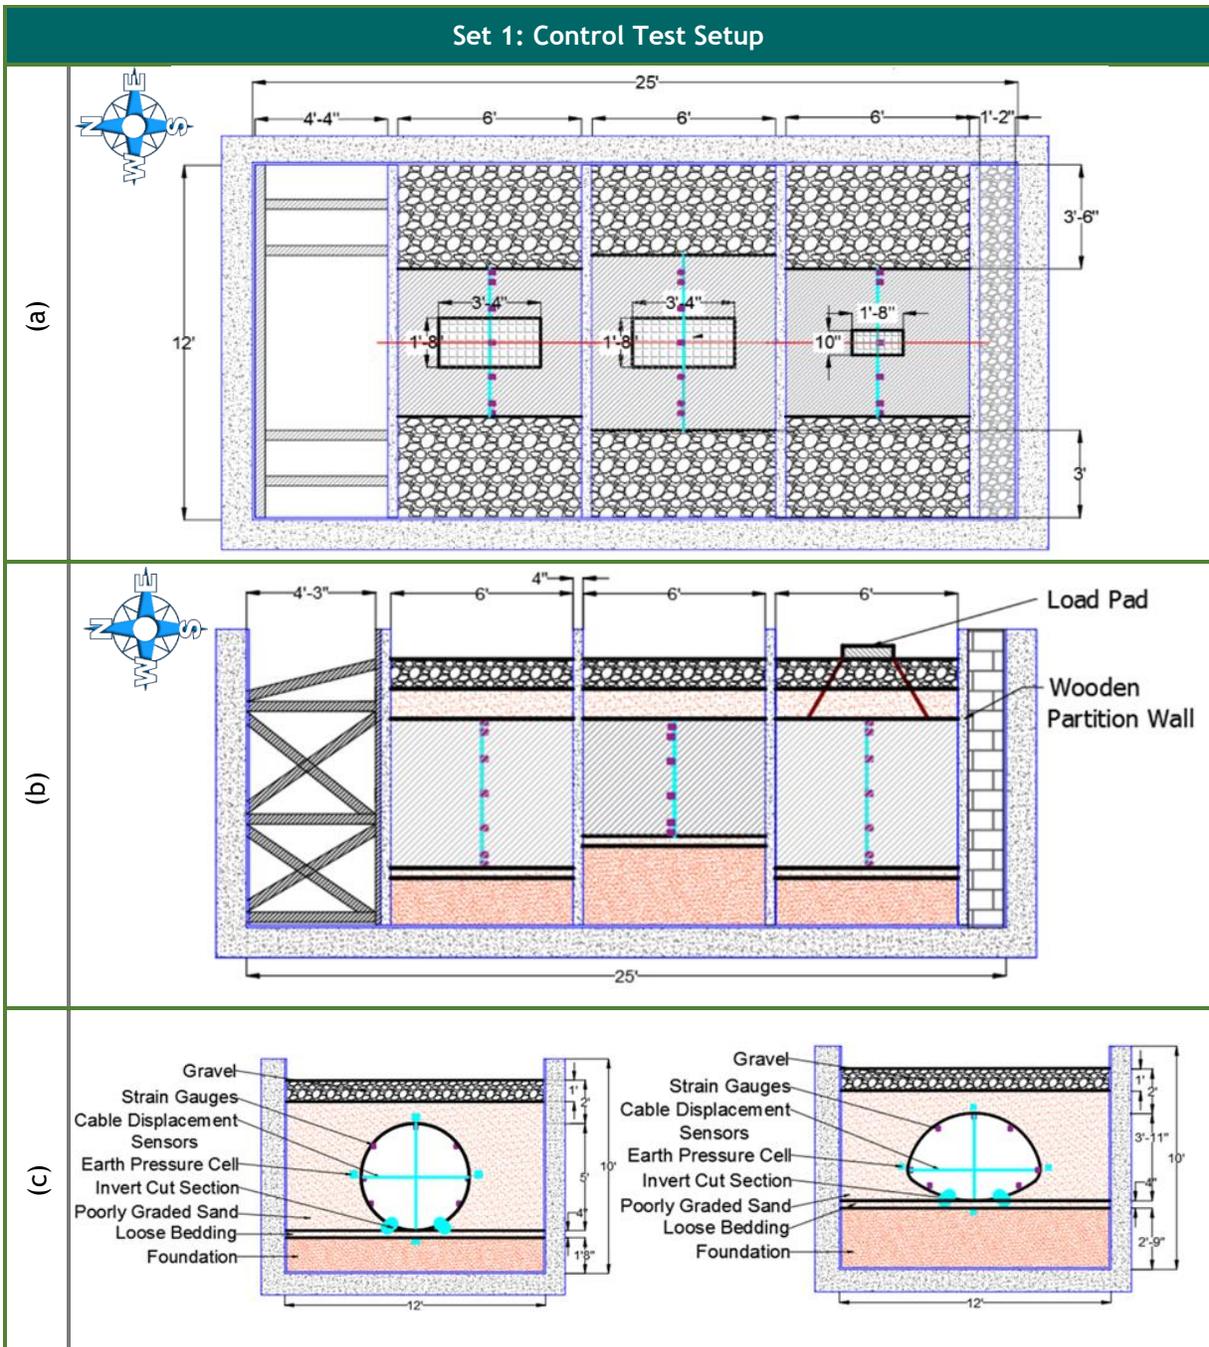
Figure 11-8. The CMPs' burial configuration (control test set): (a) plan view, (b) profile view of the aligned CMPs in the soil box, and (c) cross sectional view of both circular and CMP arch samples.

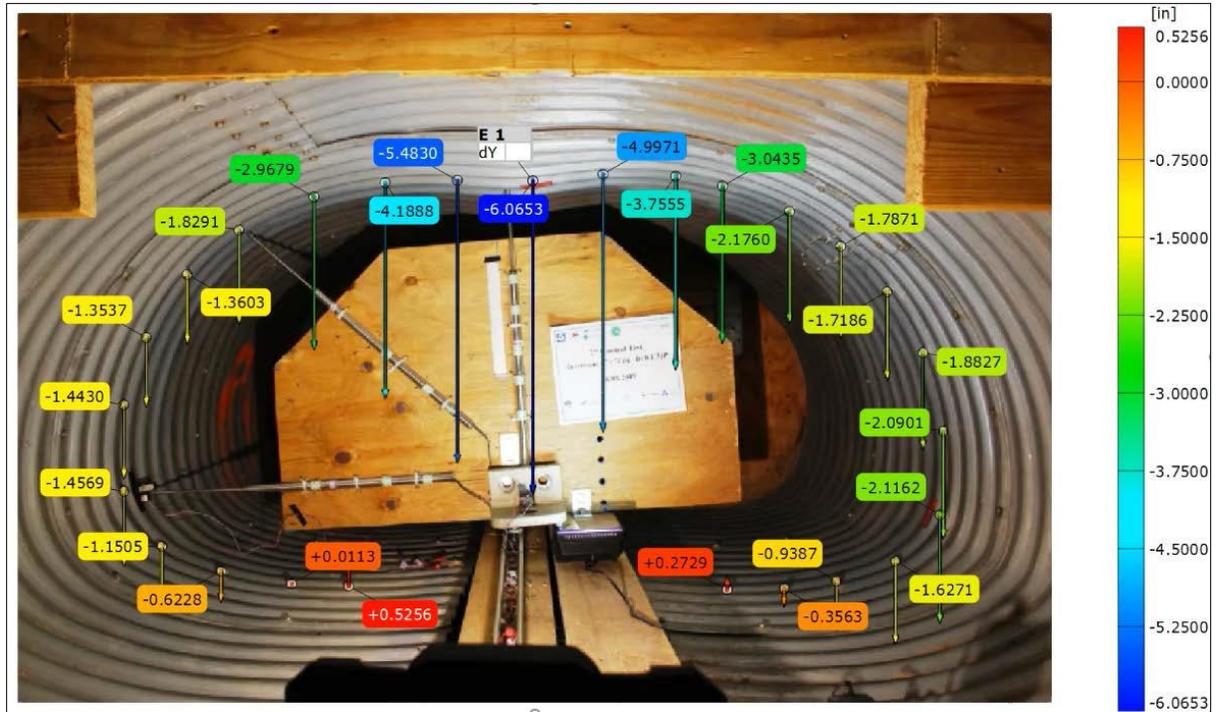
Figure 11-51. Result of DIC measurement at the end of the test (47×71 in. invert-cut arch CMP).

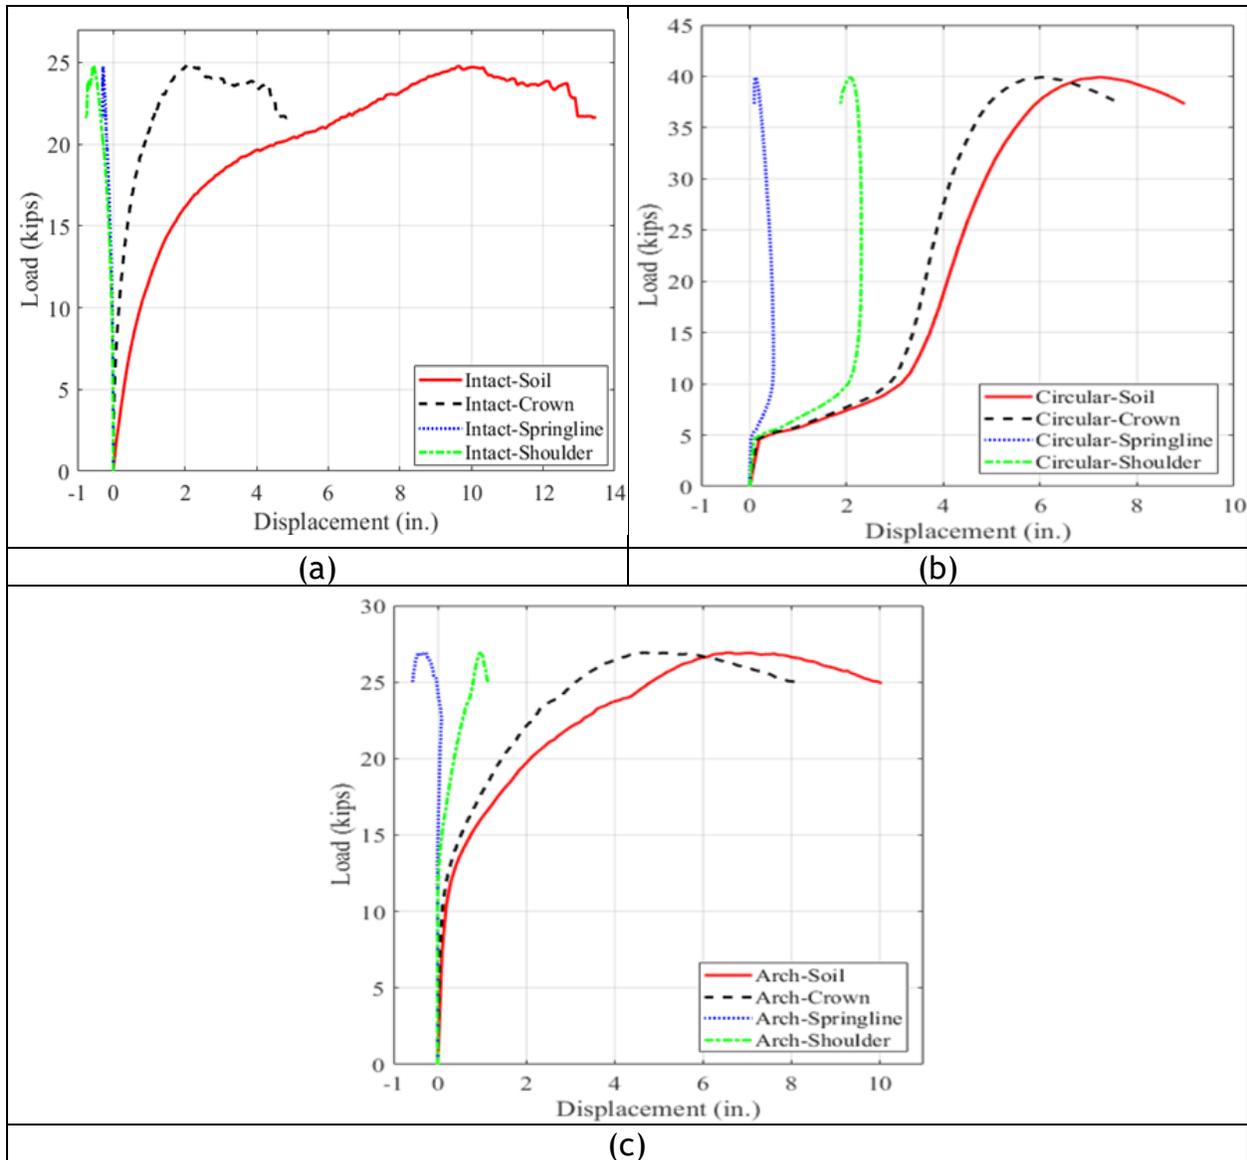
Figure 11-52. Load versus displacement of CMPs at different locations for the control test: (a) intact 60 in. circular CMP under a 10×20 in. steel load pad, (b) invert-cut 60 in. circular CMP under a 20×40 in. steel load pad, and (c) invert-cut 47×71 in. arch CMP under a 20×40 in. steel load pad.

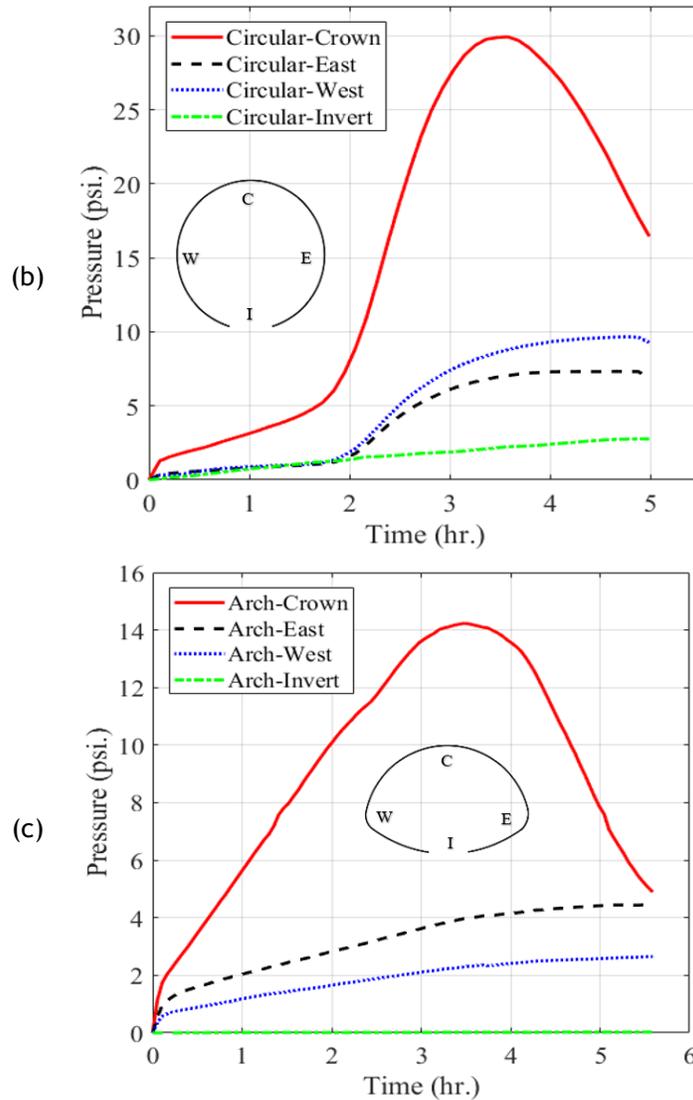
Figure 11-53. Results of earth pressure cells for the CMP control test: (a) intact circular CMP, (b) invert-cut circular CMP, and (c) invert-cut CMP arch.

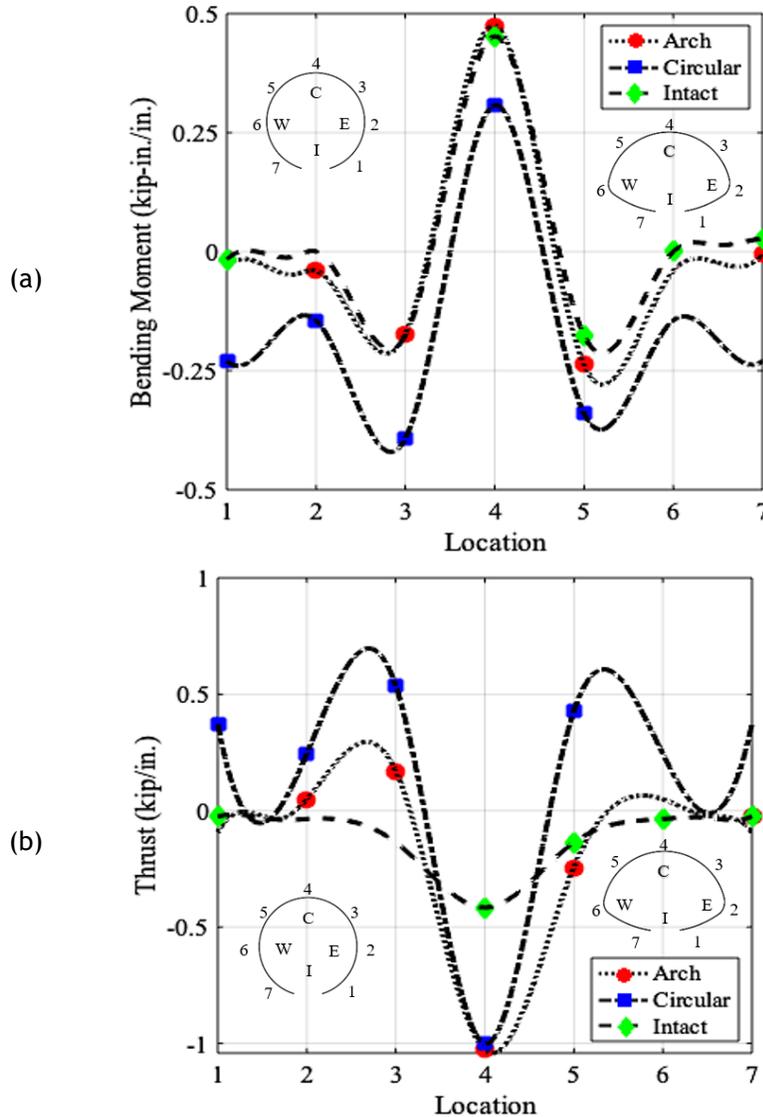
Figure 11-55. Internal forces on intact, invert-cut circular and invert-cut CMP arch samples: (a) bending moment, and (b) thrust forces for the invert-cut arch, invert-cut circular and circular intact CMPs.

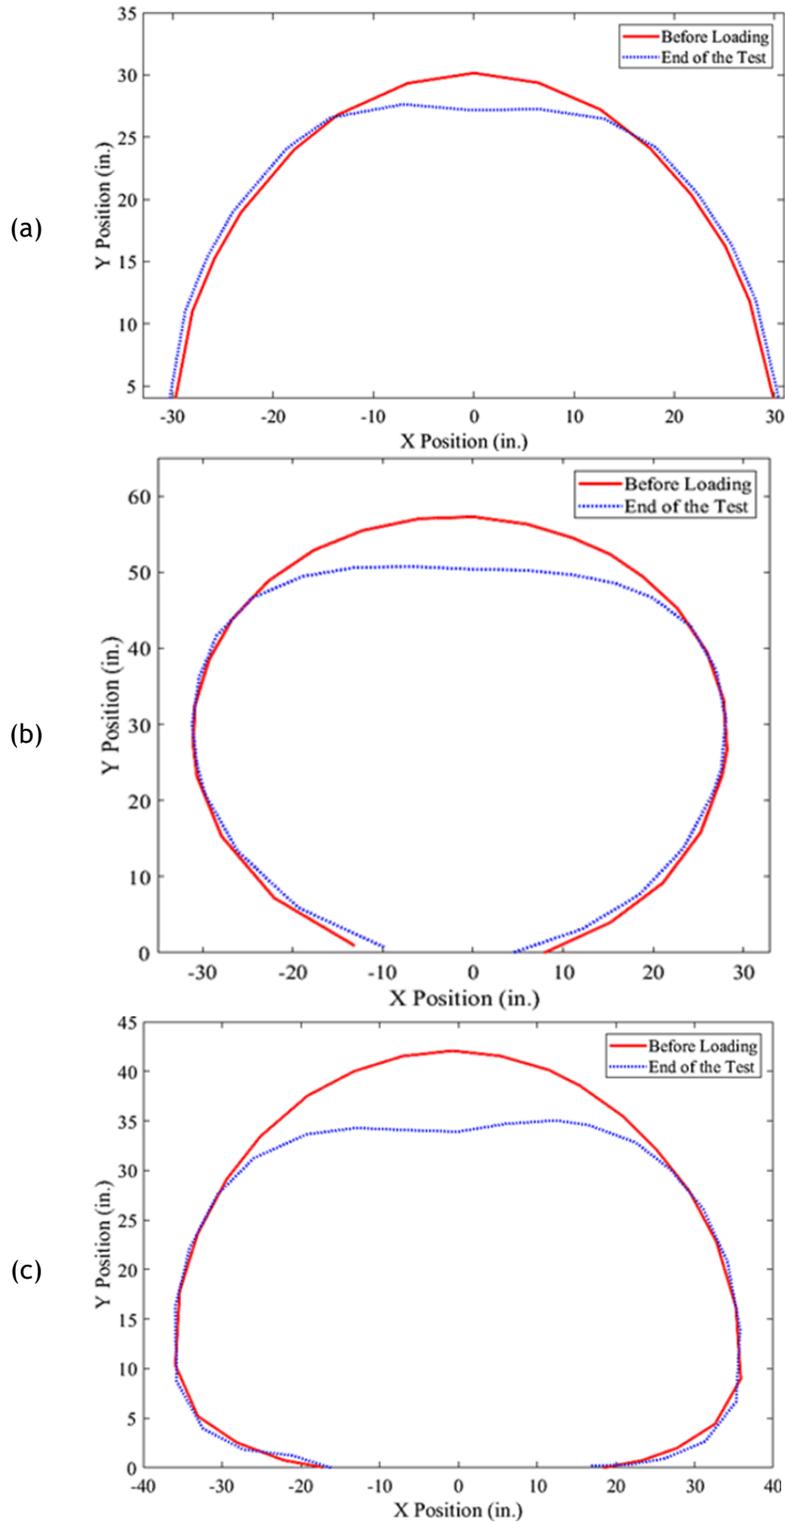
Figure 11-56. Pipe profiling using DIC results before loading and after loading at the ultimate load carrying capacity of the samples: (a) intact CMP, (b) invert-cut circular CMP, and (c) invert-cut CMP arch.

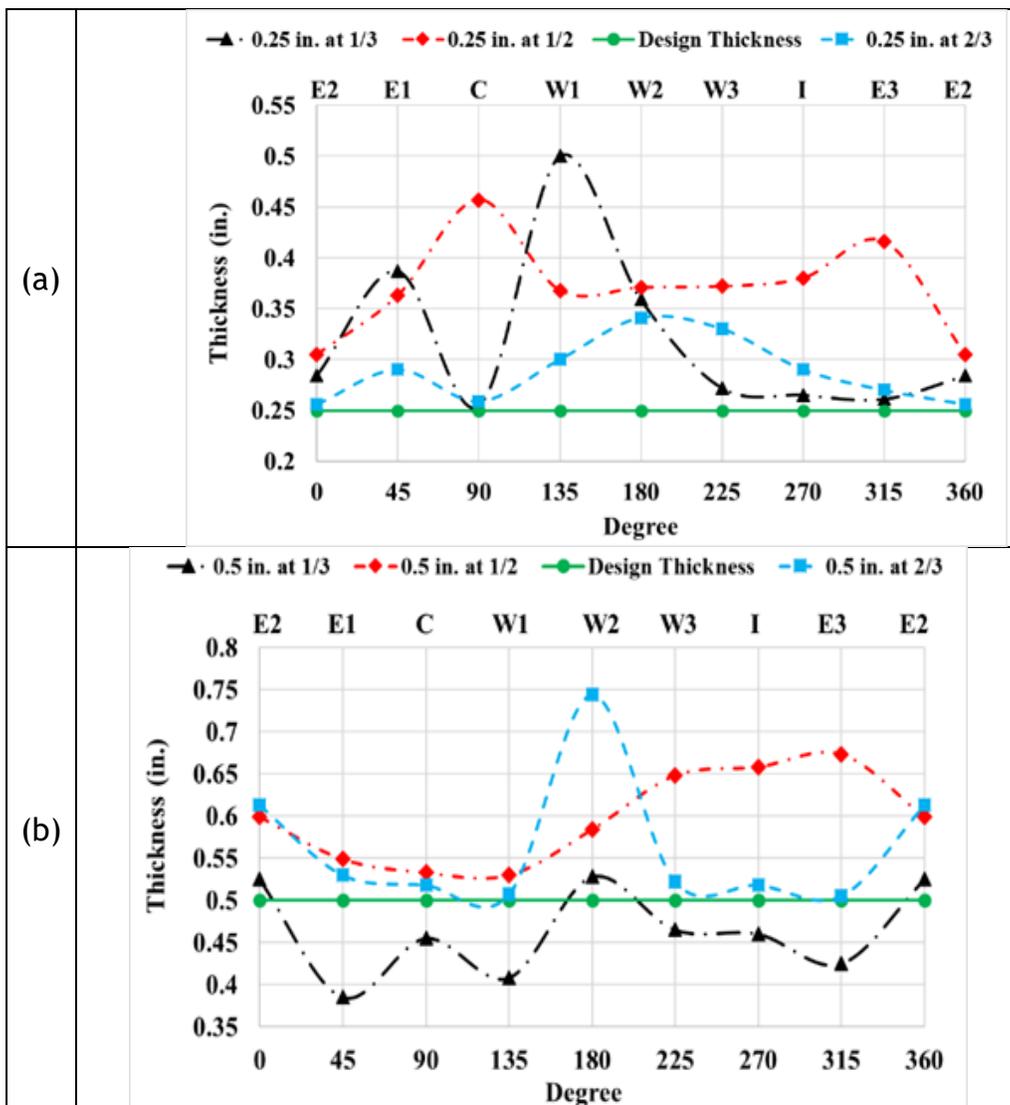
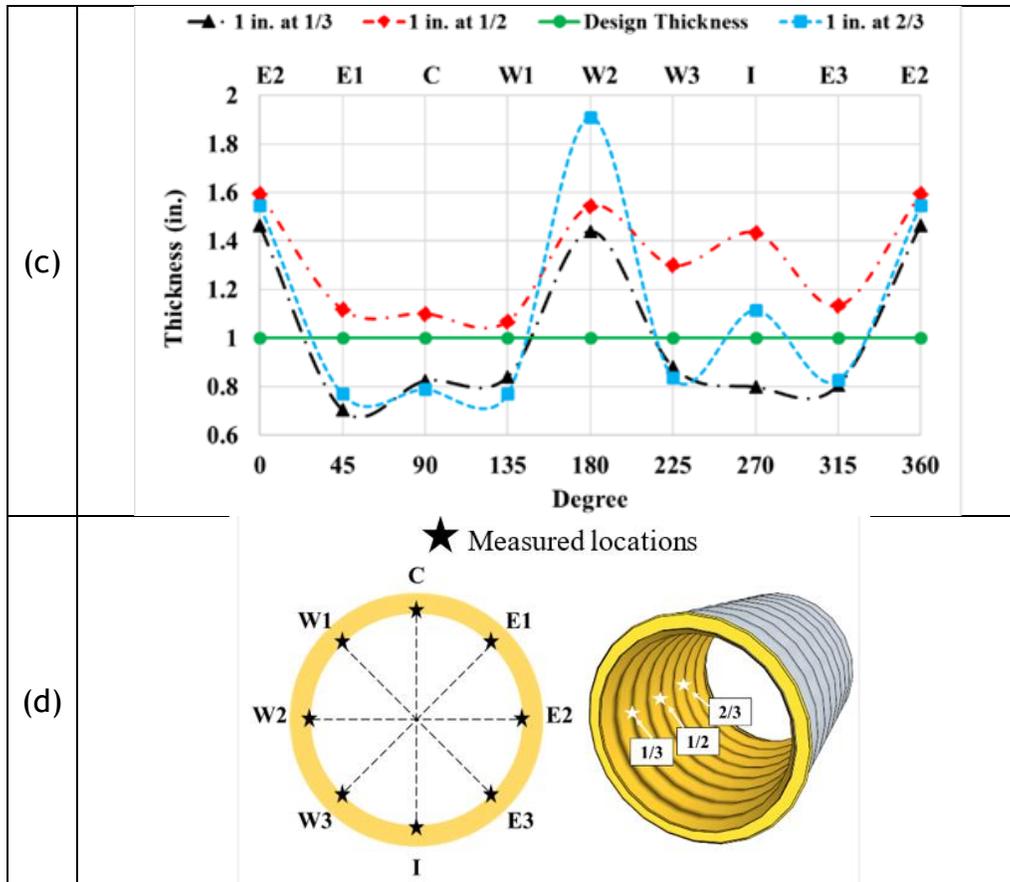
Figure 11-58. Thickness measurement results of polymeric SAPL renewed circular CMPs: (a) 0.25 in. thick SAPL, (b) 0.5 in. thick SAPL, (c) 1 in. thick SAPL, and (d) measured locations in circumferential and longitudinal direction.

- The results of thickness measurement showed that the utilization of hand spray for installation of the polymeric SAPL resulted in a thicker liner at the springline for all renewed CMPs than the designated thickness. However, the SAPL was installed closer to the required thickness at crown and both shoulders. One of the possible reasons for the inconsistent thickness installation could be due to the sagging and movement of the SAPL material at the initial stage (i.e., before hardening) of installation due to gravity.

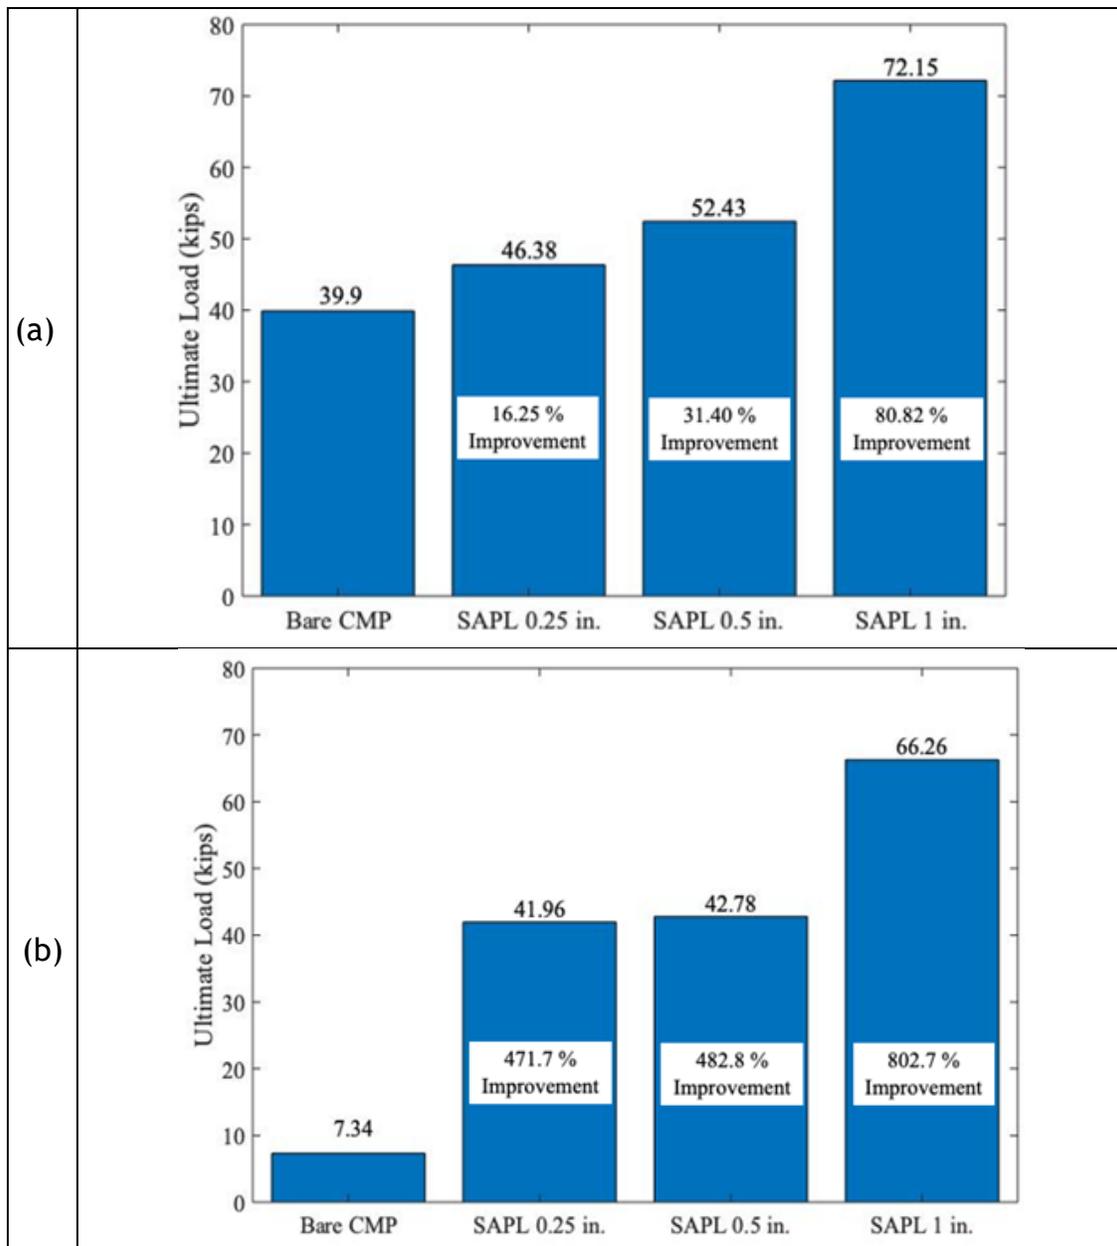
Figure 11-61. Load improvement by SAPL application: (a) ultimate load comparison of renewed SAPL circular CMPs with bare CMP, and (b) load comparison of renewed SAPL CMPs with bare CMP at 2 in. pipe deflection.

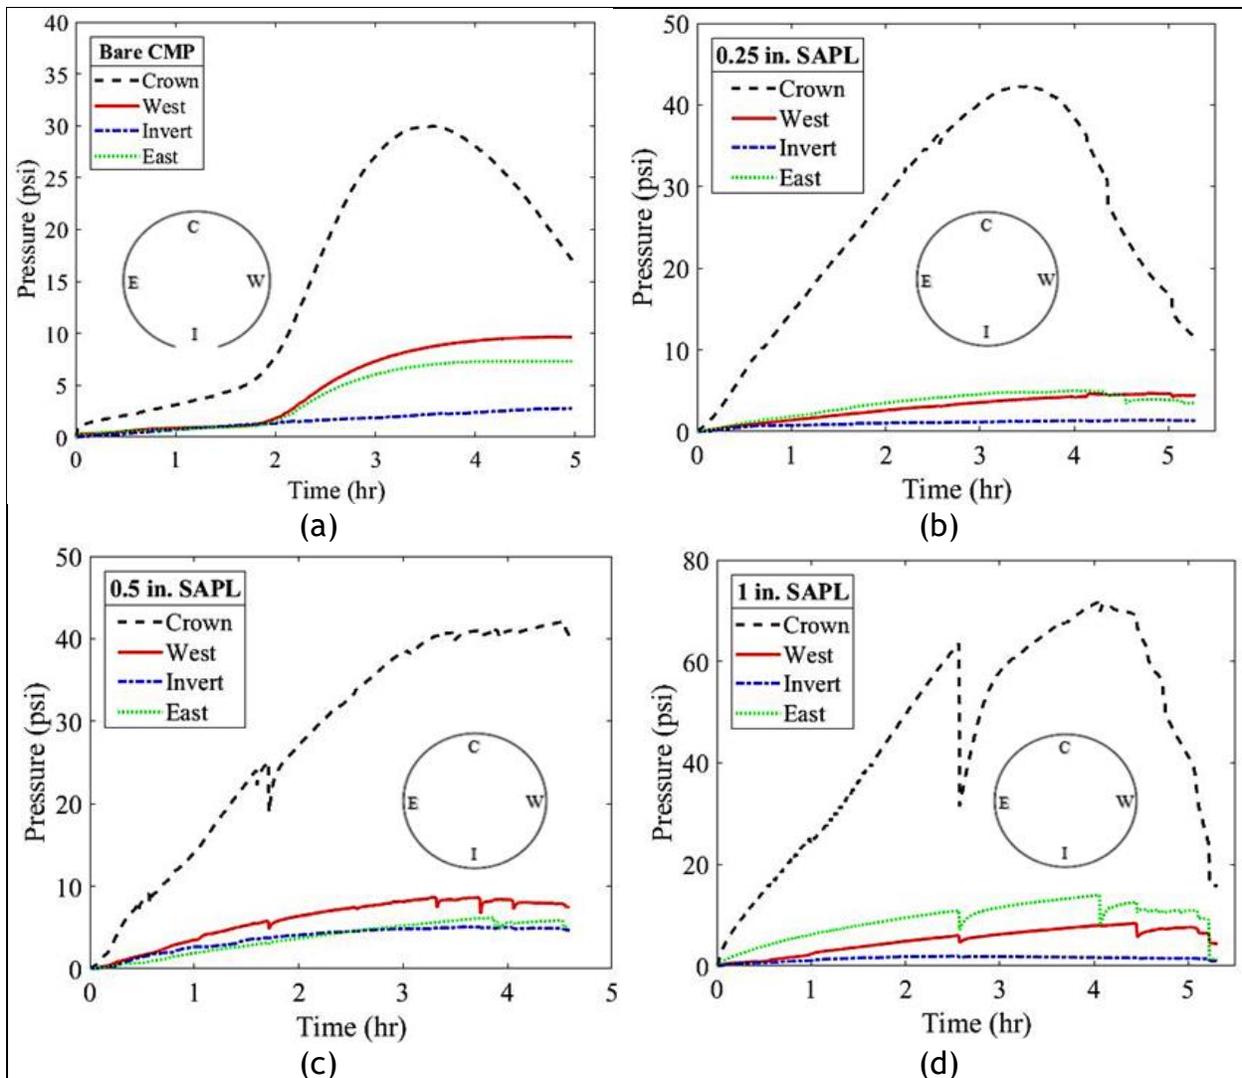
Figure 11-62. Earth pressure cells' results: (a) bare circular CMP, (b) 0.25 in. SAPL renewed circular CMP (c) 0.5 in. SAPL renewed circular CMP and (d) 1 in. SAPL renewed circular CMP.

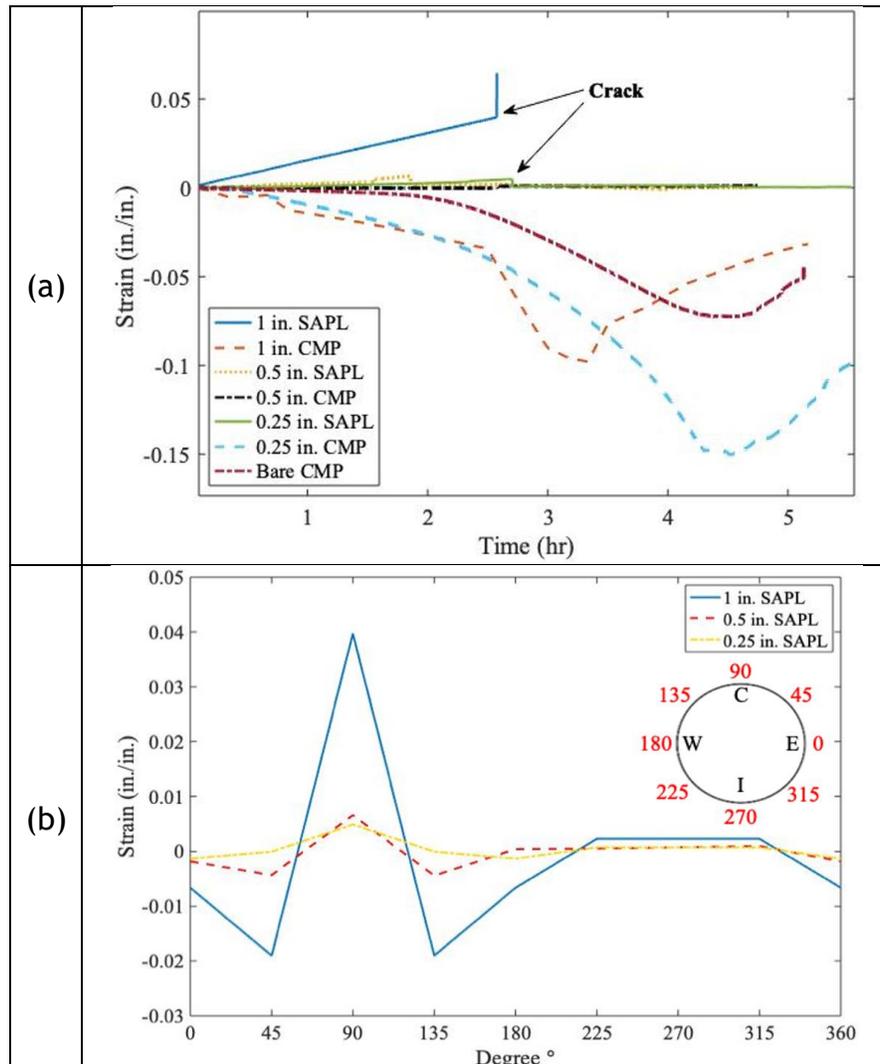
Figure 11-63. Strain gauge results for SAPL renewed circular CMP: (a) at the crown and (b) around the SAPL at the time of first structural crack.

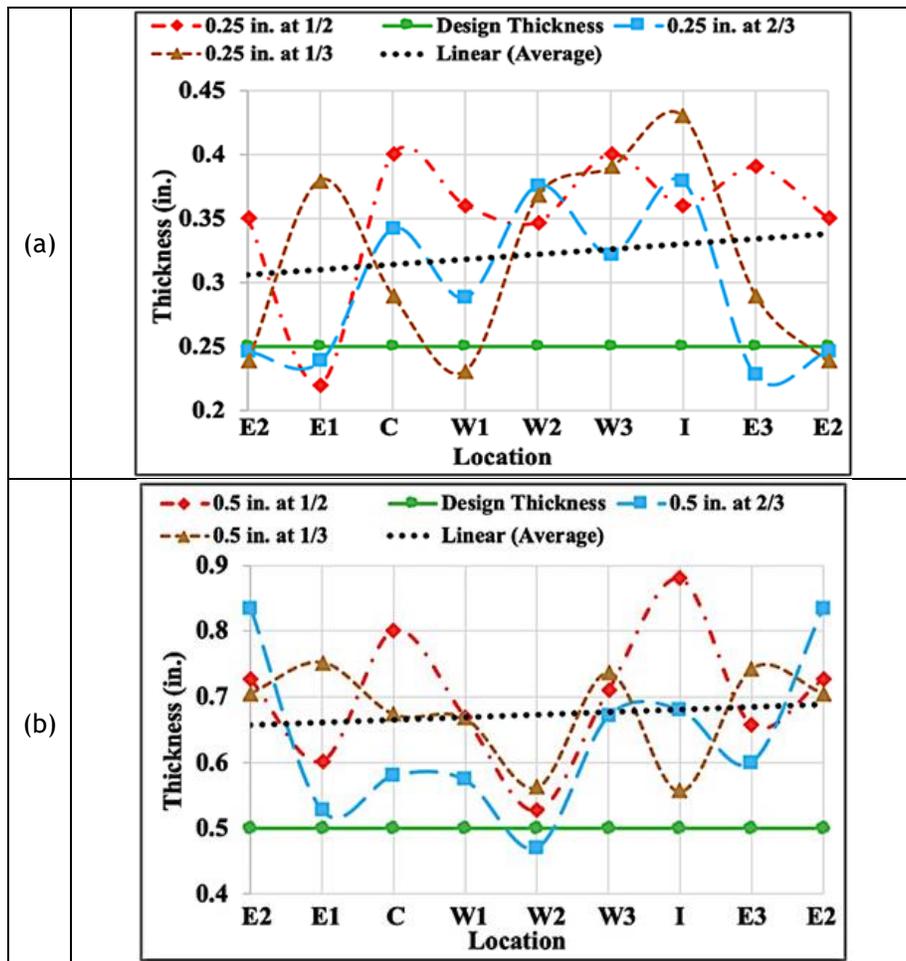
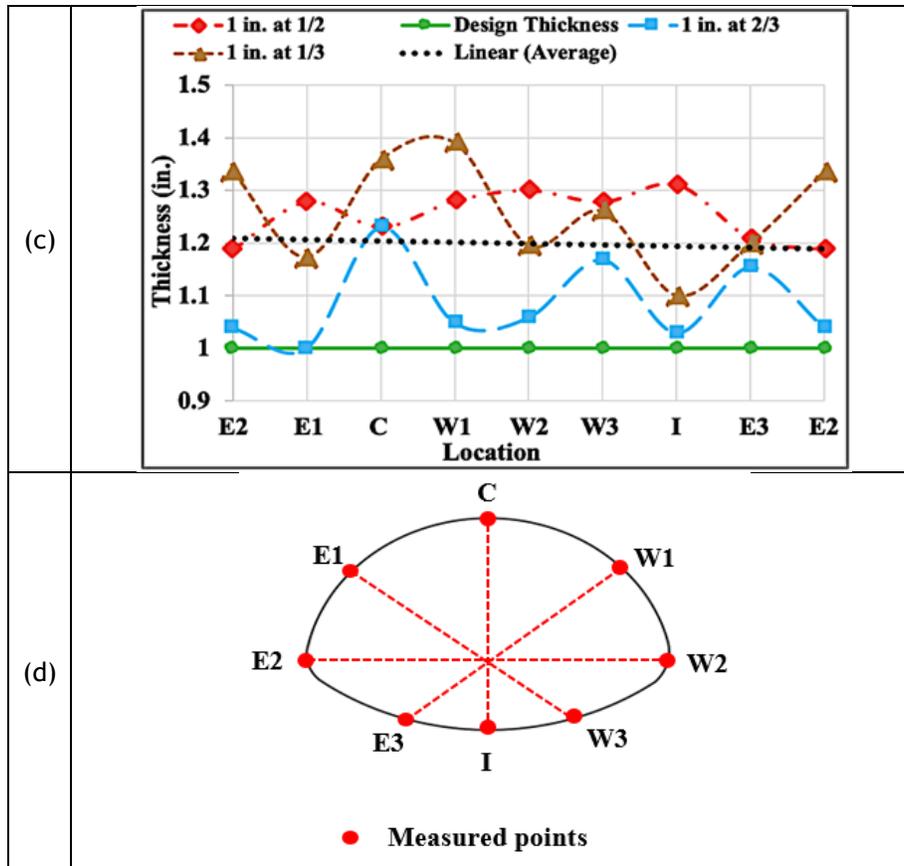
Figure 11-66. Thickness measurement results of polymeric SAPL renewed CMPAs: (a) quarter, (b) half, (c) one inch SAPL renewed CMP arch samples, and (d) measured locations in circumferential direction.

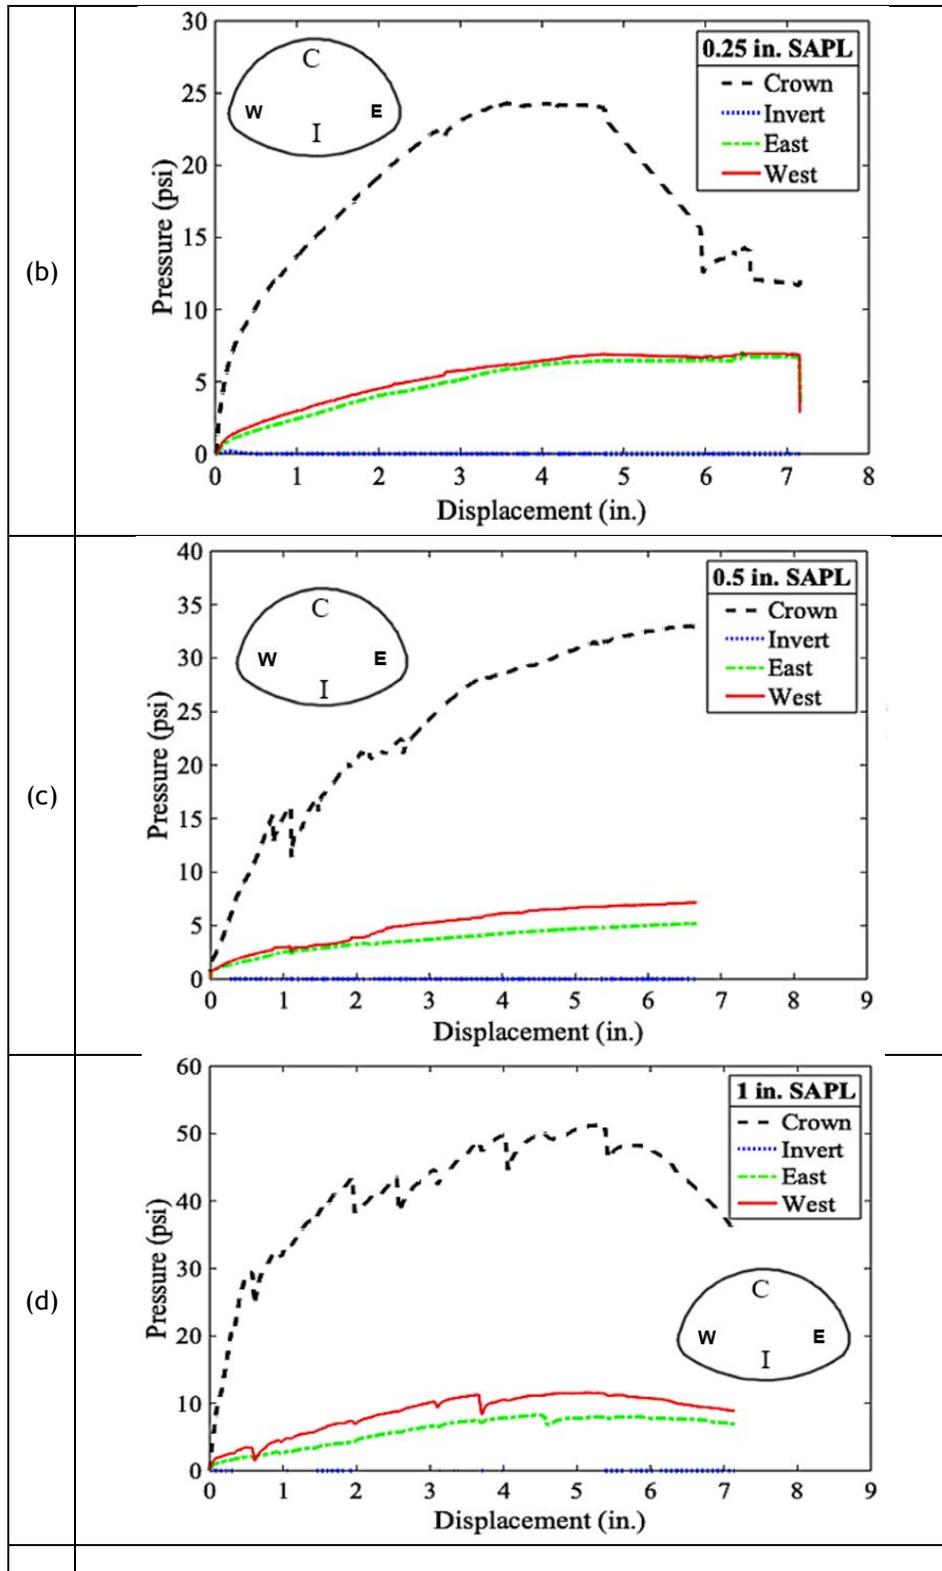
Figure 11-71. Pressure vs. crown displacement graphs: (a) invert-cut bare CMP arch, (b) 0.25 in. SAPL renewed CMP arch, (c) 0.5 in. SAPL renewed CMP arch, and (d) 1 in. SAPL renewed CMP arch.

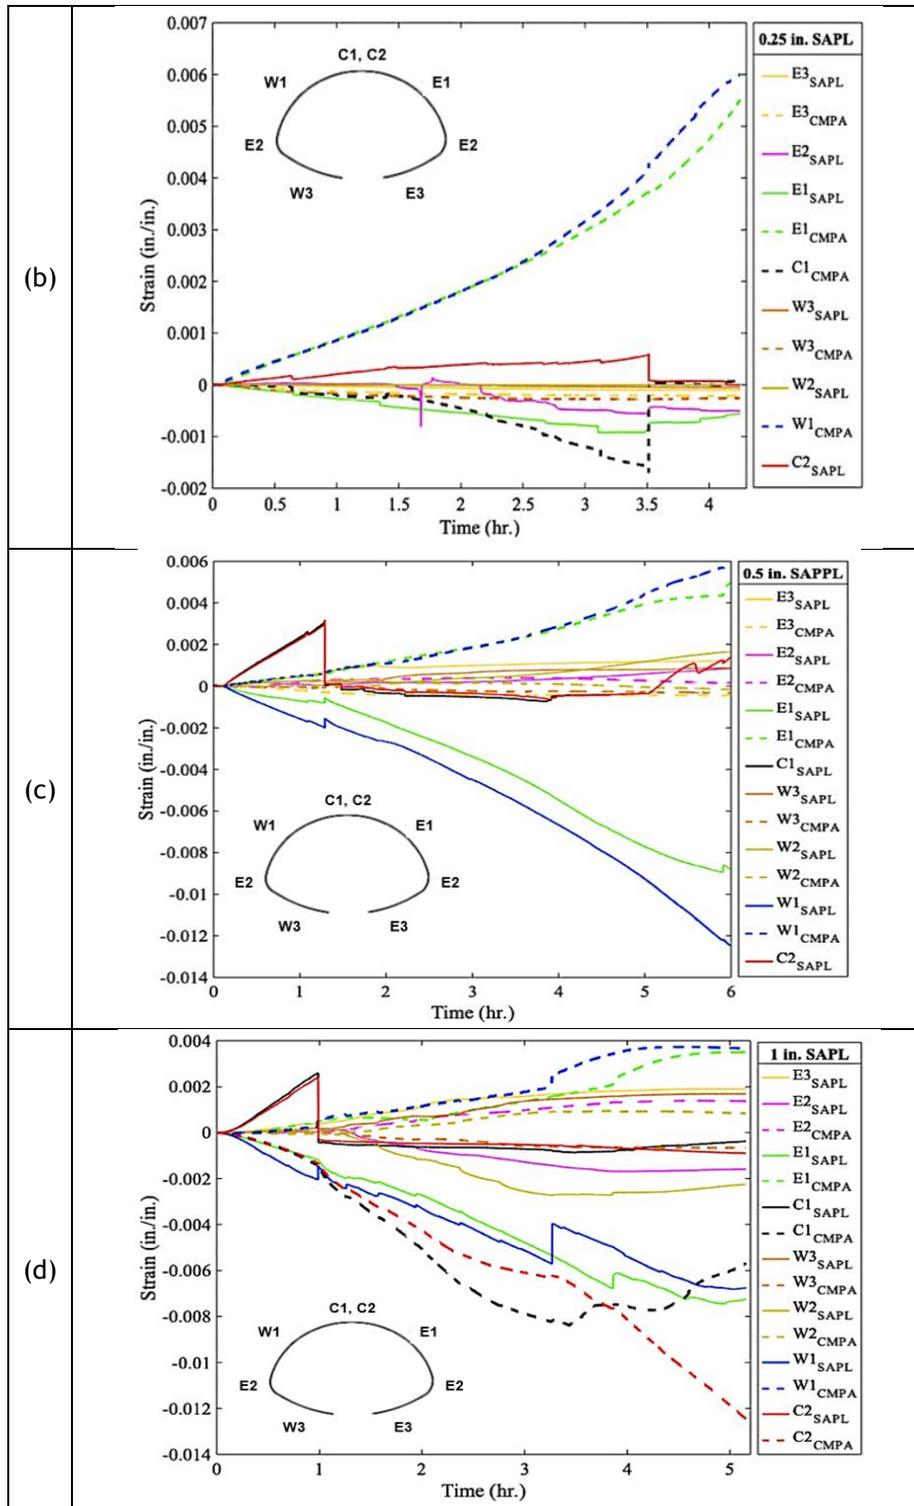
Figure 11-73. Strain gauge results: (a) invert-cut bare CMP arch, (b) 0.25 in. SAPL renewed CMP arch, (c) 0.5 in. SAPL renewed CMP arch, and (d) 1 in. SAPL renewed CMP arch.

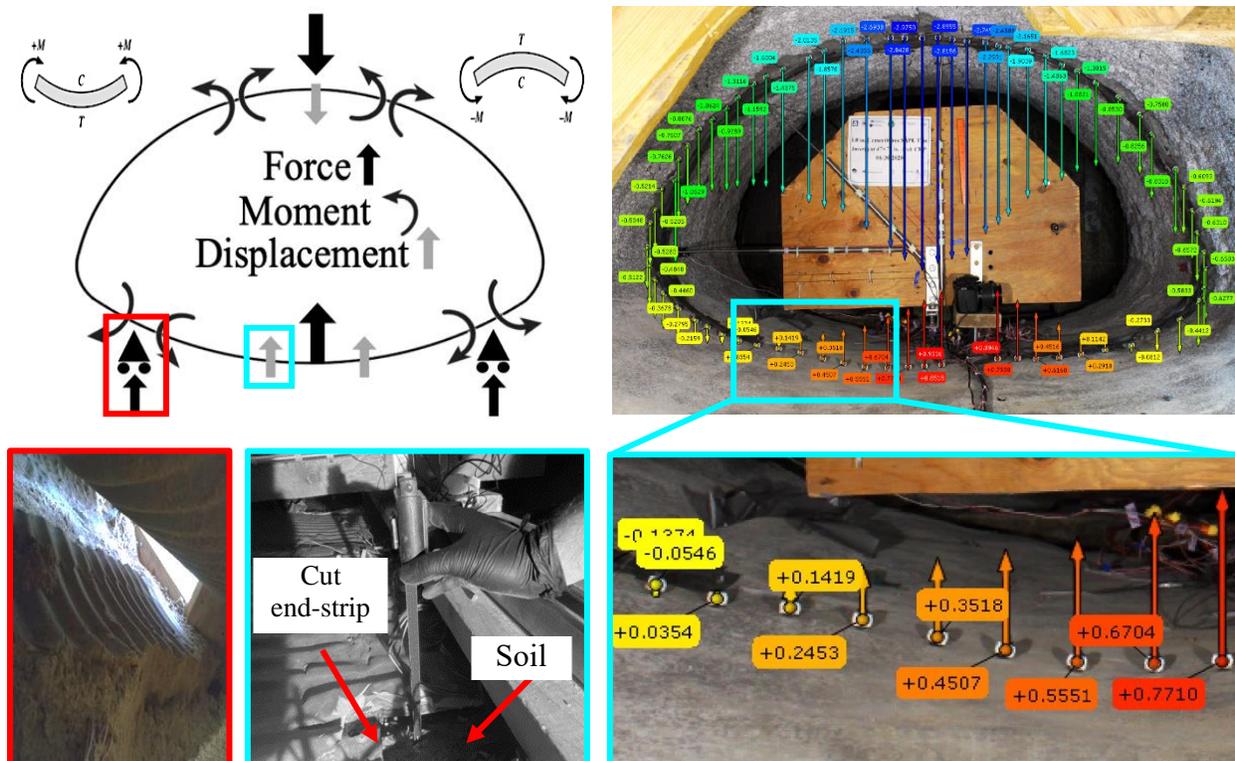
Figure 11-76. CMP arch behavior due to the vertical load, where the red boxes show the soil support under the pipe on the west haunch area and the blue boxes illustrates the pipe upward movement.

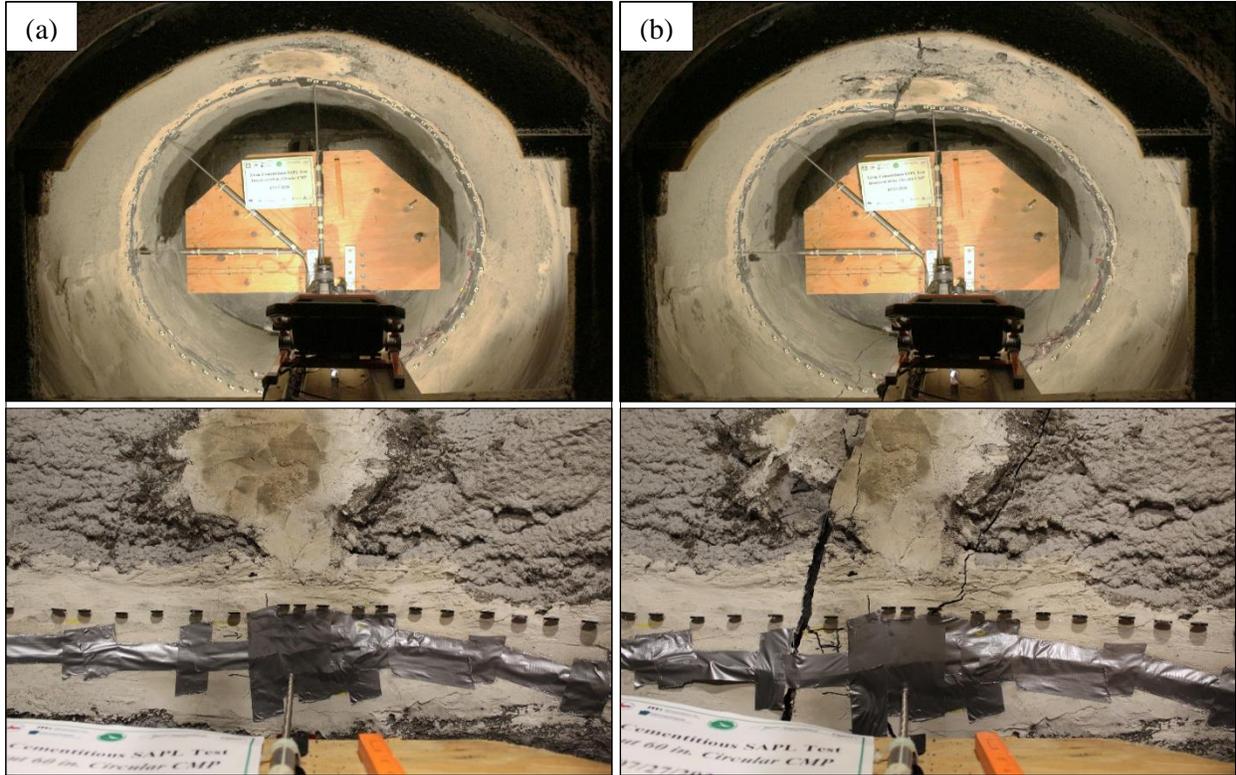
Figure 11-109. Invert-cut circular CMP renewed with 3 in. cementitious SAPL:
 (a) before loading, and (b) after loading.

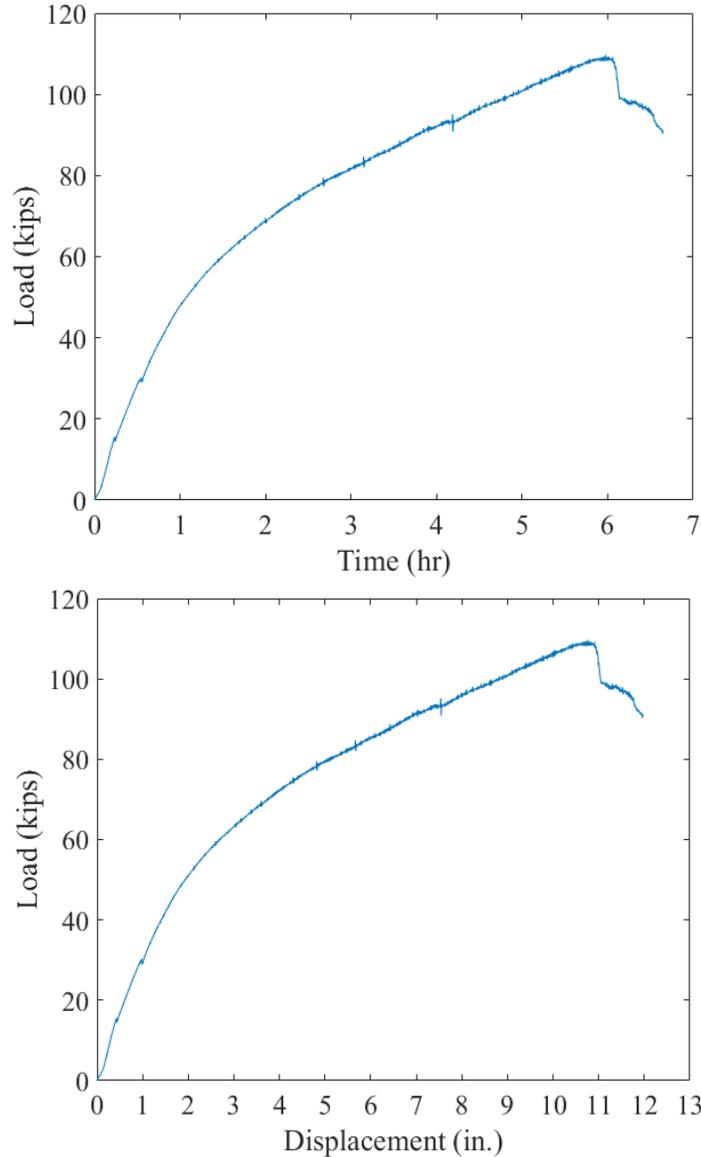
Figure 11-110. Invert-cut circular CMP renewed with 3-in. thick cementitious SAPL subjected to static live load: (top) load-time, and (bottom) load-soil displacement graphs.

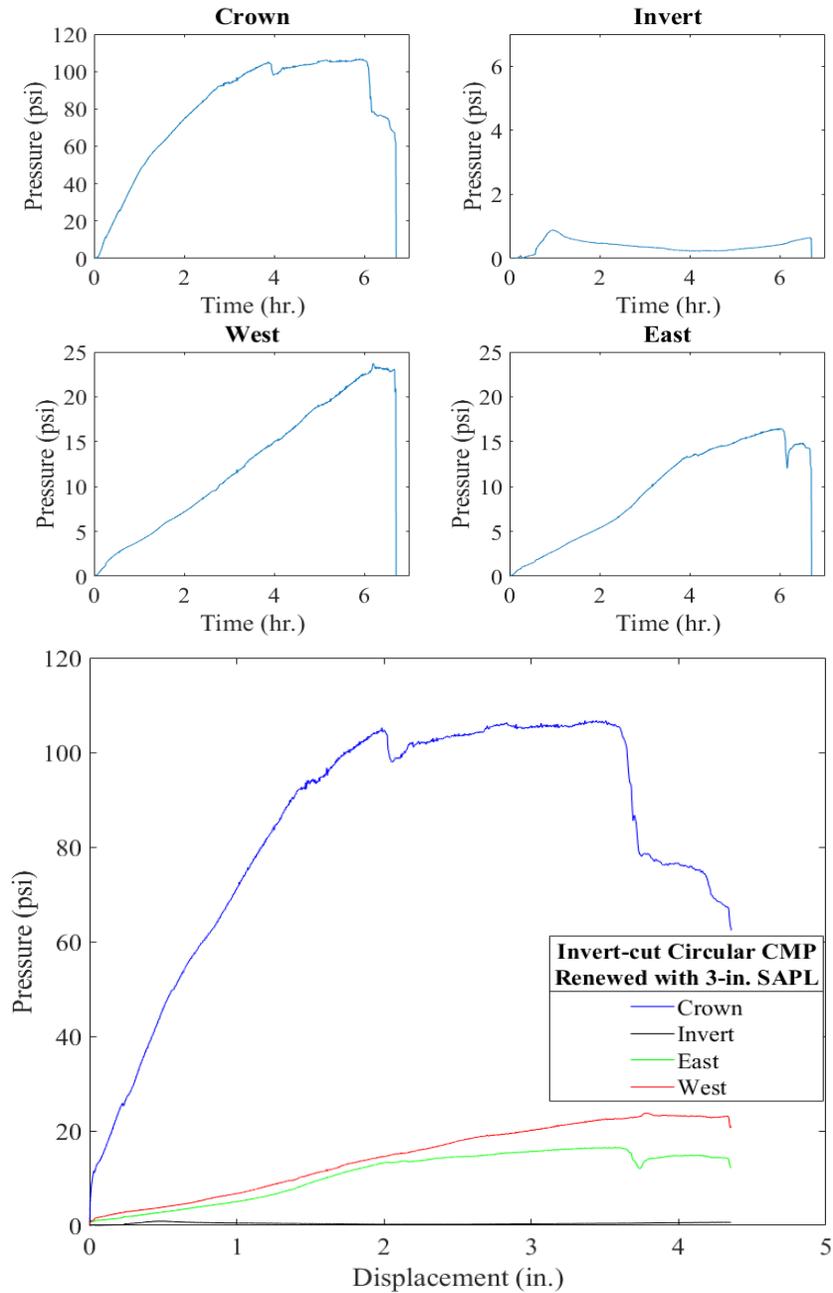
Figure 11-111. Earth pressure cell results for the 3-in. thick SAPL renewed invert-cut circular CMP with respect to: (top) time, and (bottom) crown displacement.

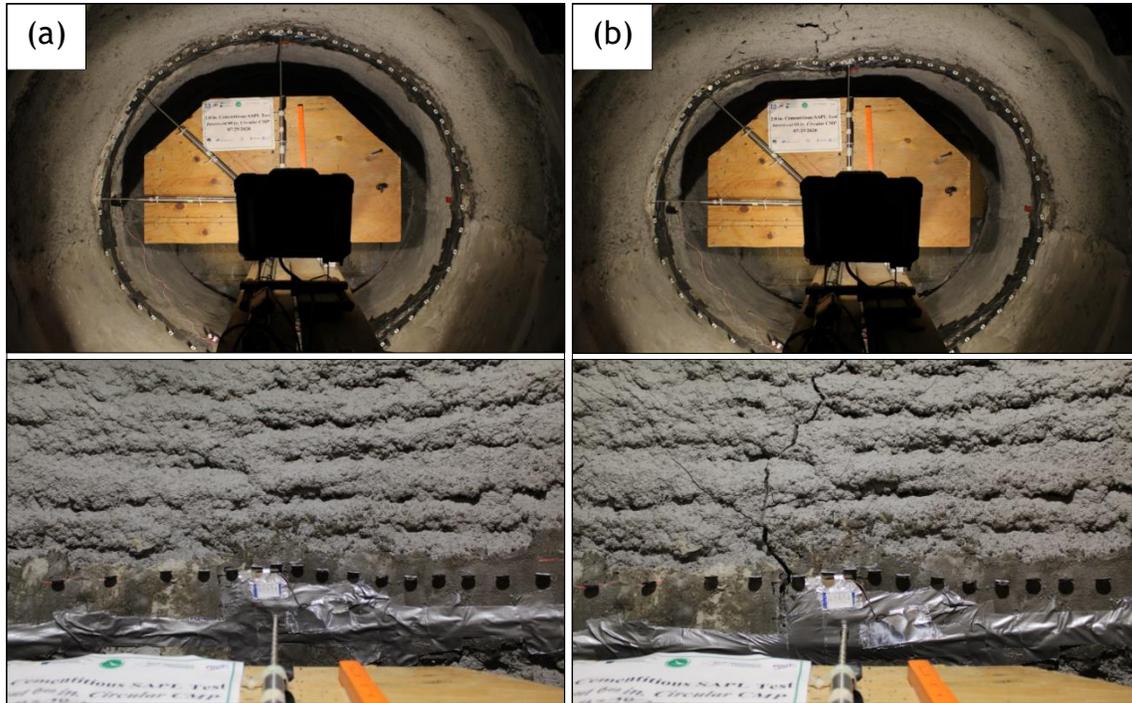
Figure 11-118. Invert-cut circular CMP renewed with 2 in. cementitious SAPL: (a) before loading, and (b) after loading.
