Structural Design Methodology for Spray Applied Pipe Liners in Gravity Storm Water Conveyance Conduits

Prepared for:
 The Ohio Department of Transportation,
 Office of Statewide Planning & Research

Project ID Number: 103453

1. Report No. FHWA/OH-2021/10		2. Government Accession No.		3. Recipient's Catalog No.	
4. Title and Subtitle Structural Design Methodology for Spray Applied Pipe Liners in Gravity Storm Water Conveyance Conduits				5. Report Date April 2021

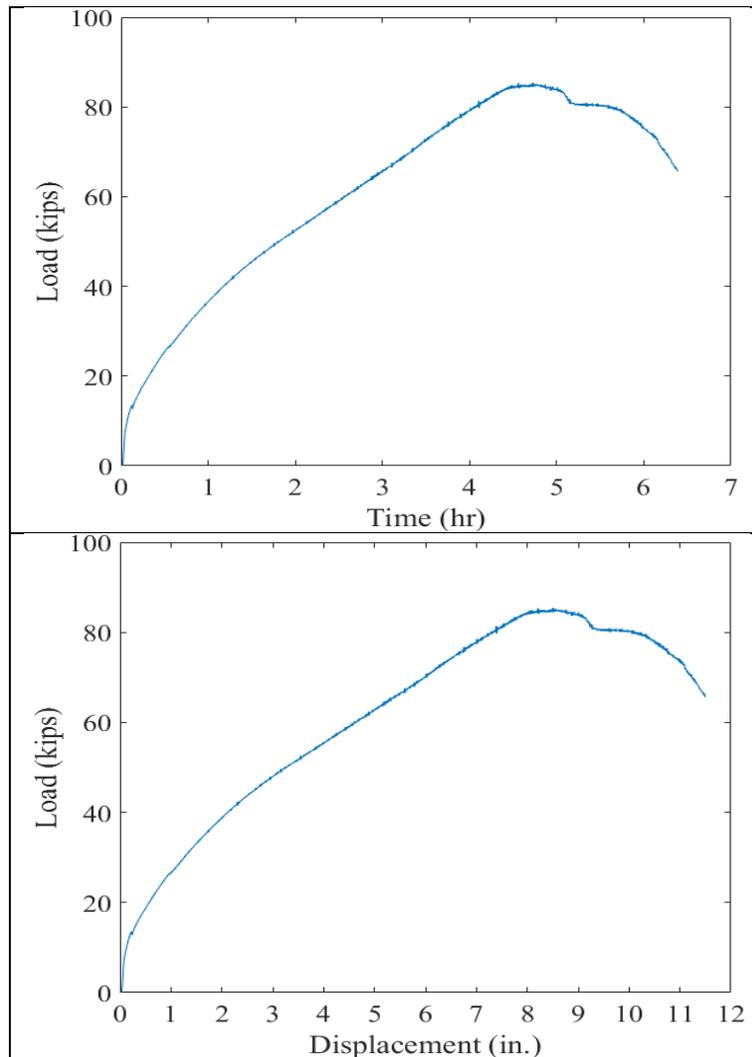
Figure 11-119. Invert-cut circular CMP renewed with 2-in. thick cementitious SAPL subjected to static live load: (top) load-time, and (bottom) load-soil displacement graphs.

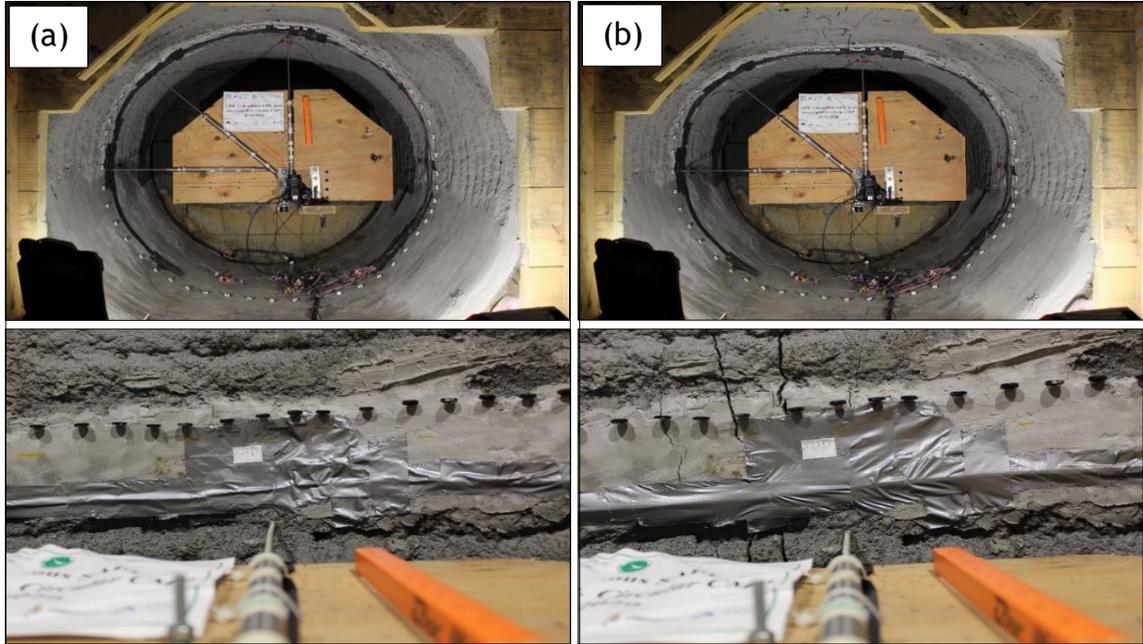
Figure 11-127. Invert-cut circular CMP renewed with 1 in. cementitious SAPL:
(a) before loading, and (b) after loading.

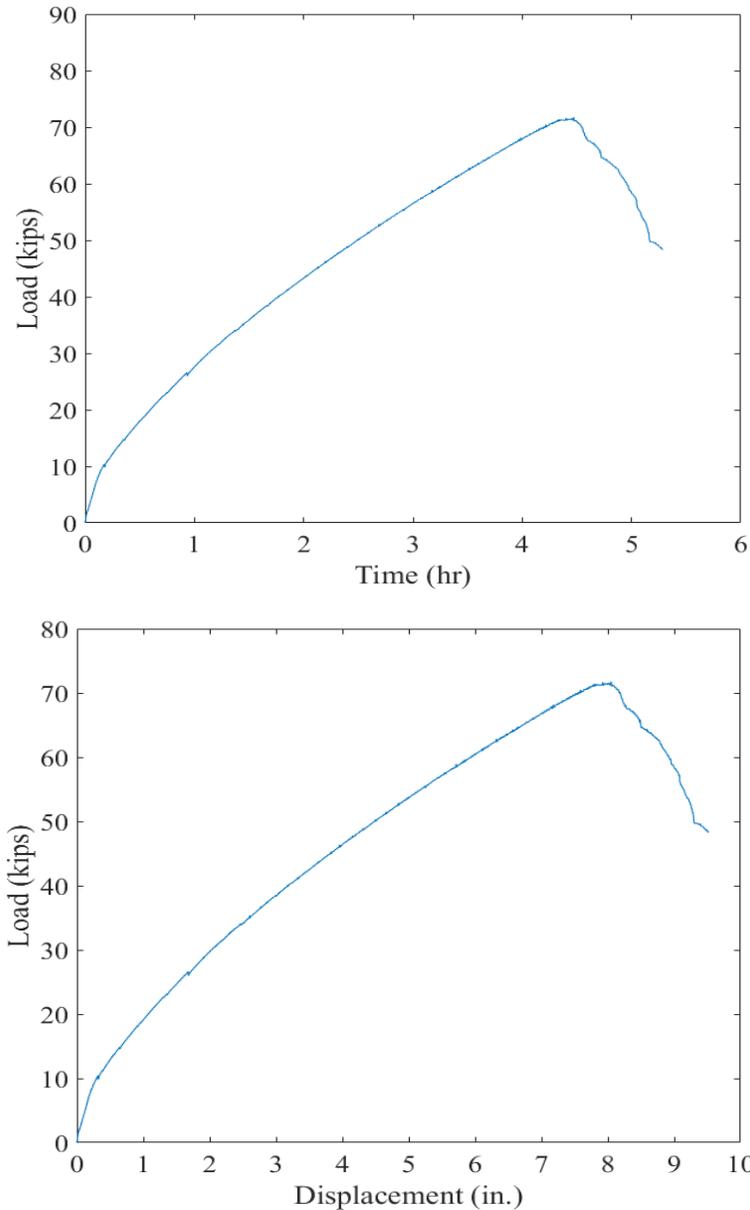
Figure 11-128. Invert-cut circular CMP renewed with 1-in. thick cementitious SAPL subjected to static live load: (top) load-time, and (bottom) load-soil displacement graphs.

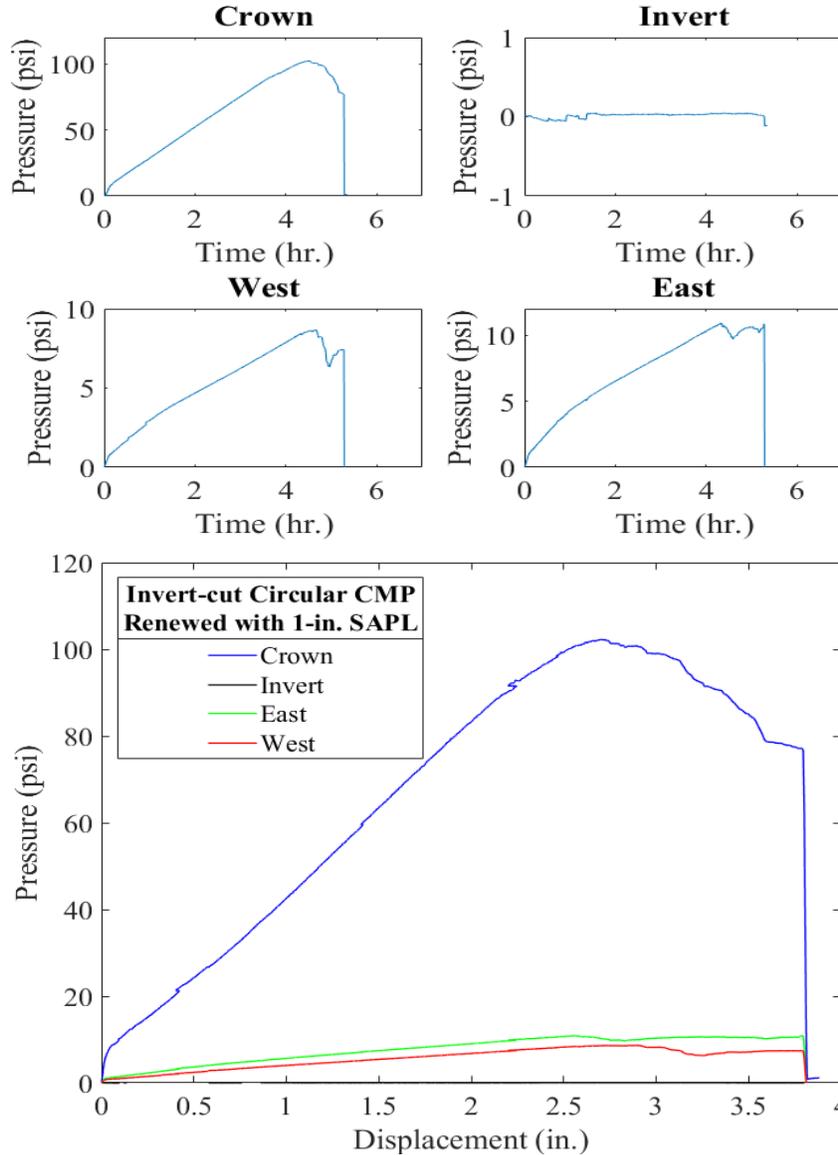
Figure 11-129. Earth pressure cell results for the 1-in. thick SAPL renewed invert-cut circular CMP with respect to: (top) time, and (bottom) crown displacement.

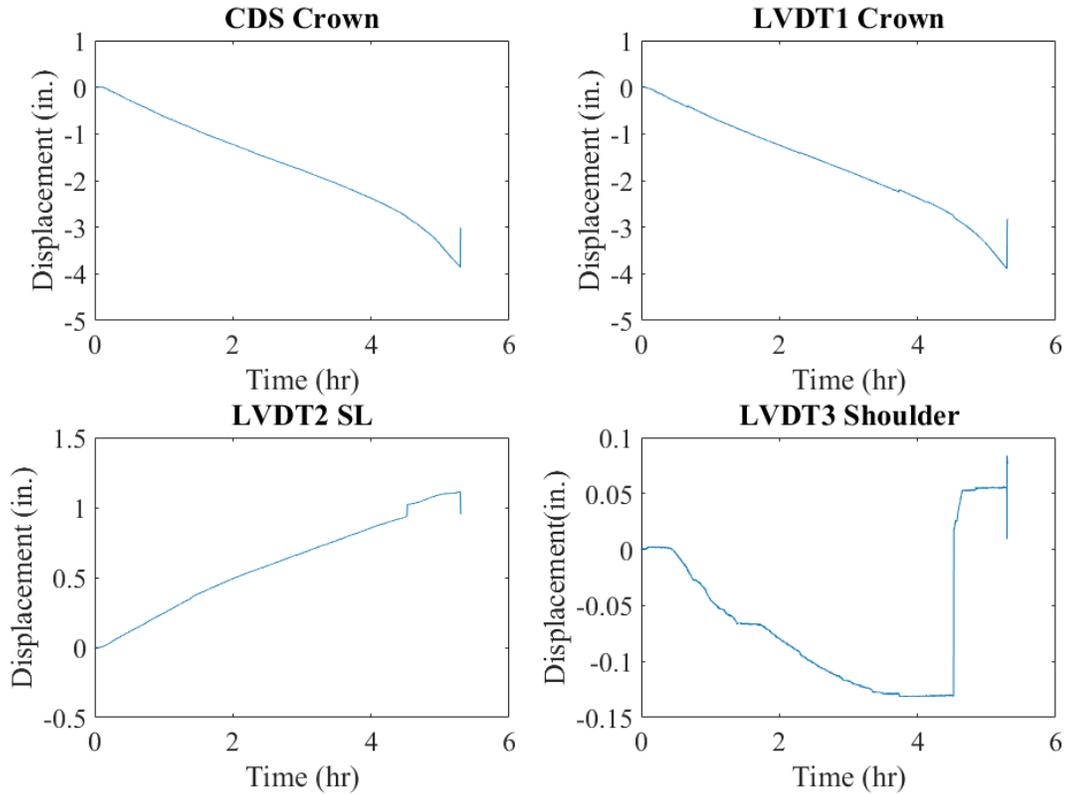
Figure 11-130. Mechanical sensors result for 1-in. thick SAPL renewed invert-cut circular CMP.
